Addressing Slope Failures involving Problematic Soils in Kansas

Amanda Keeney, P.E.
Geotechnical Asset Management Engineer

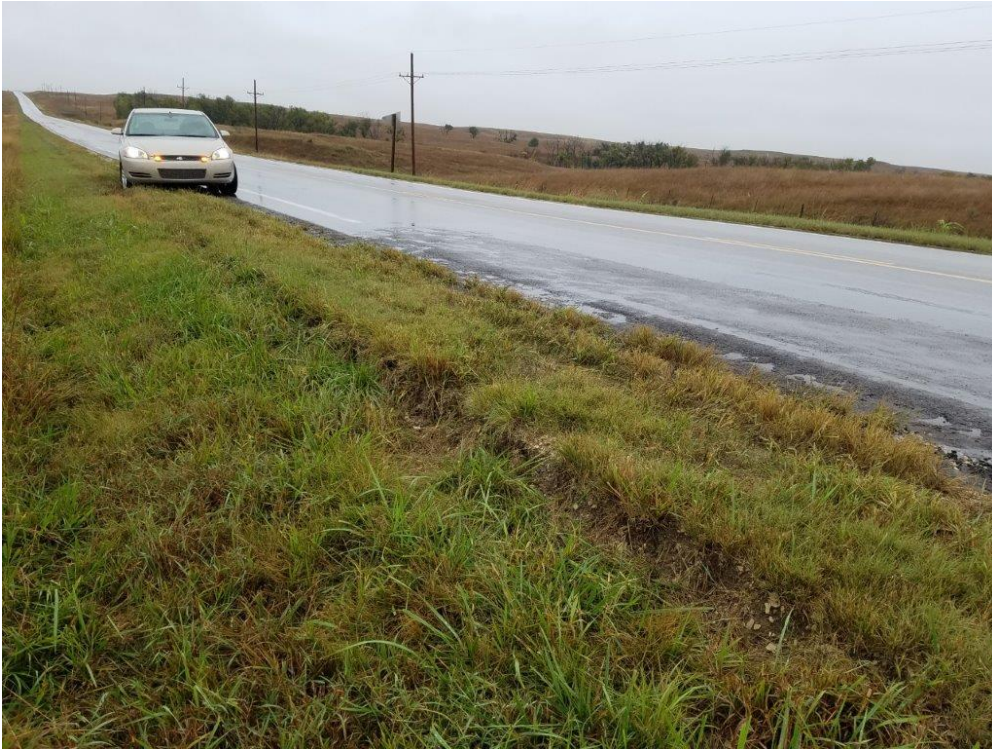
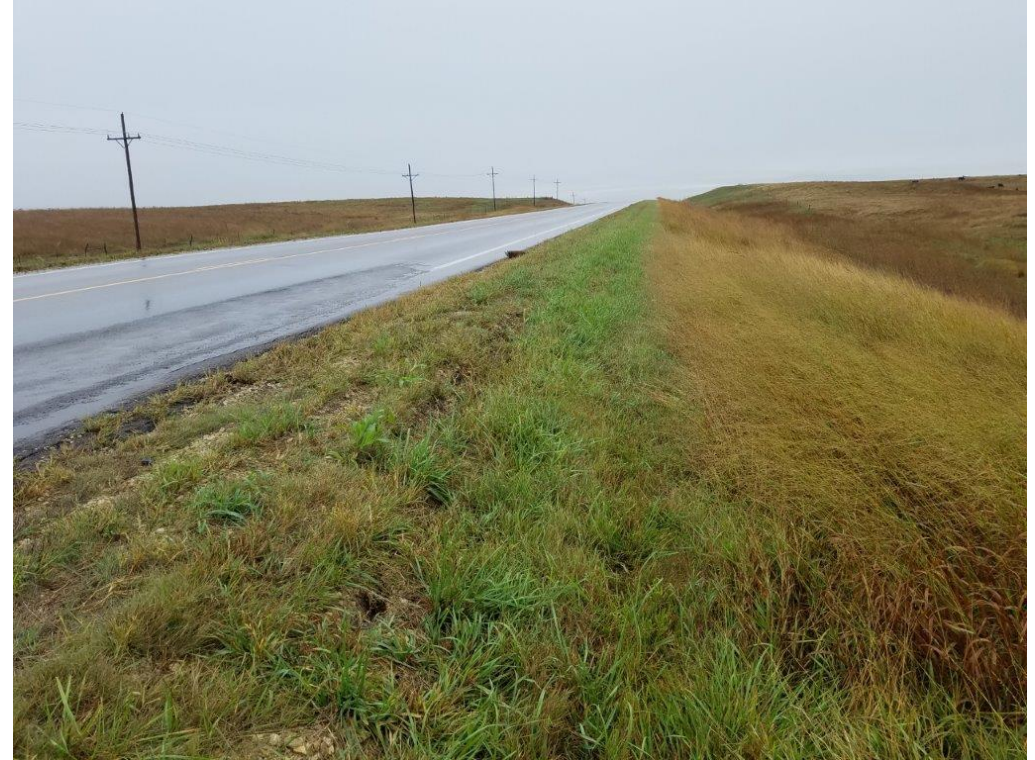
- 1st signs of Failure: Fall 2017

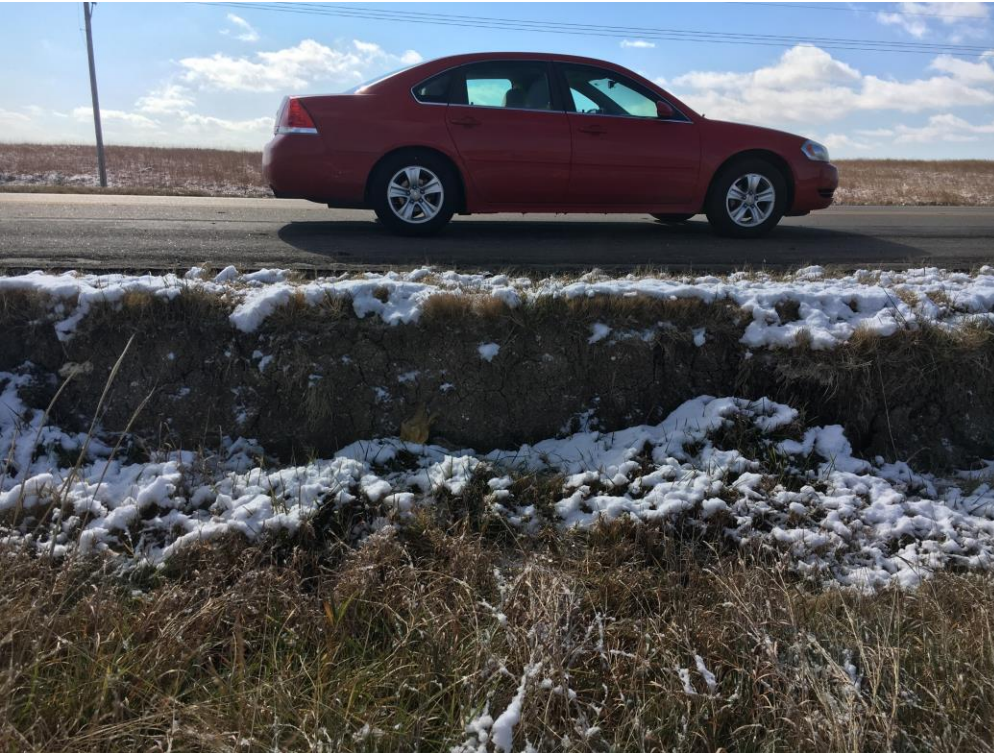
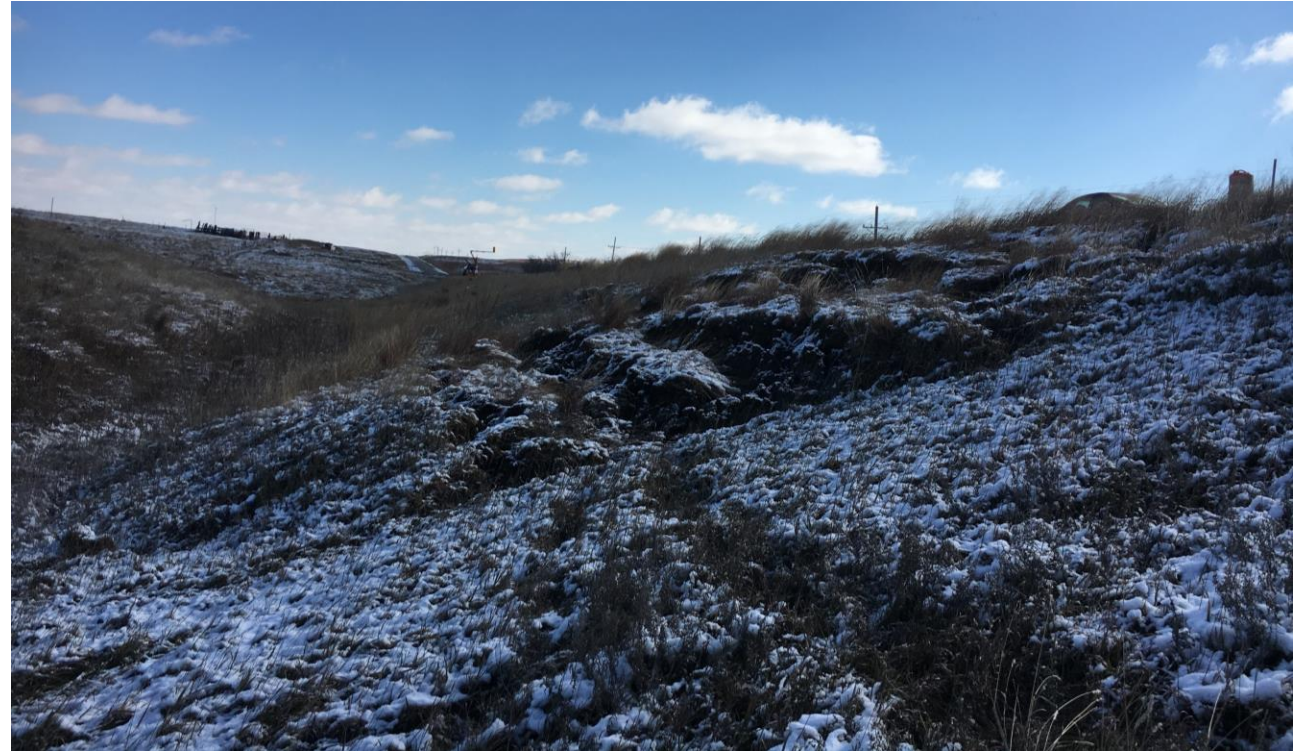
- 1 week prior to the scheduled investigation:
Nov. 2018

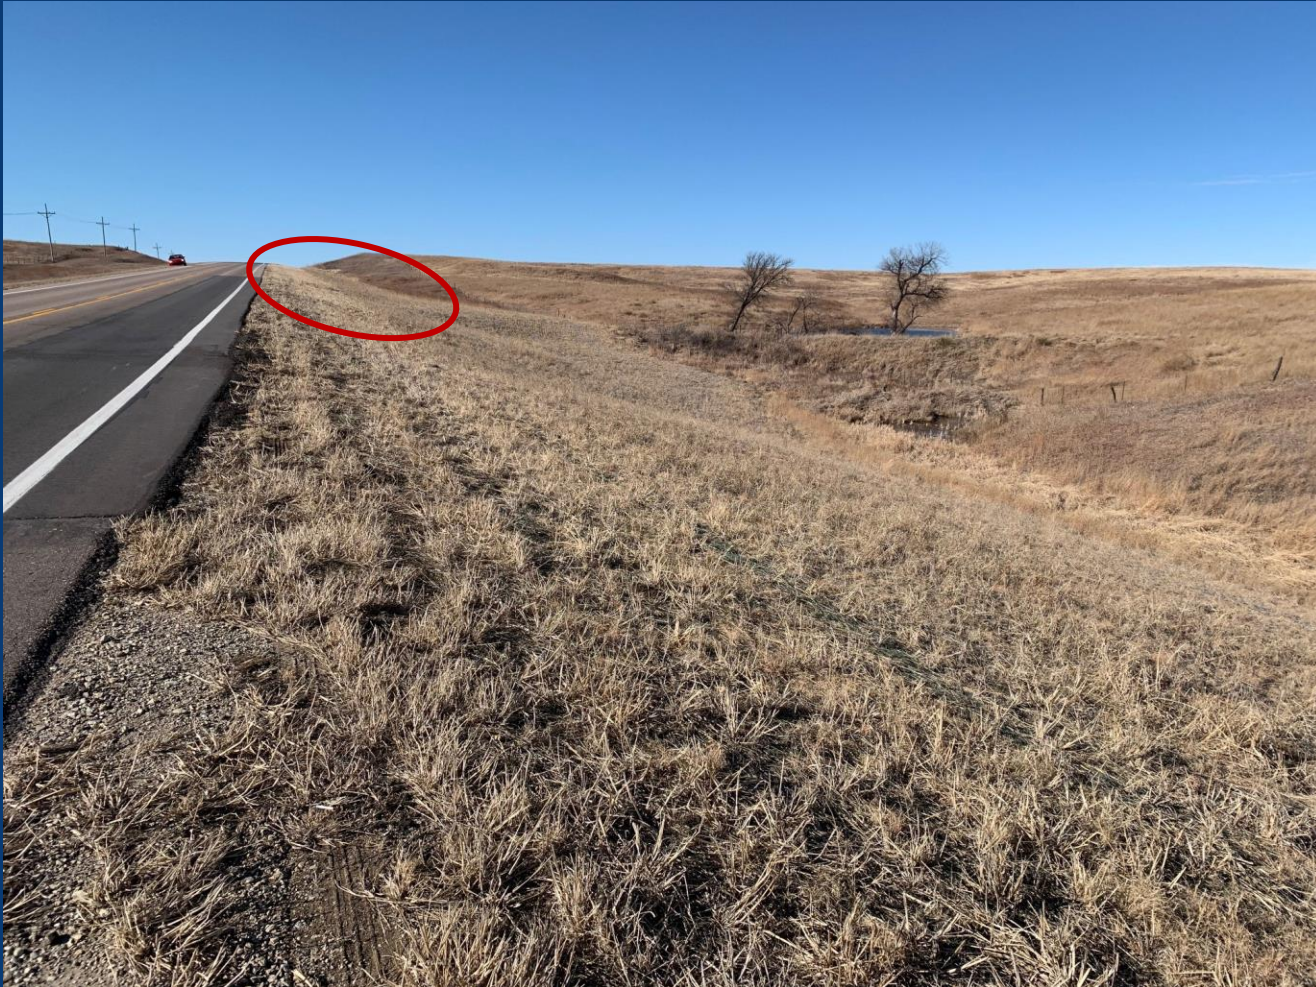
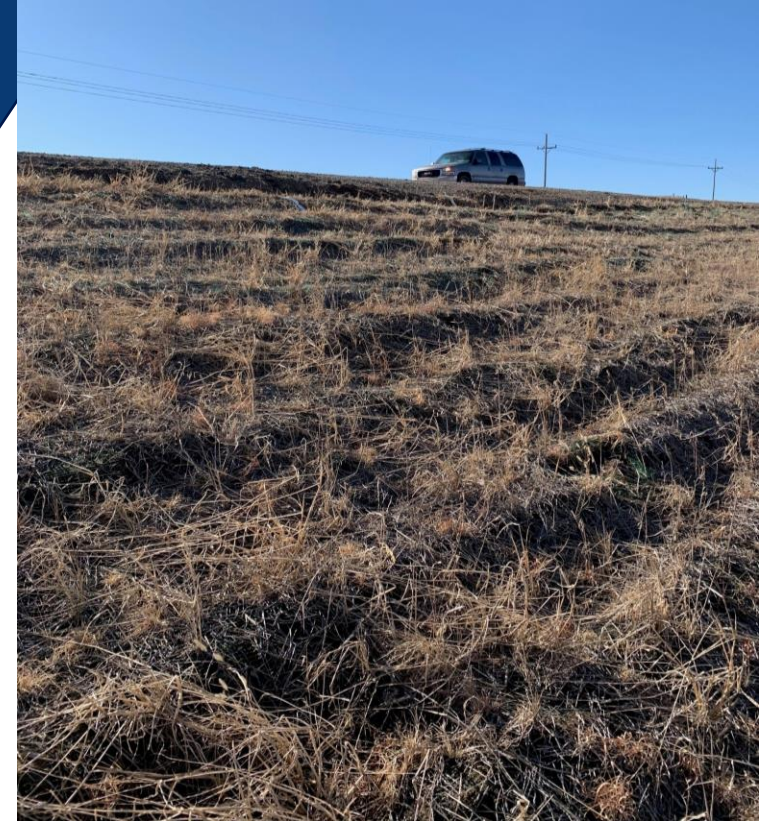
**Rutting Caused by
Mowing Operations**

**Creates Surfaces
for Water
Infiltration**

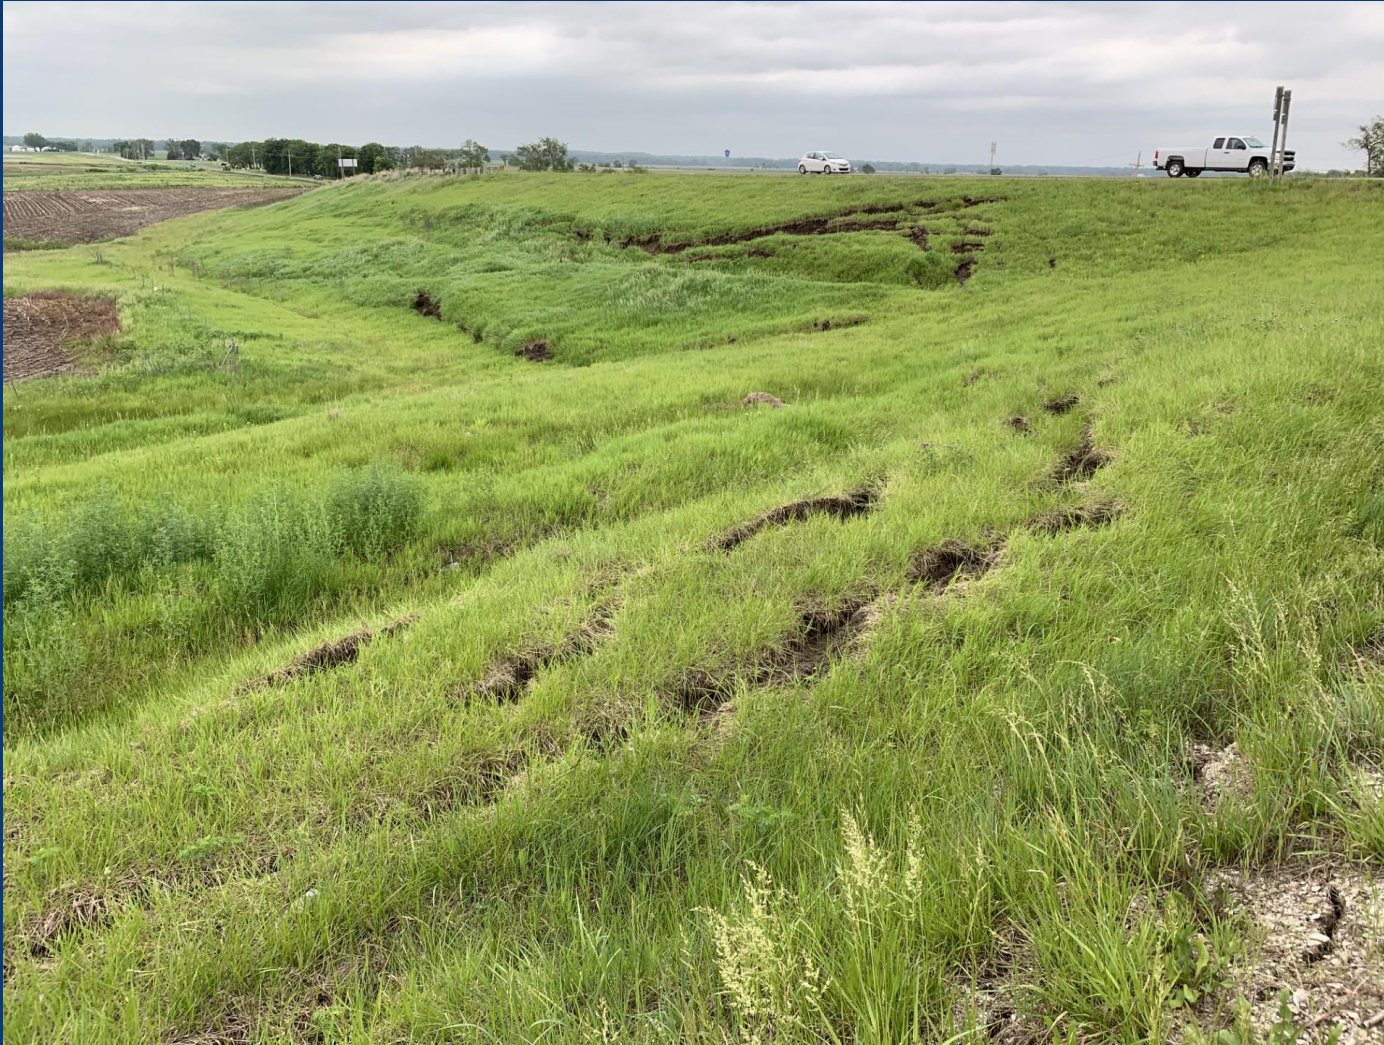
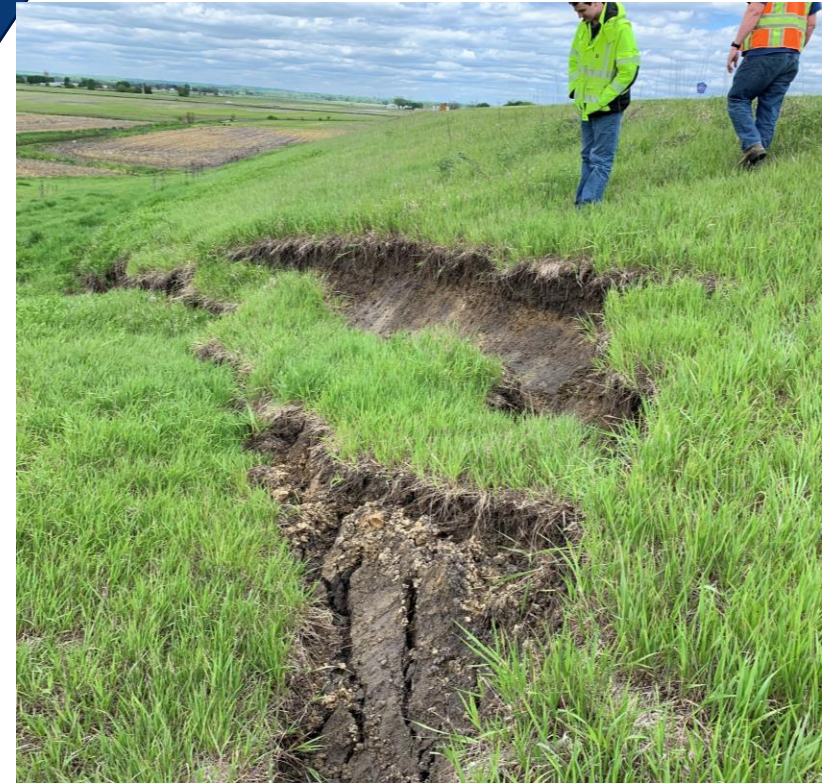
**Slickensides and Cracking
along scarps**

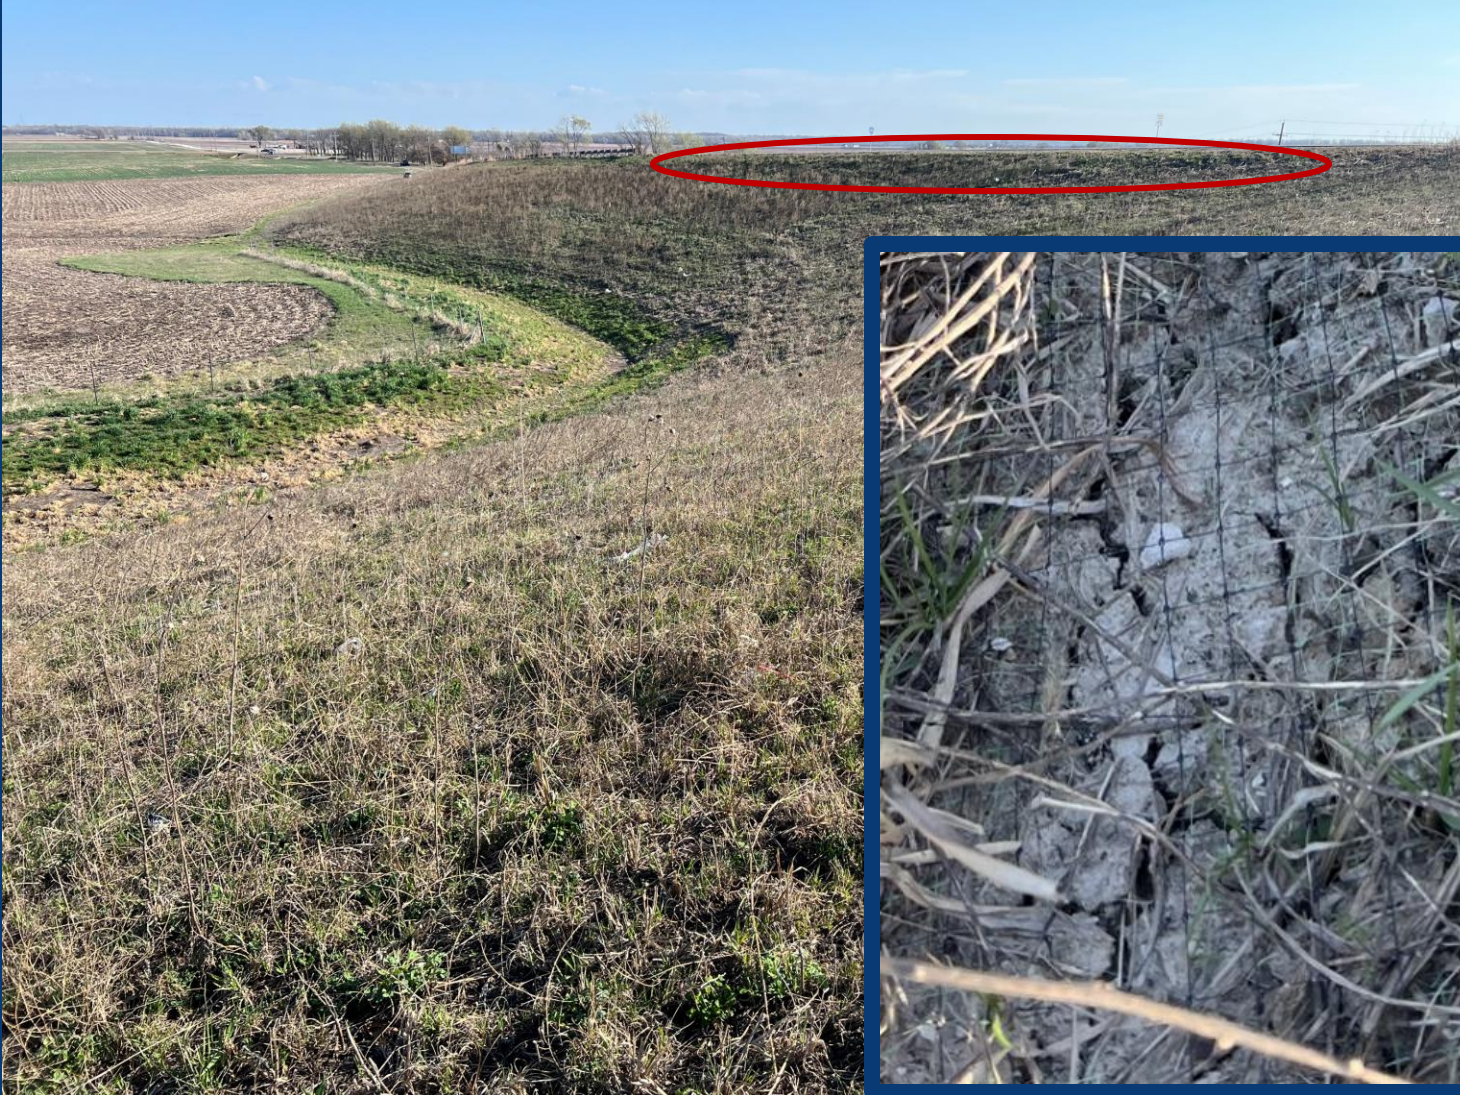
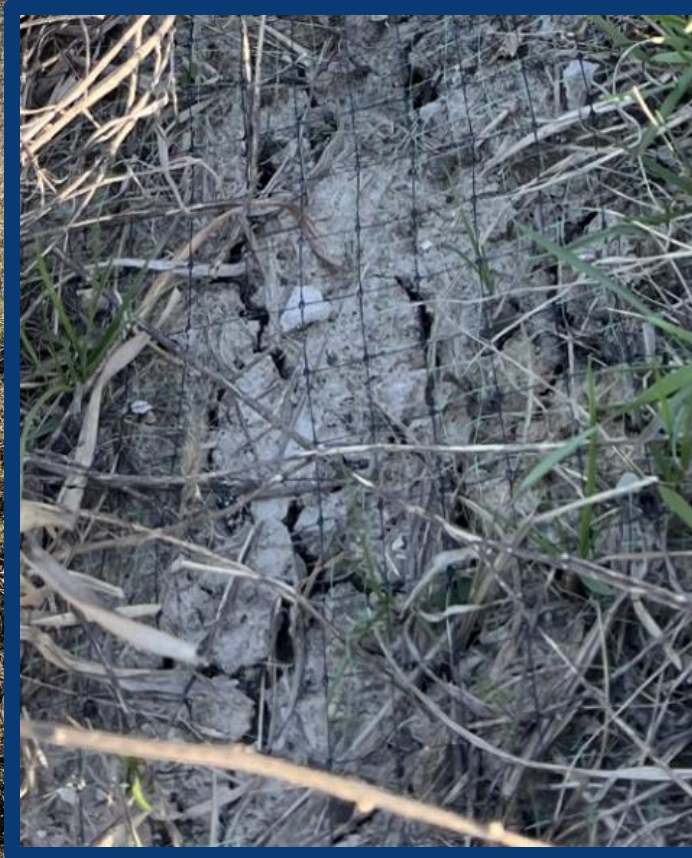
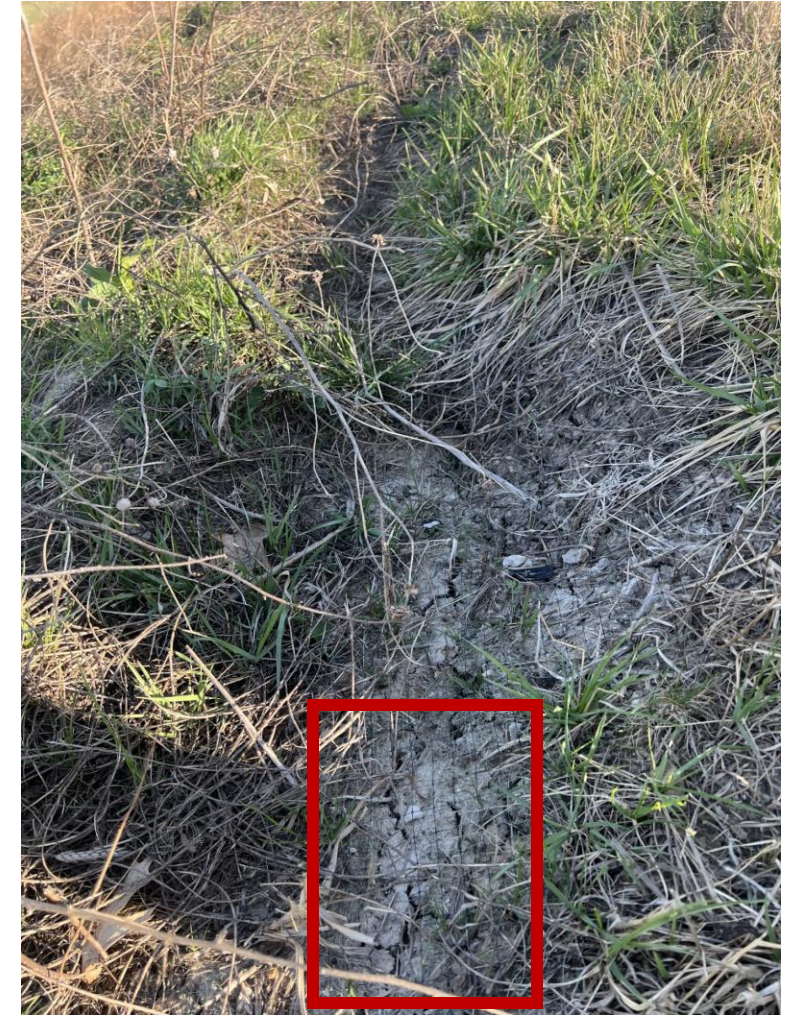
Tension Cracks

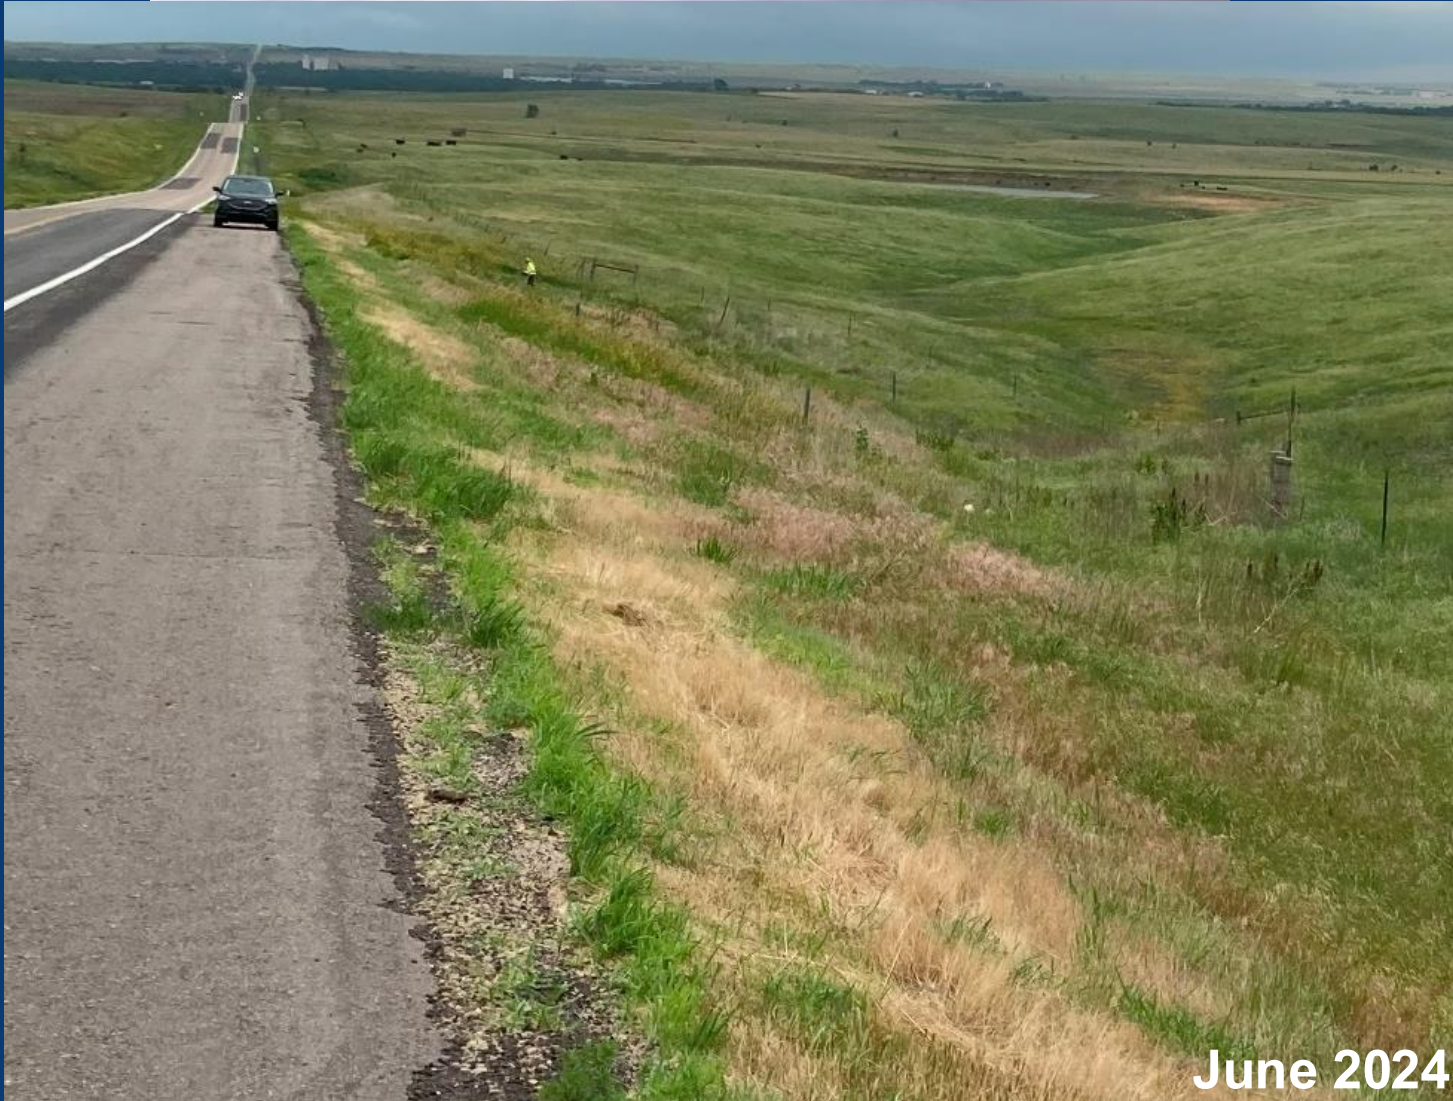
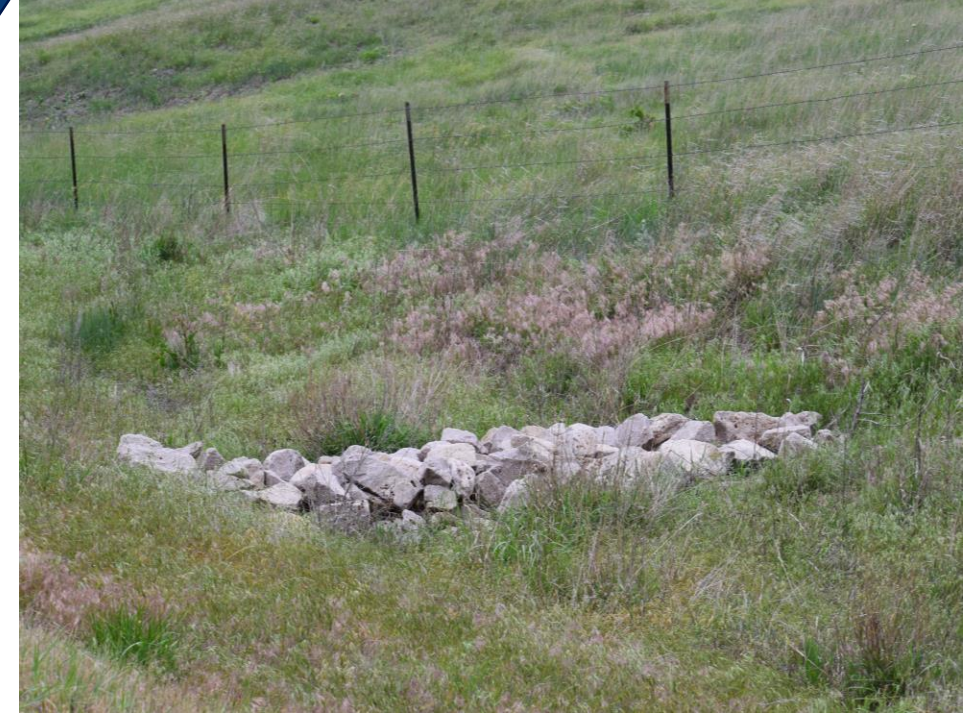
Erosion Control Barrier

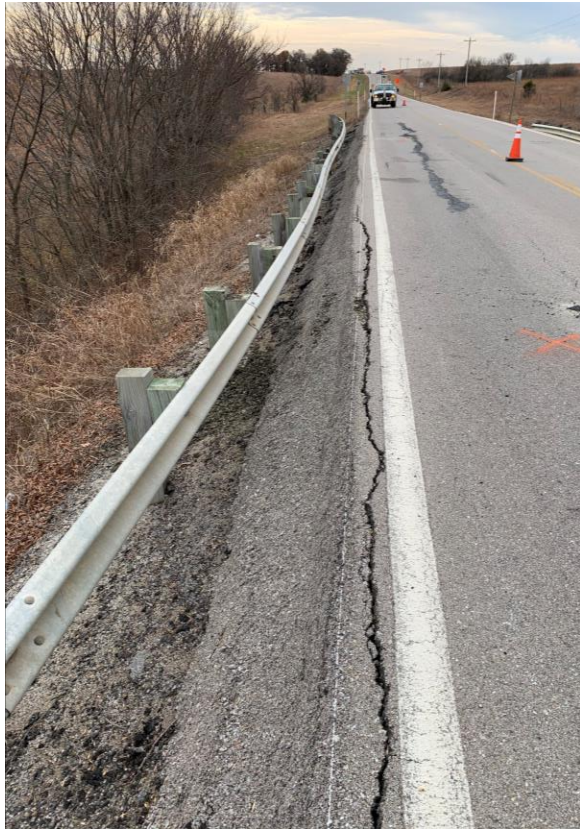
Cracking/Settling of Pavement

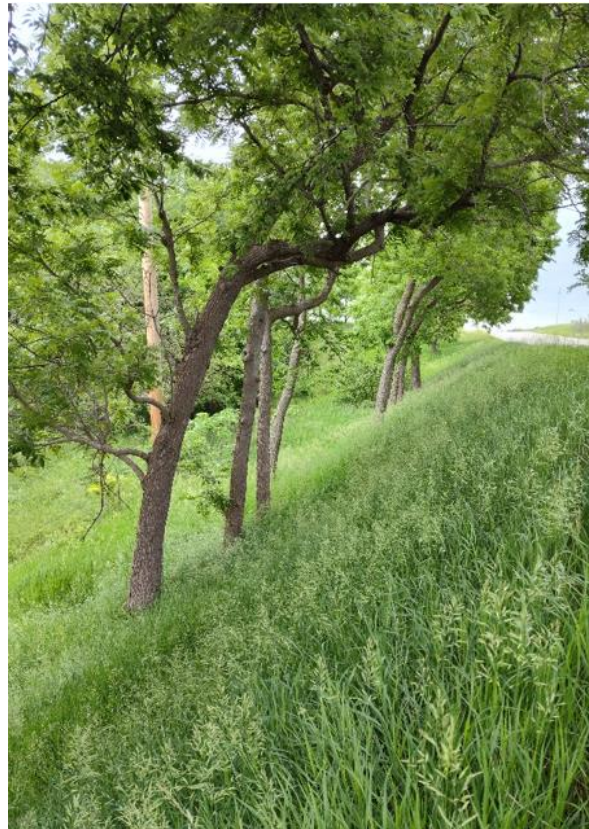
Inclination of Trees along Slope
