EB I-70 Lewis & Clark Emergency Gusset Repairs

Andrew Spencer, P.E. - KDOT

Kevin Gribble, P.E. - HDR

March 5th, 2026

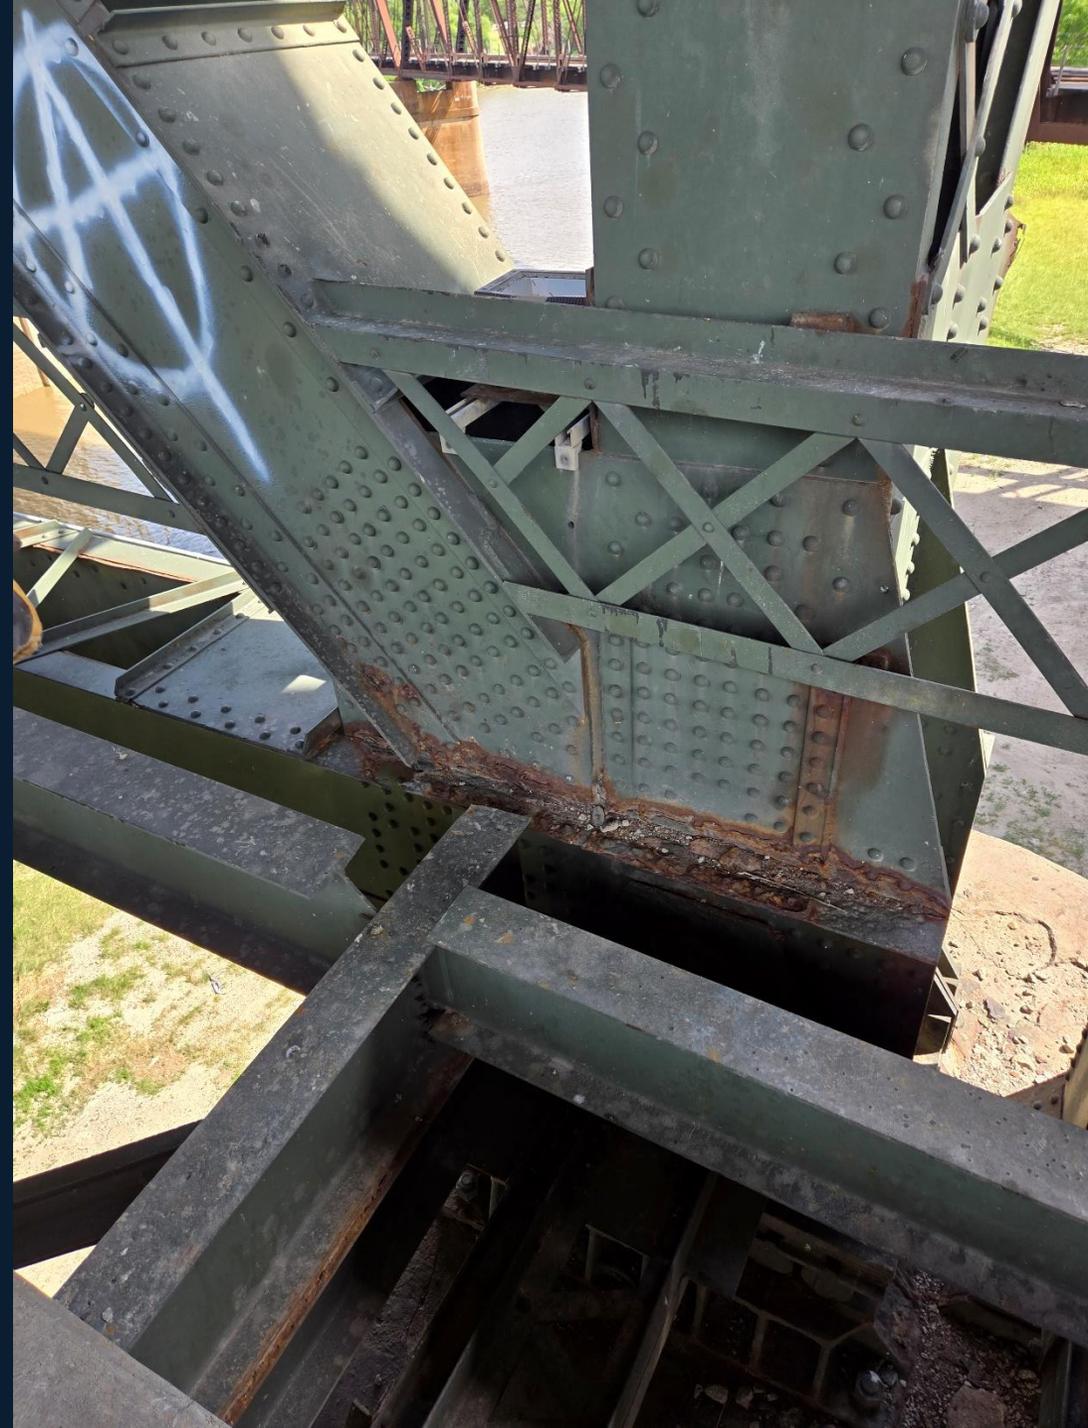
View from Pedestrian Walkway of
L21B
(North Truss, South Truss Similar)

Vertical
L21-U21

Diagonal
M20-L21

Node L21

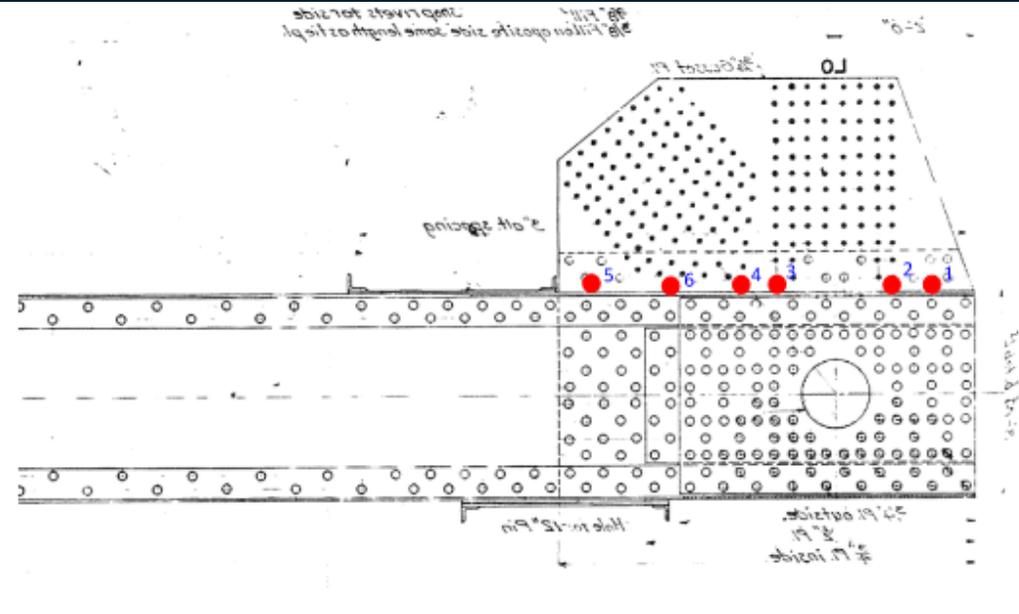
L21A South Truss

Inner Gusset Plate

1 = 0.193"

2 = 0.186"

3 = 0.232"

4 = 0.208"

5 = 0.144"

6 = 0.18"

Avg = 0.19"

- Heavy gusset plate corrosion found along shear plane
- As-built inner gusset plate thickness = $\frac{3}{4}$ "
- Significant capacity loss ~ 70-75% in inner plates
- Existing condition plate thickness
 - South Inner Gusset ~ 0.19"
 - North Inner Gusset ~ 0.22"

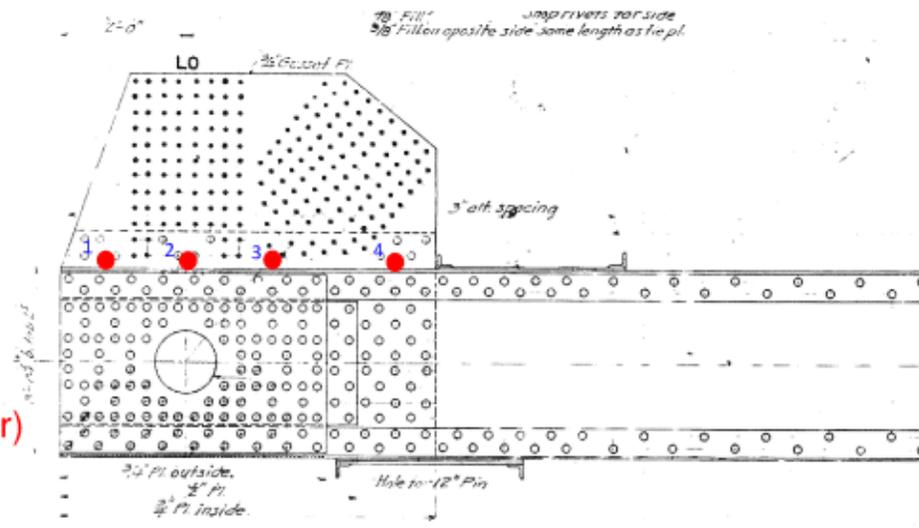
L21B North Truss

Inner Gusset Plate

1 = 0.180"

2 = 0.32" (outlier)

3 = 0.198"

4 = 0.20"

Avg = 0.22" (includes outlier)

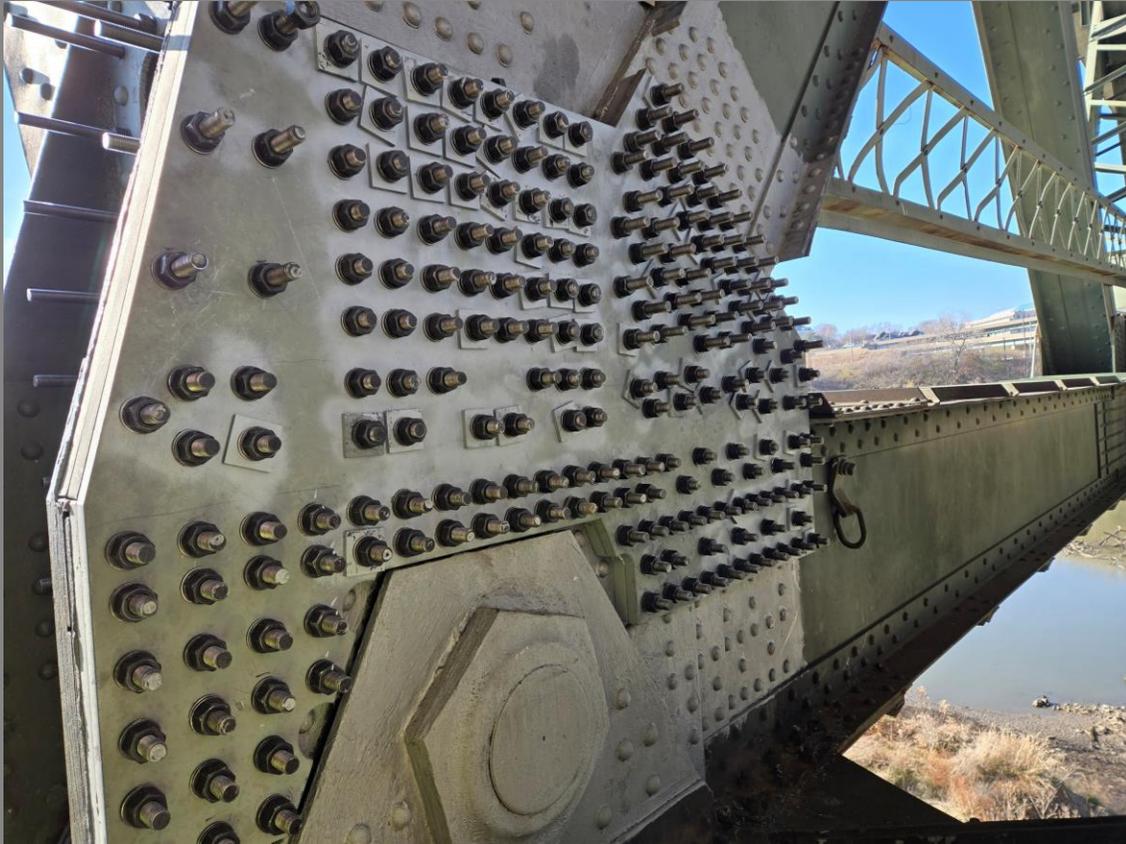
L21 South Inner Gusset Repair

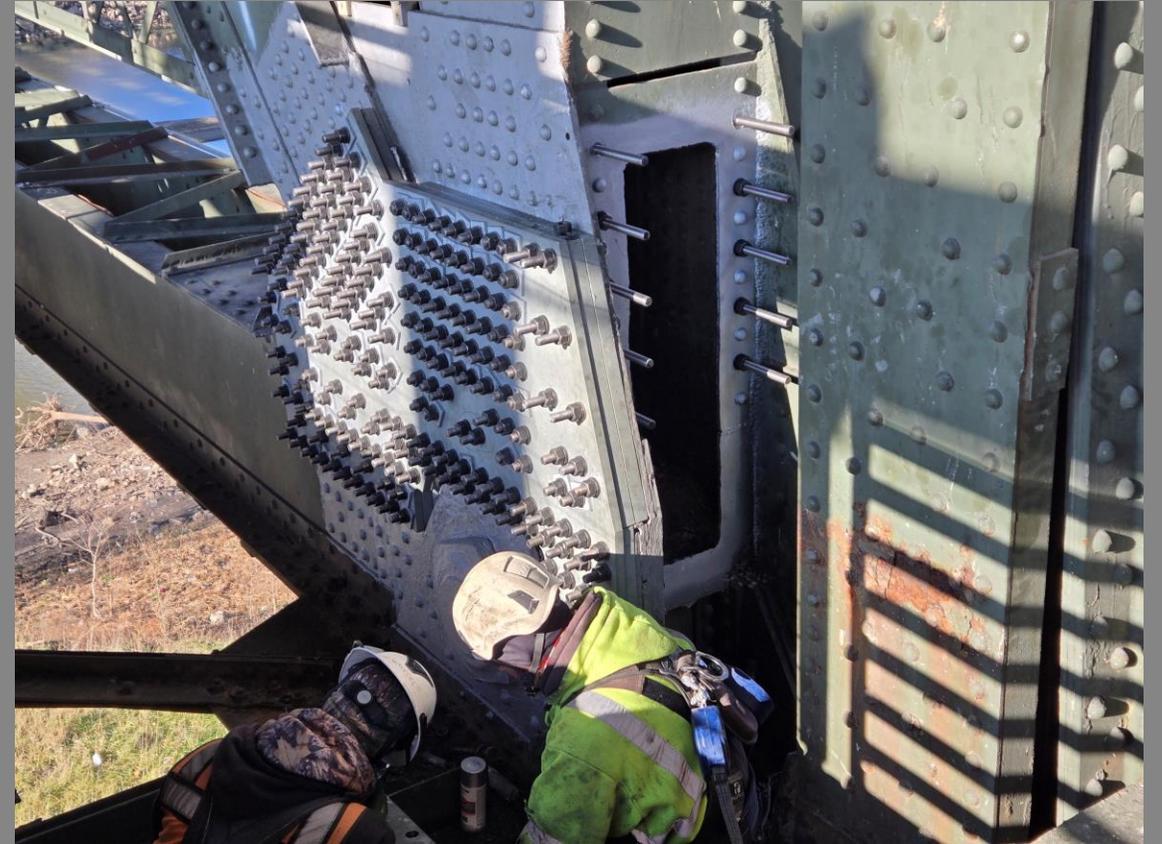
L21 North Inner Gusset Repair

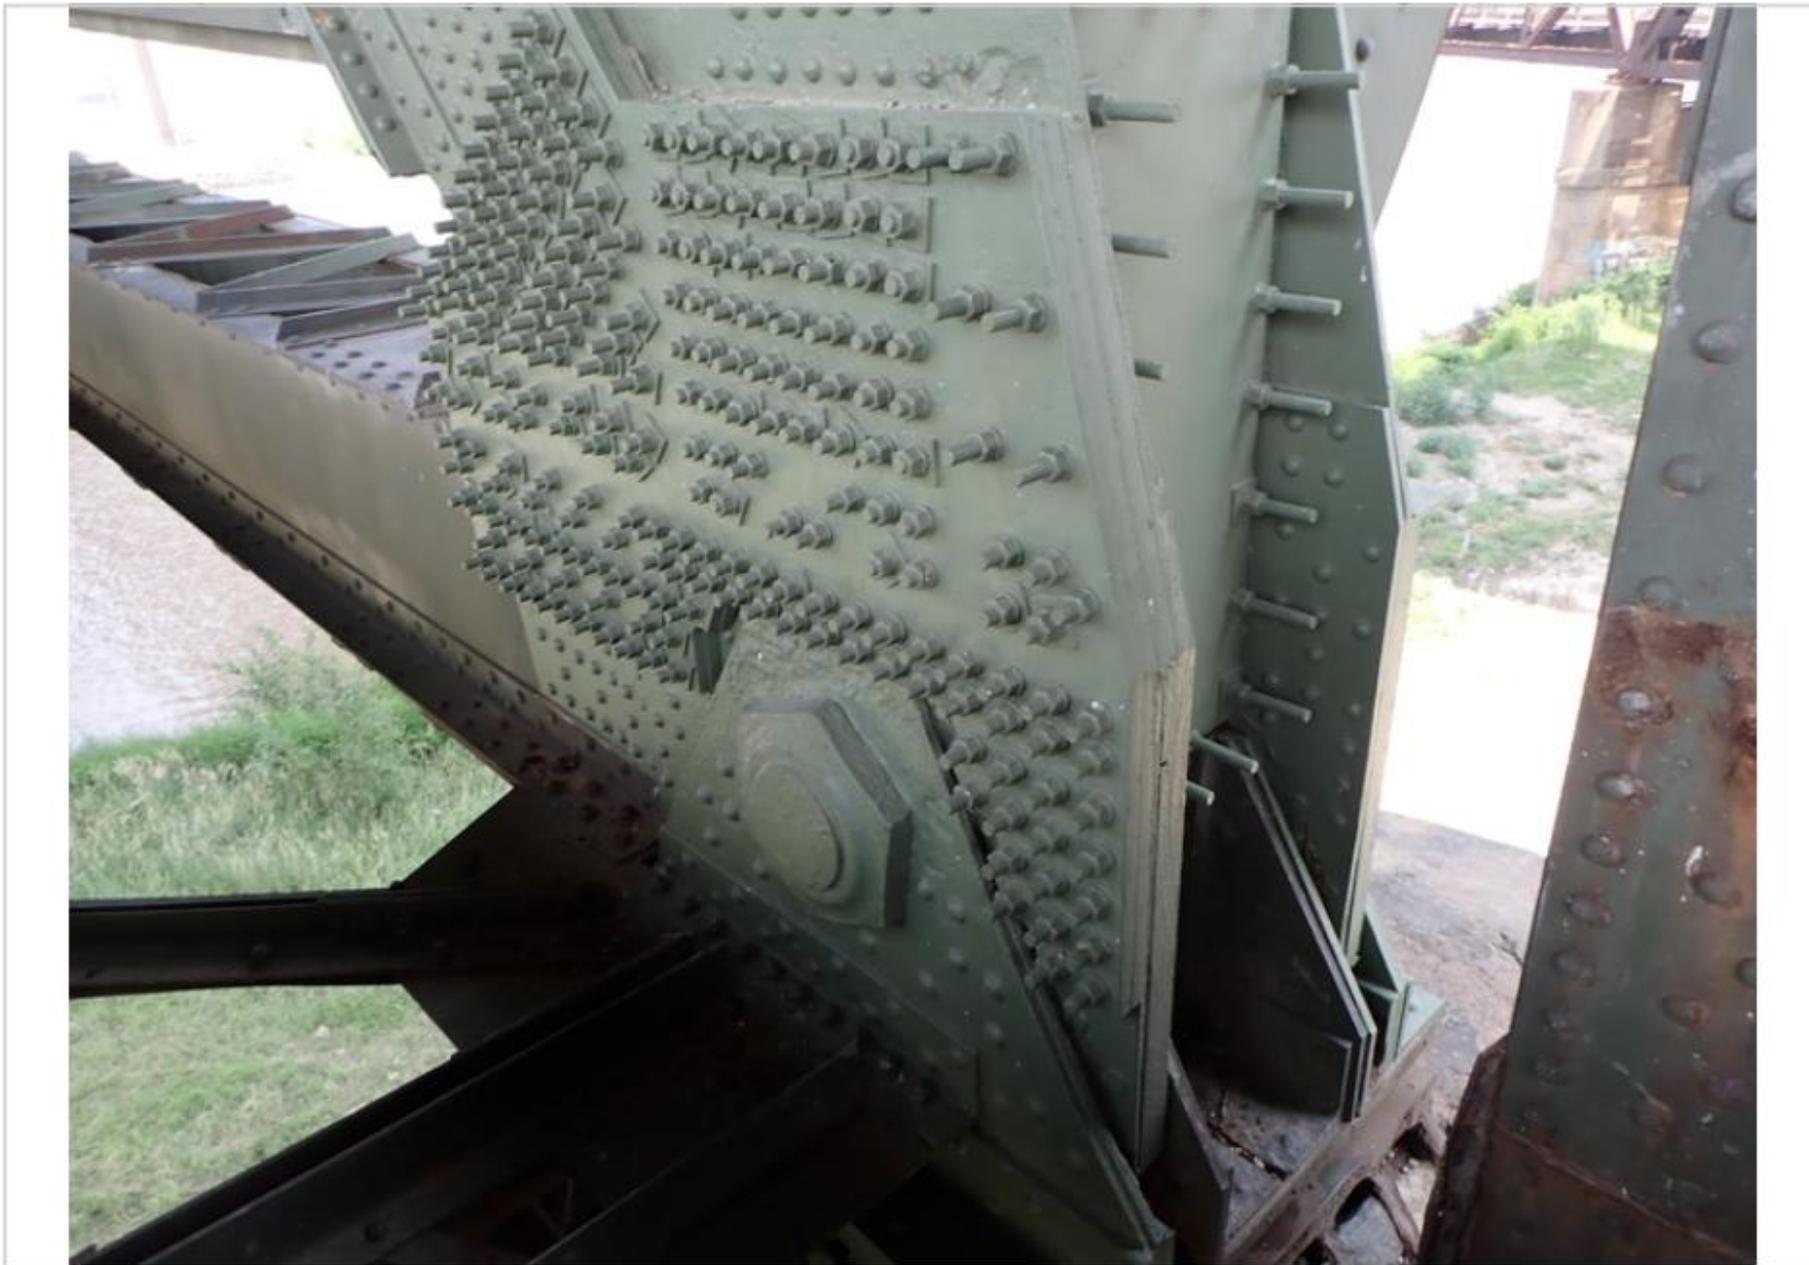
45. L21B, view of repaired interior gusset plate

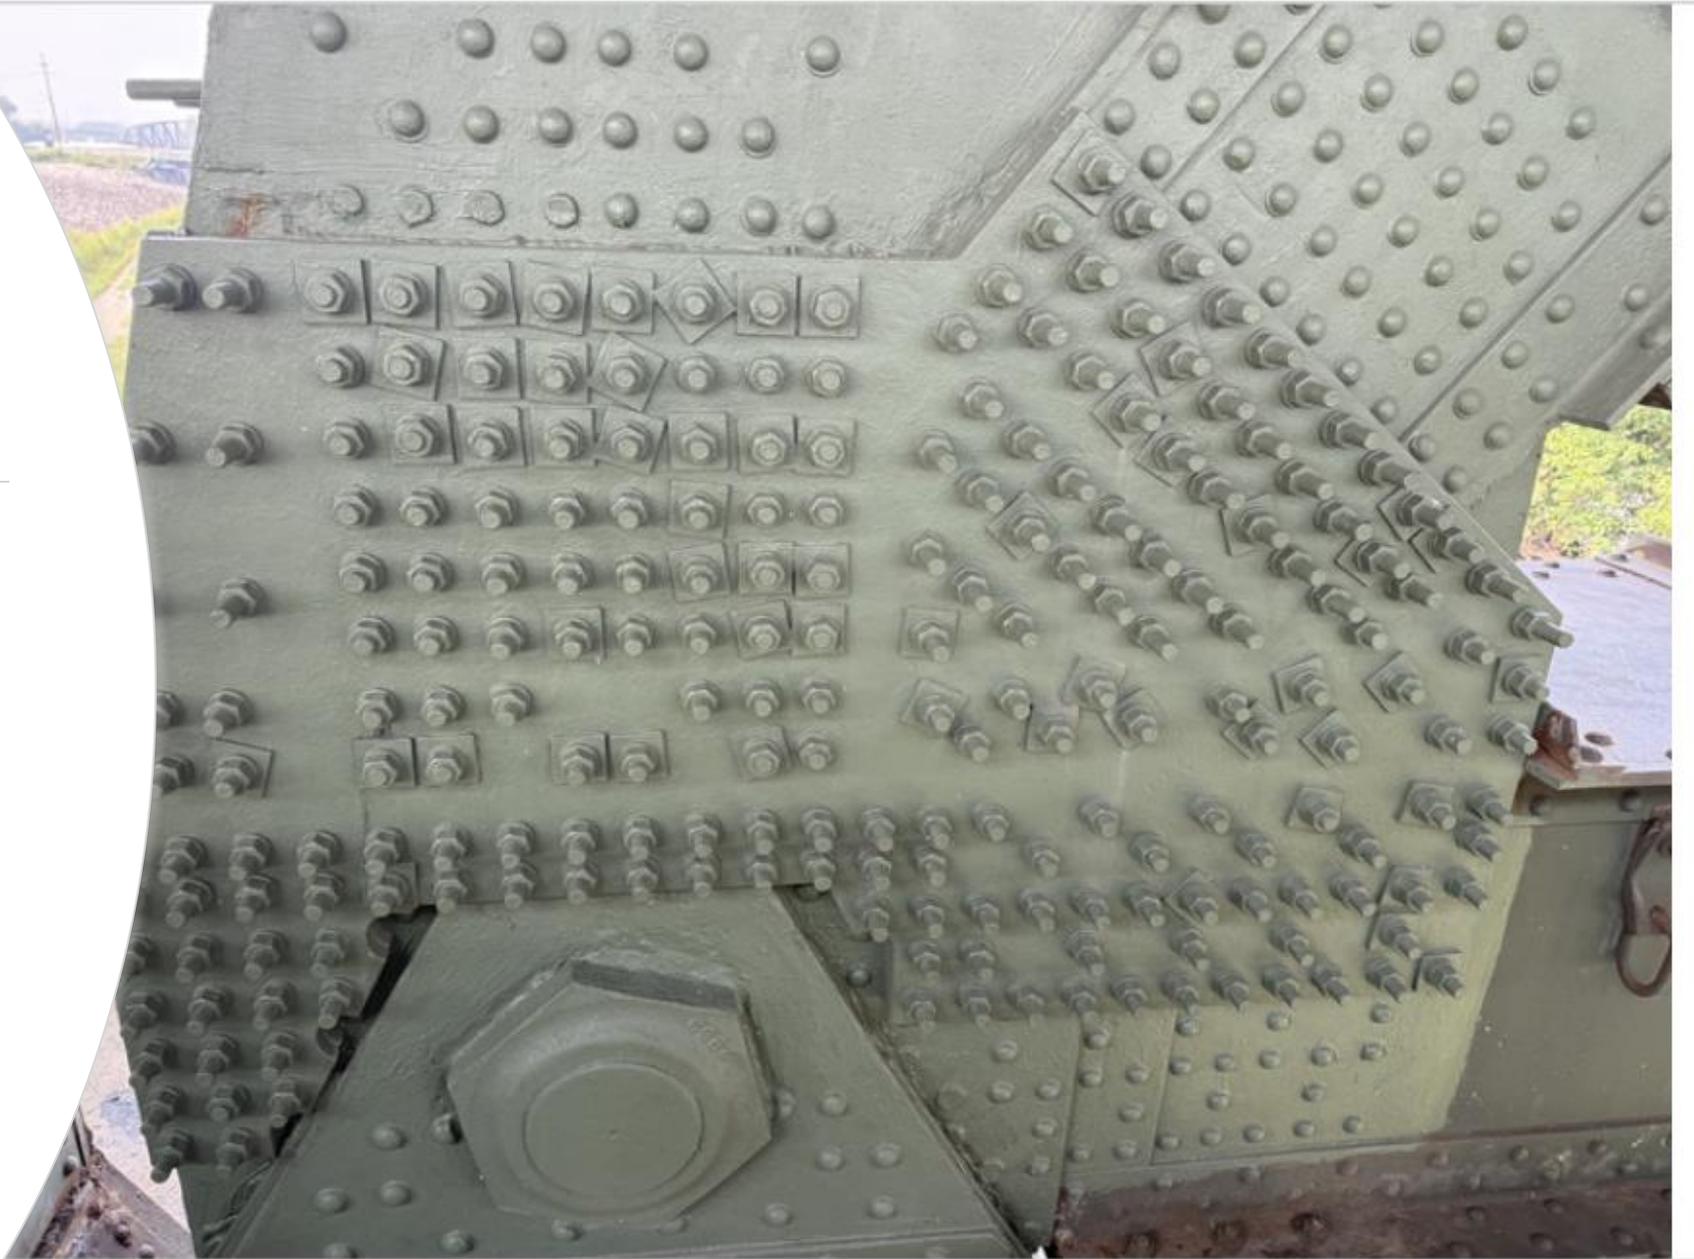
10. Typical inside gusset repair
