Ralph B. Peck Lecture

Slope Stabilization using Tall Soil Nail Walls at Natchez National Cemetery and Teton Pass

Case Histories: Two Major Landslides Repaired using Soil Nailing

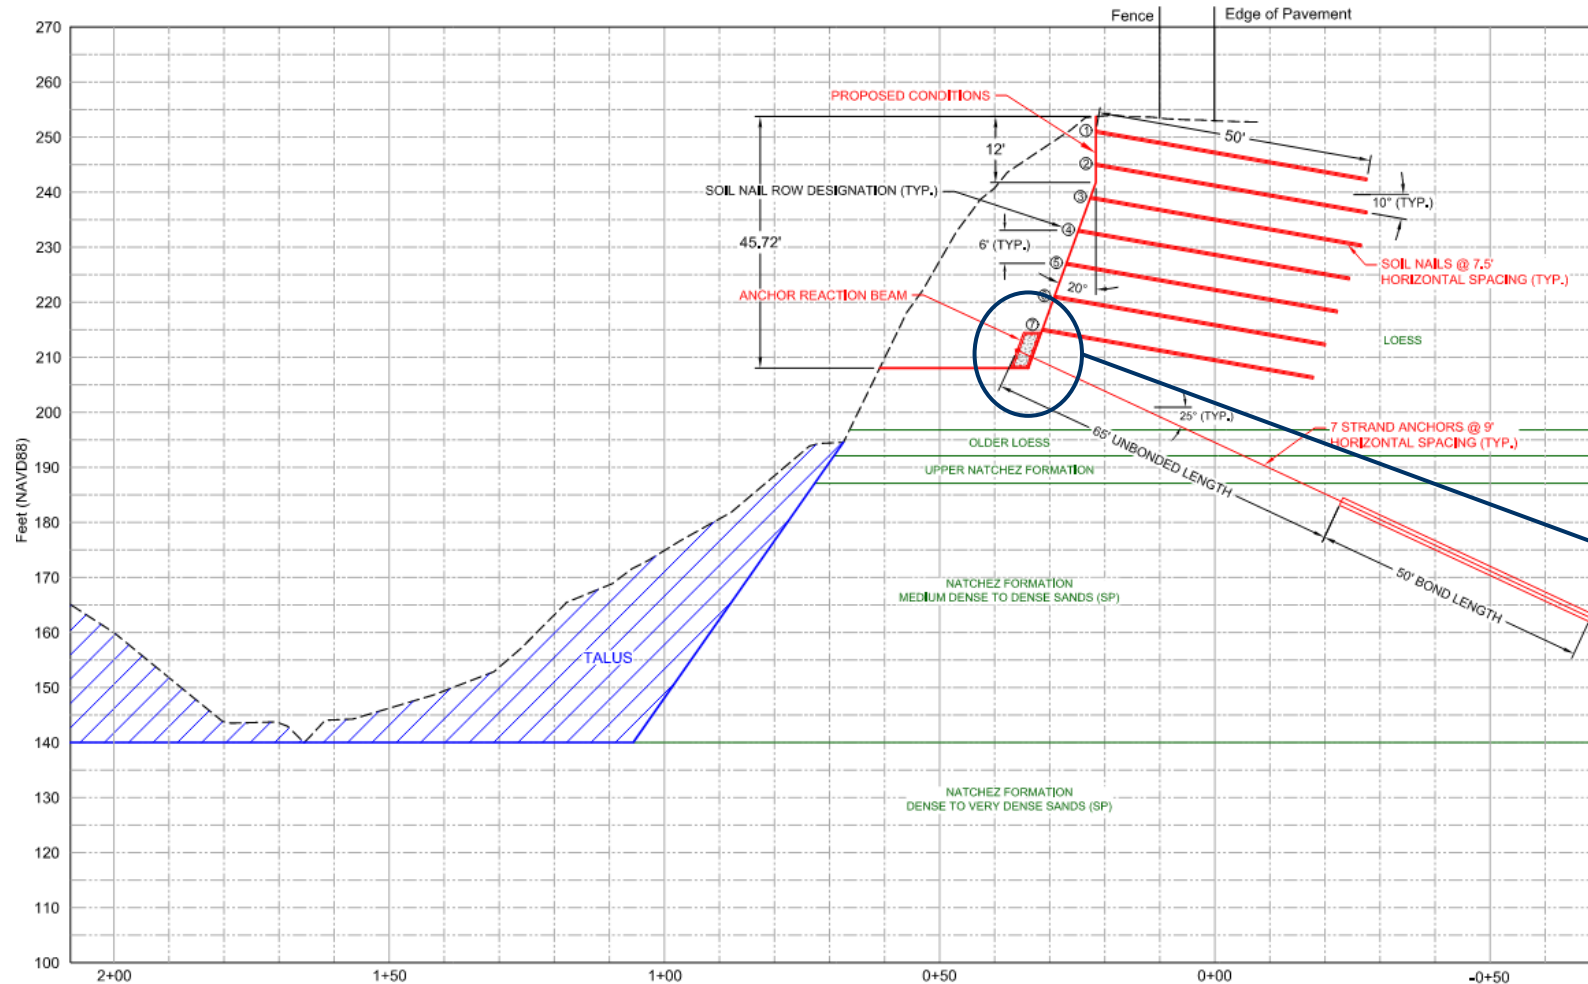
Anchored Soil Nail Wall Solution

- 7 rows of 40 ft to 50 ft soil nails
- 6' x 6' and 7.5' x 6' Spacings
- 1 row of Ground Anchors of 150 to 180 LF at base for Global Stability
- Shotcreted Anchor Reaction Beam
- Top two lifts vertical
- Remaining lifts battered at 20 degrees

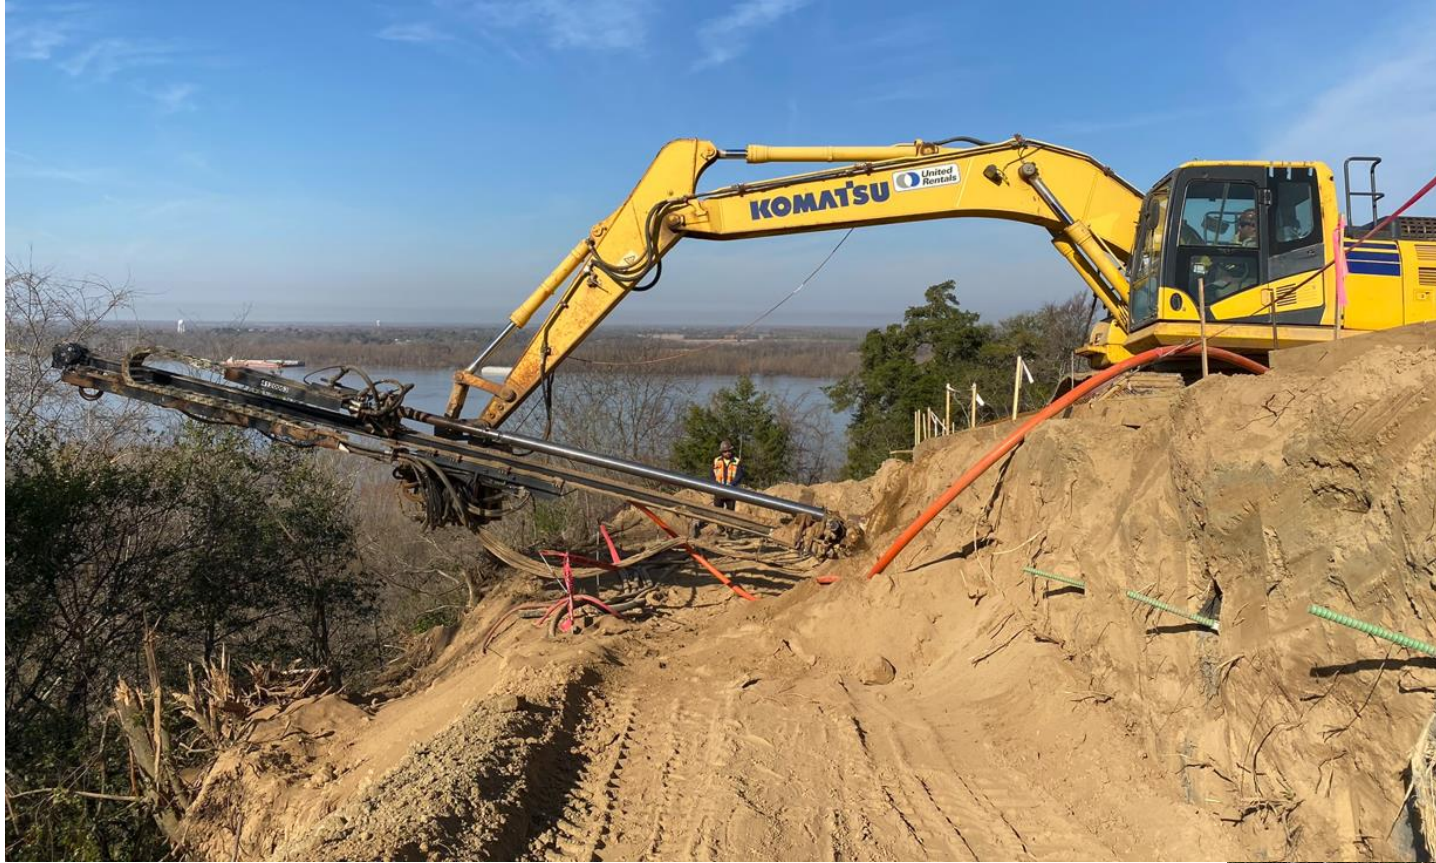
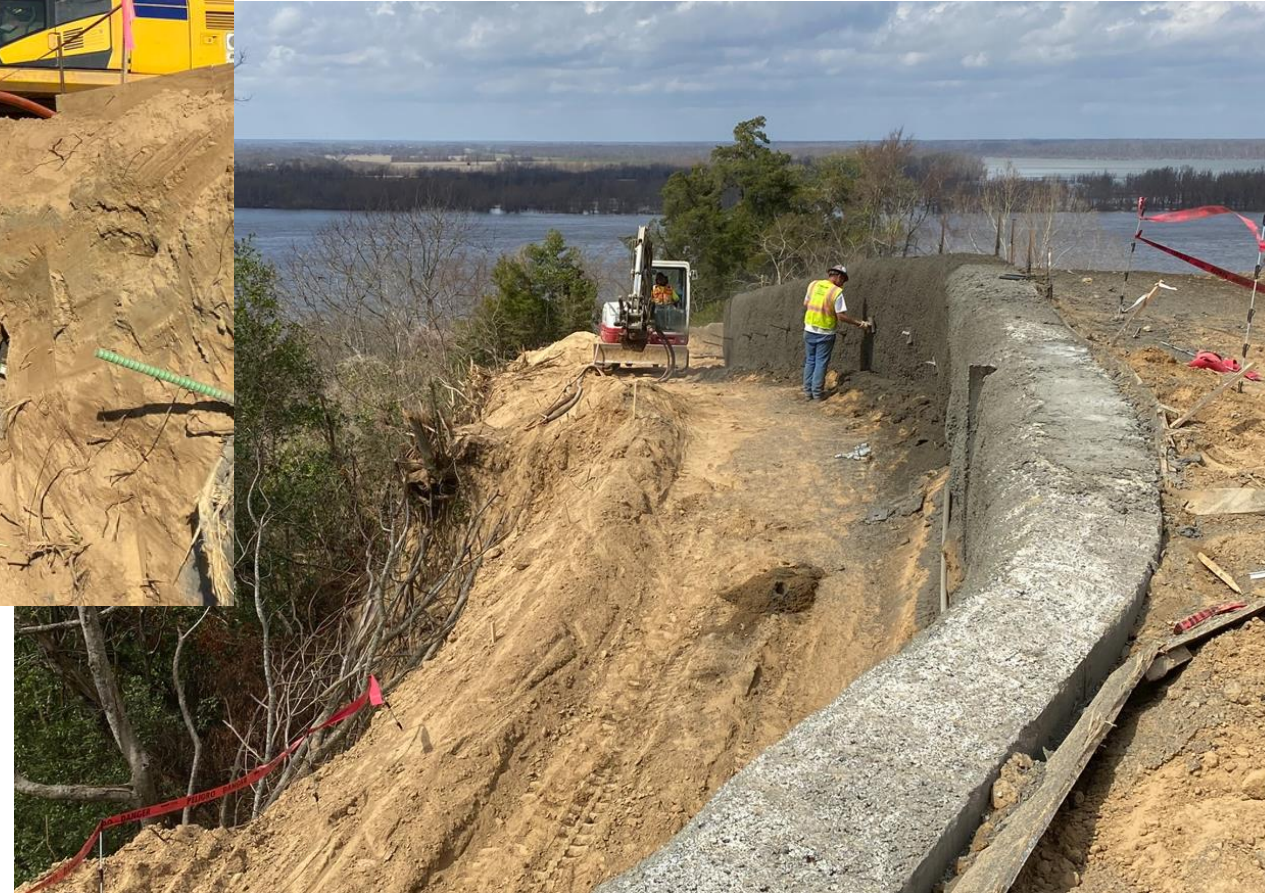
First Lift Construction – Vertical Lifts

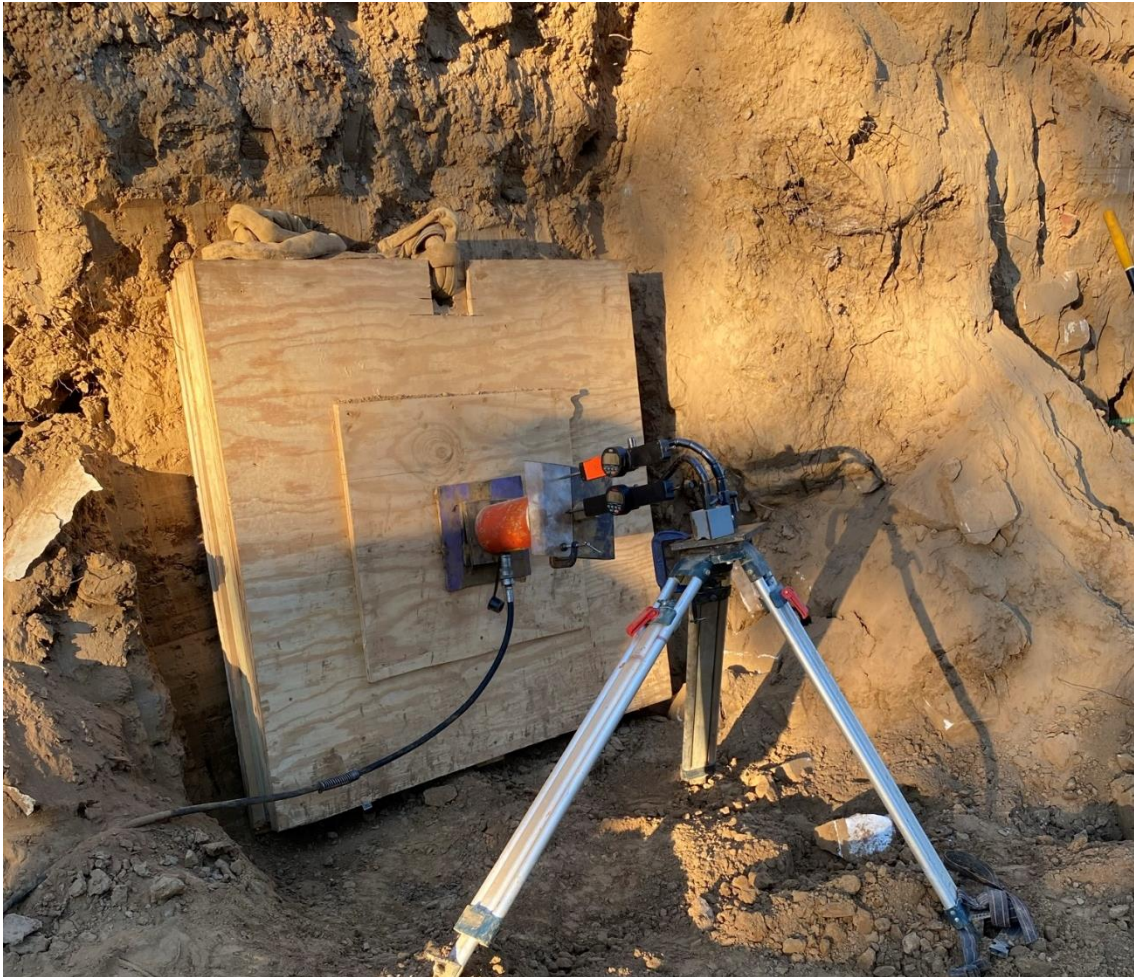
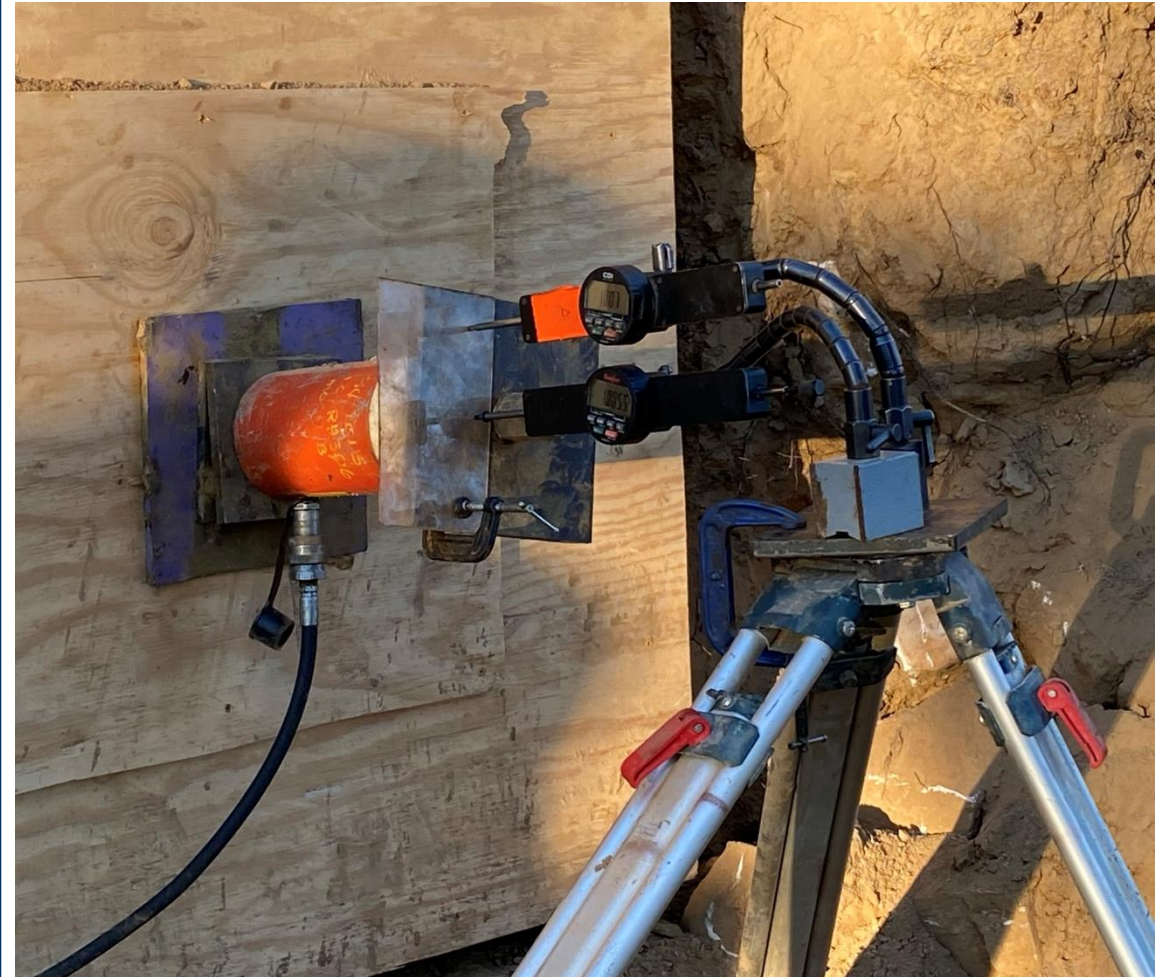
Sacrificial Test Nails to Confirm Assumed Bond Stress

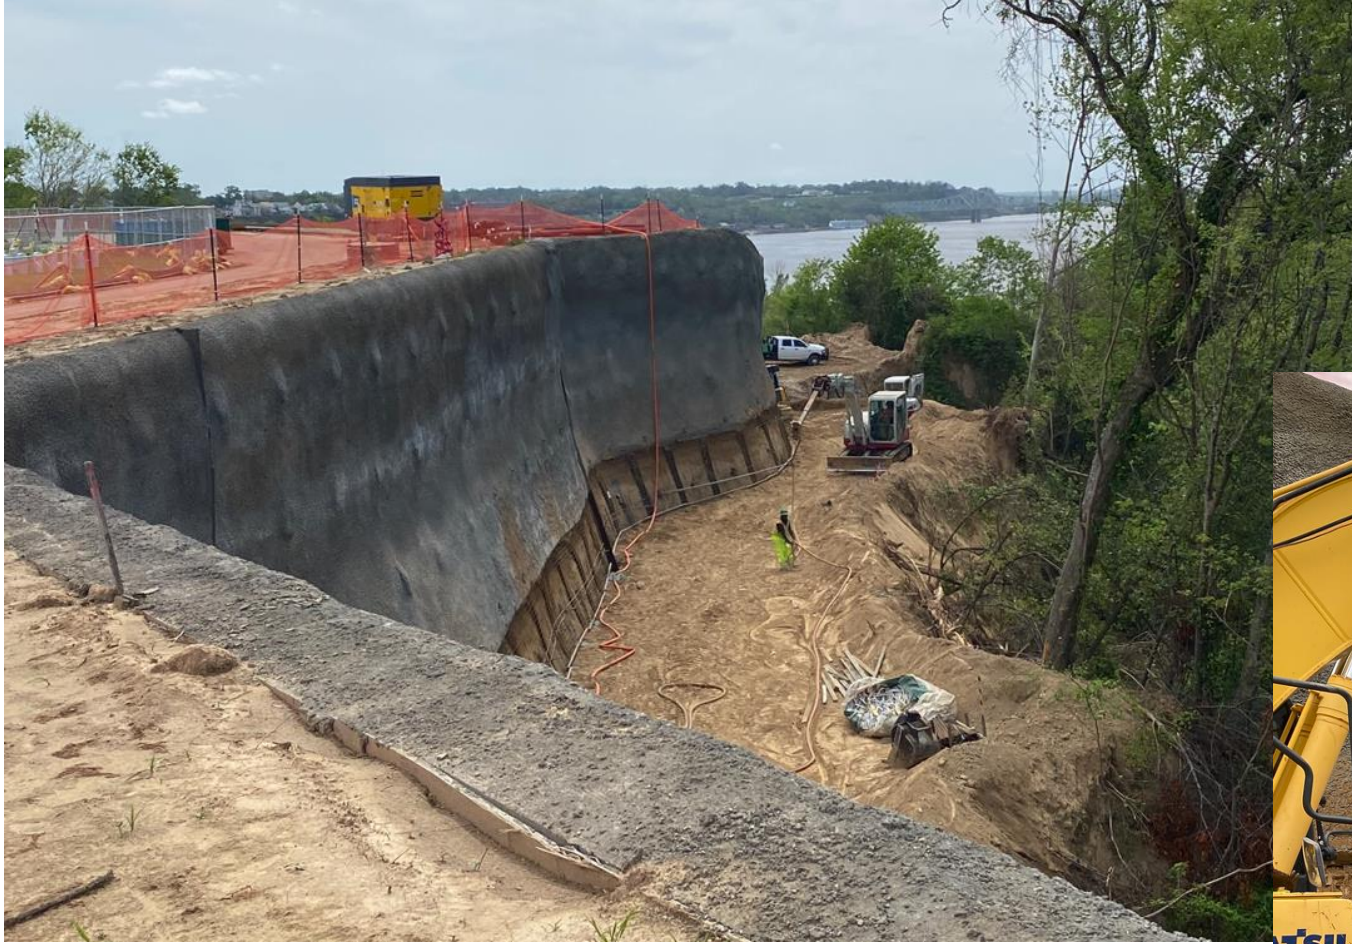
Remaining Wall Construction – Battered Lifts

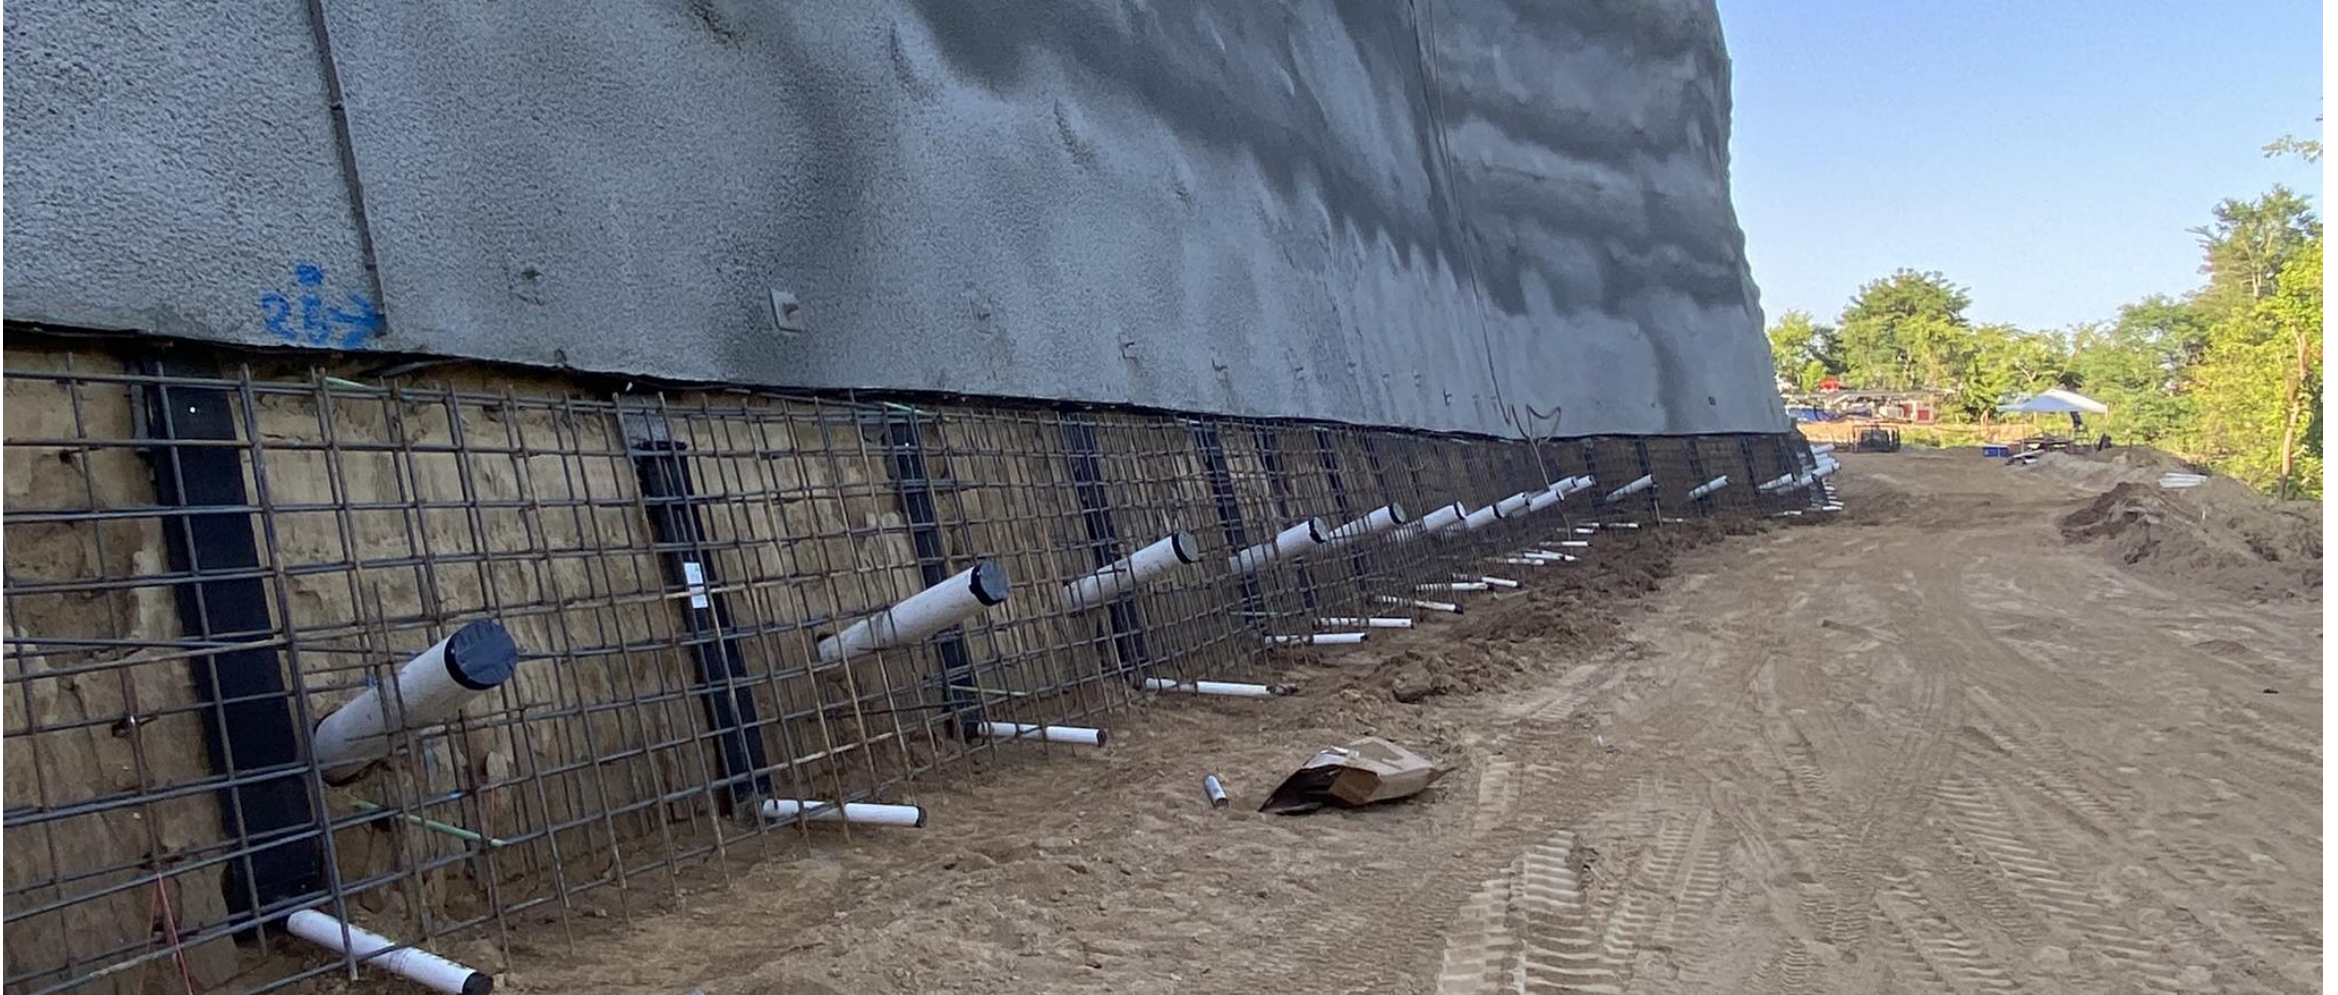
Bottom of Wall Reinforcement and Drainage Details including Deep Tieback Anchor Locations

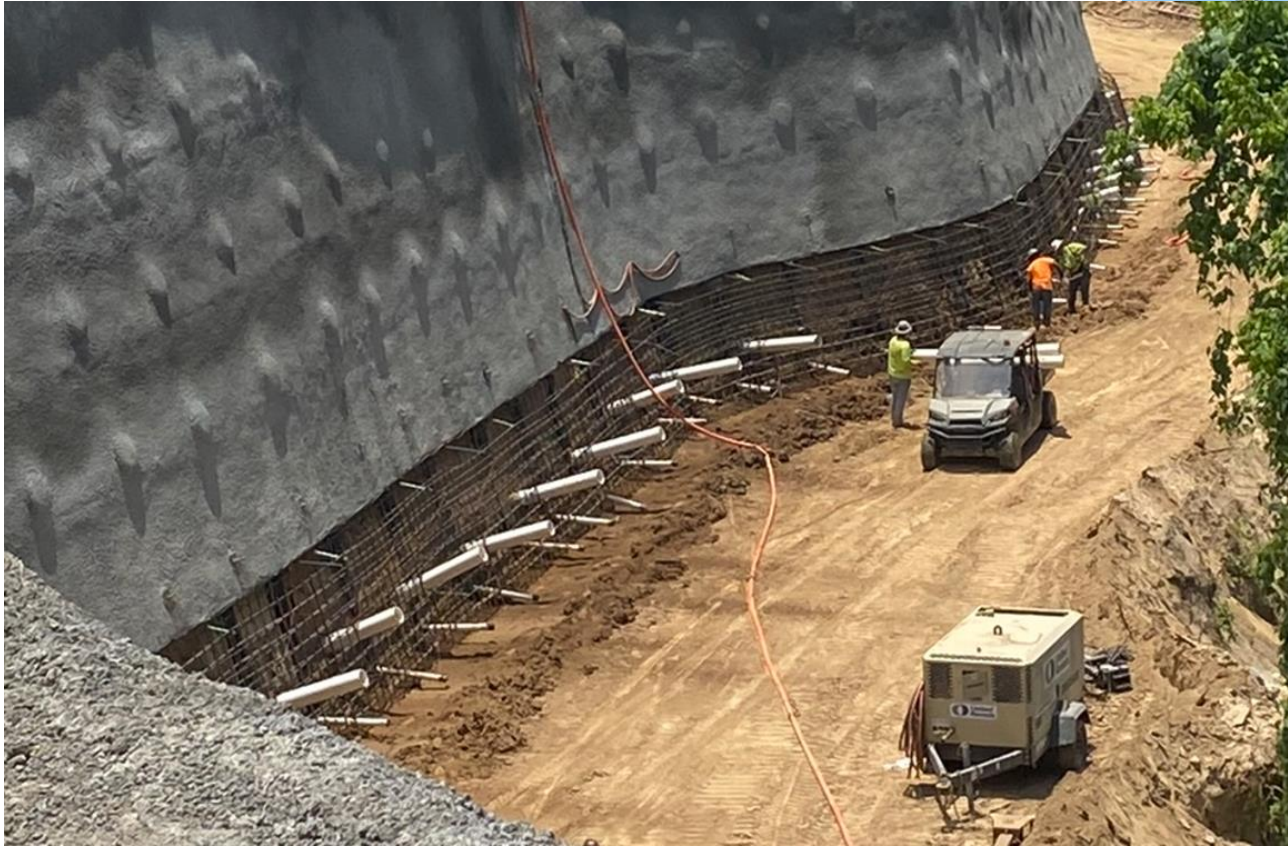
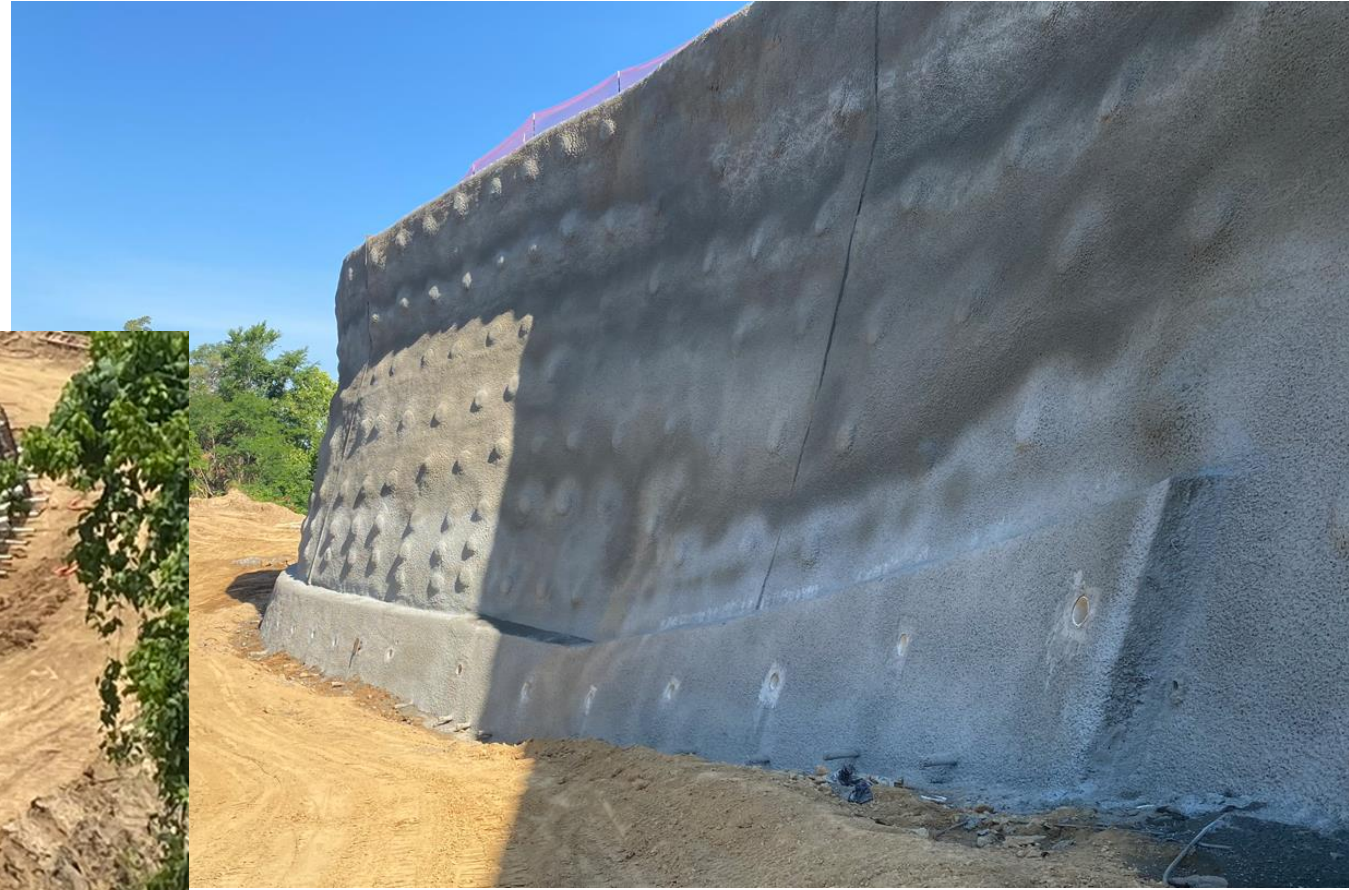
Shotcrete Tieback Anchor Reaction Beam

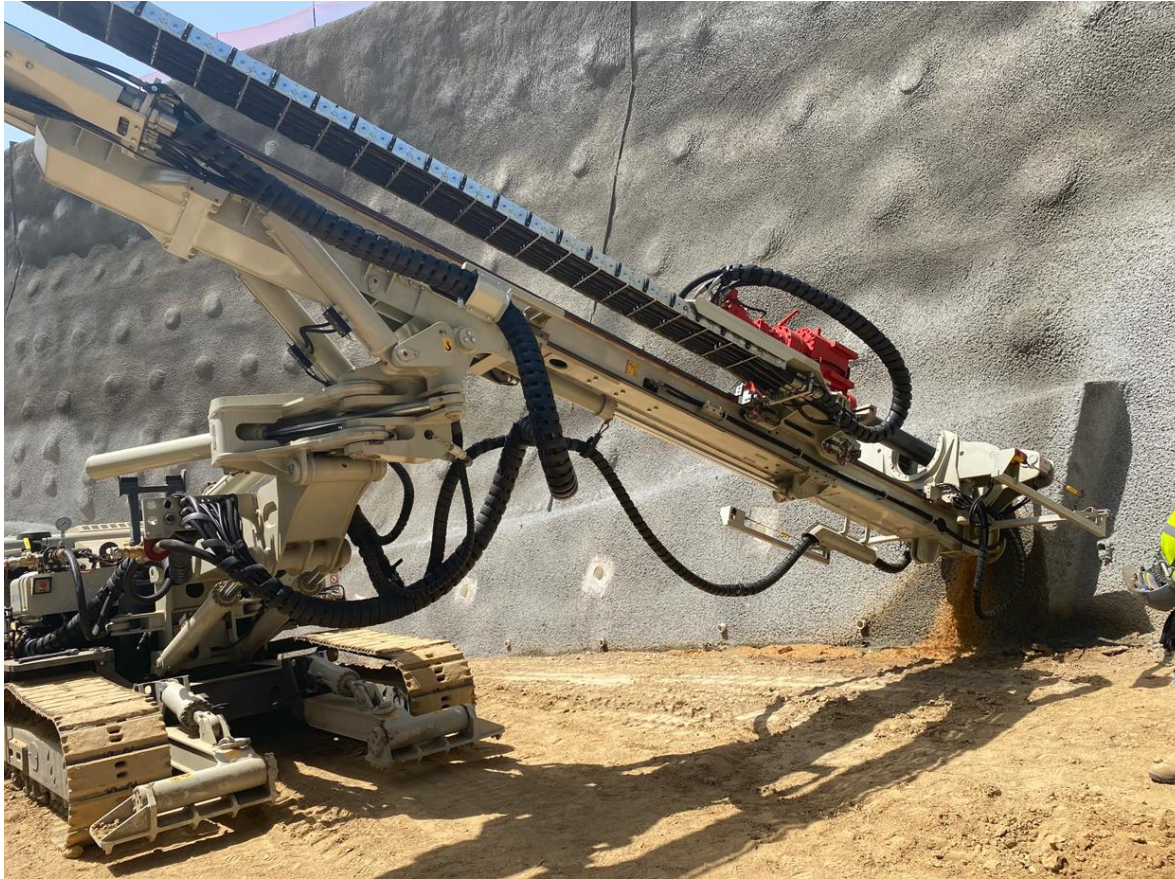
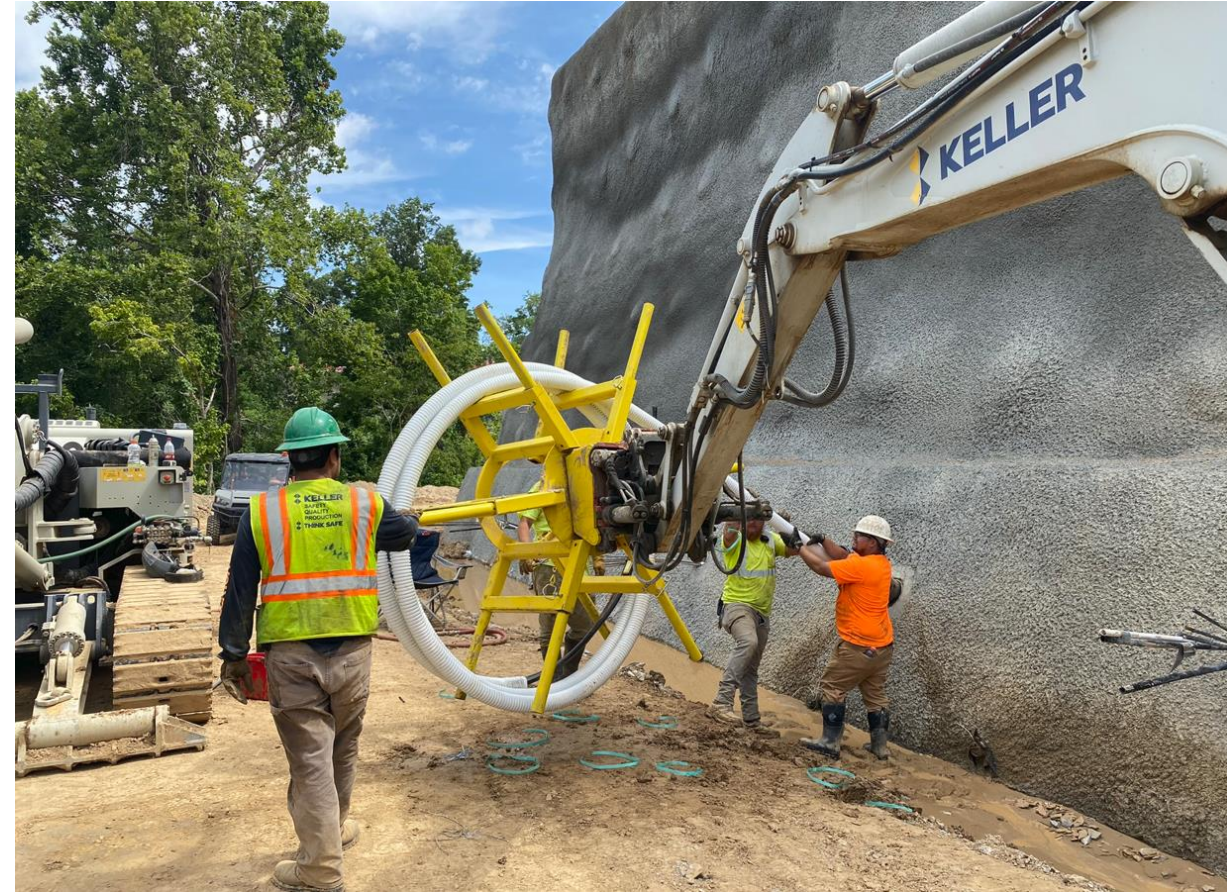
Steel Strand Tieback Anchors – 4-7 Strands - 245 kip max Spacing varies 6ft, 9ft, 10ft c-c

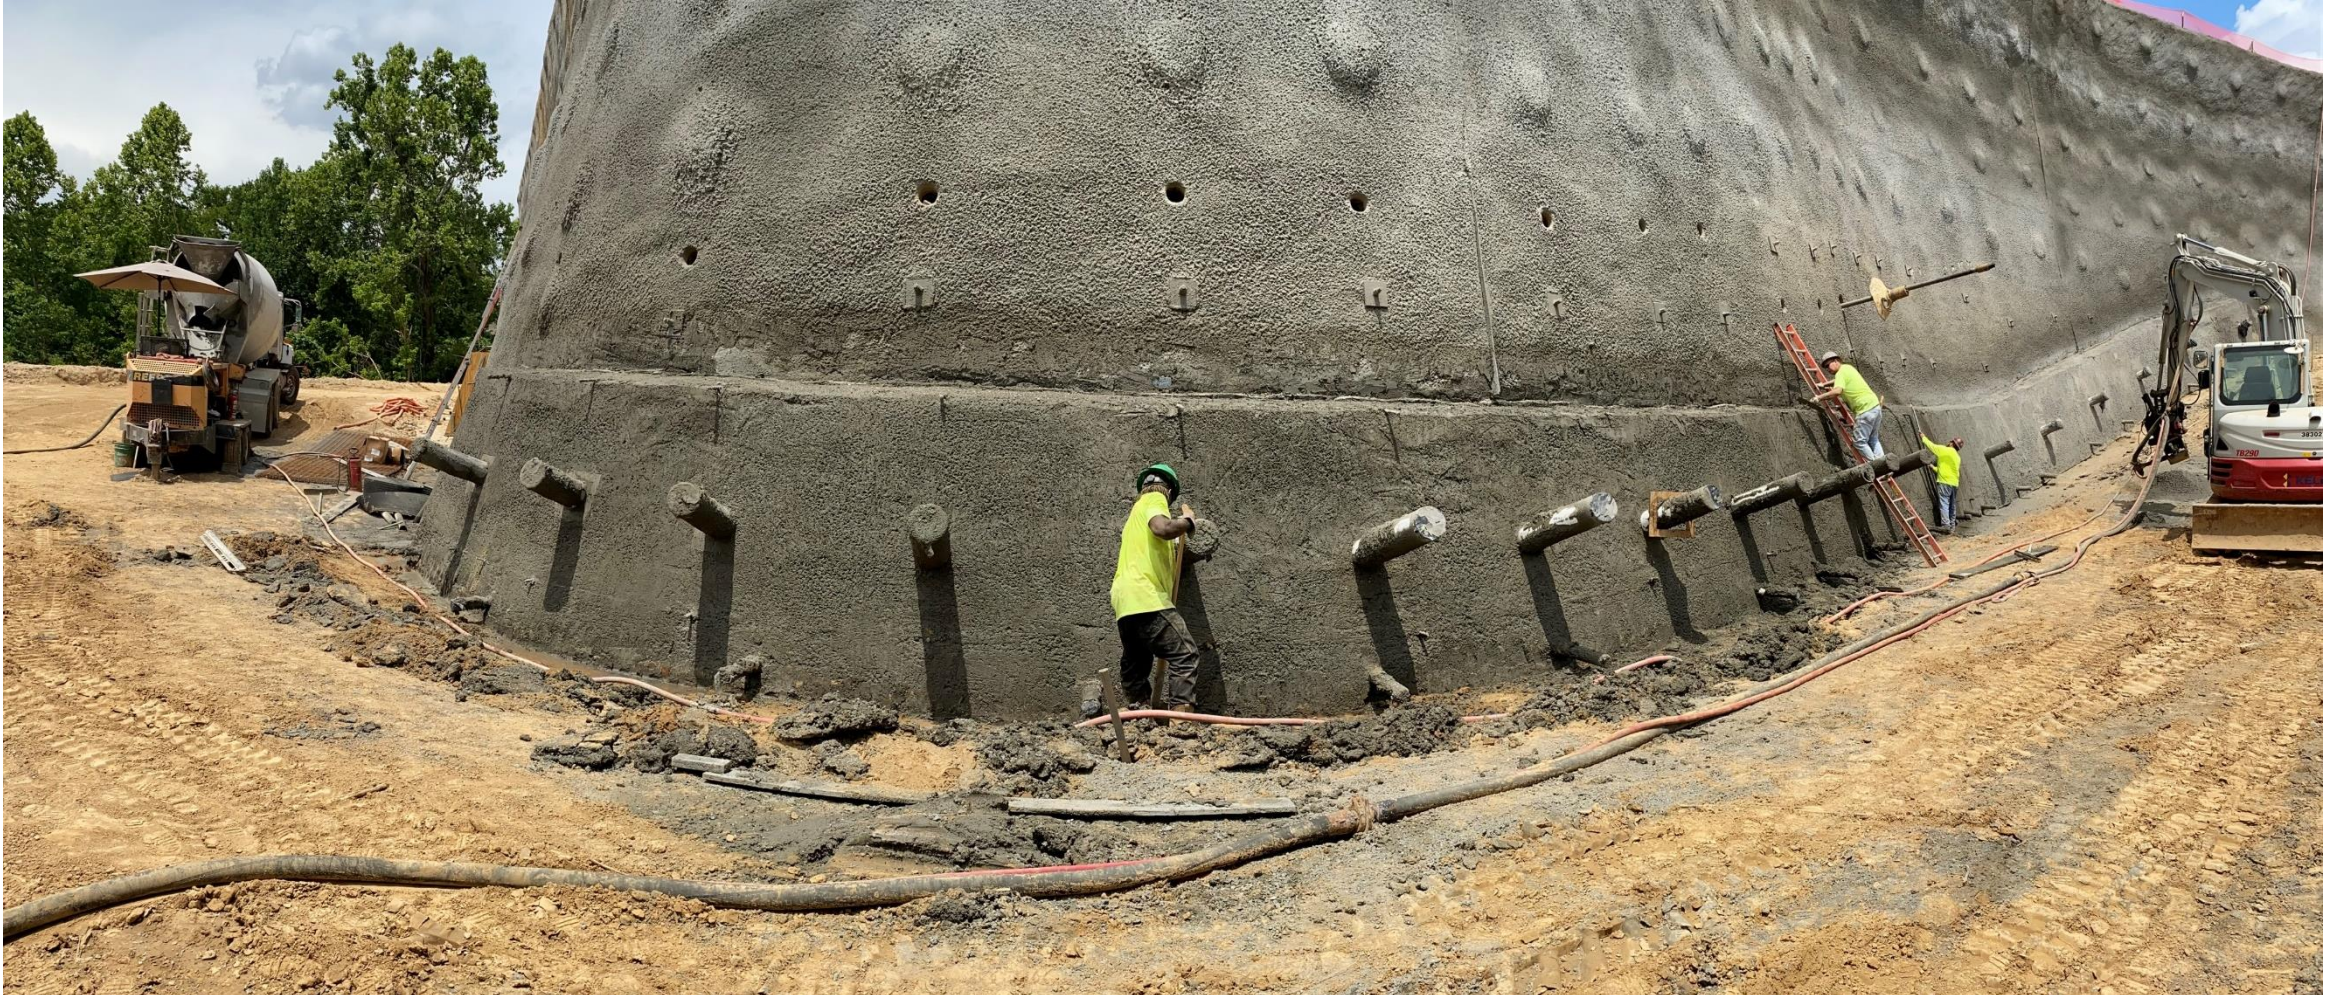
Tricky Outside Corner

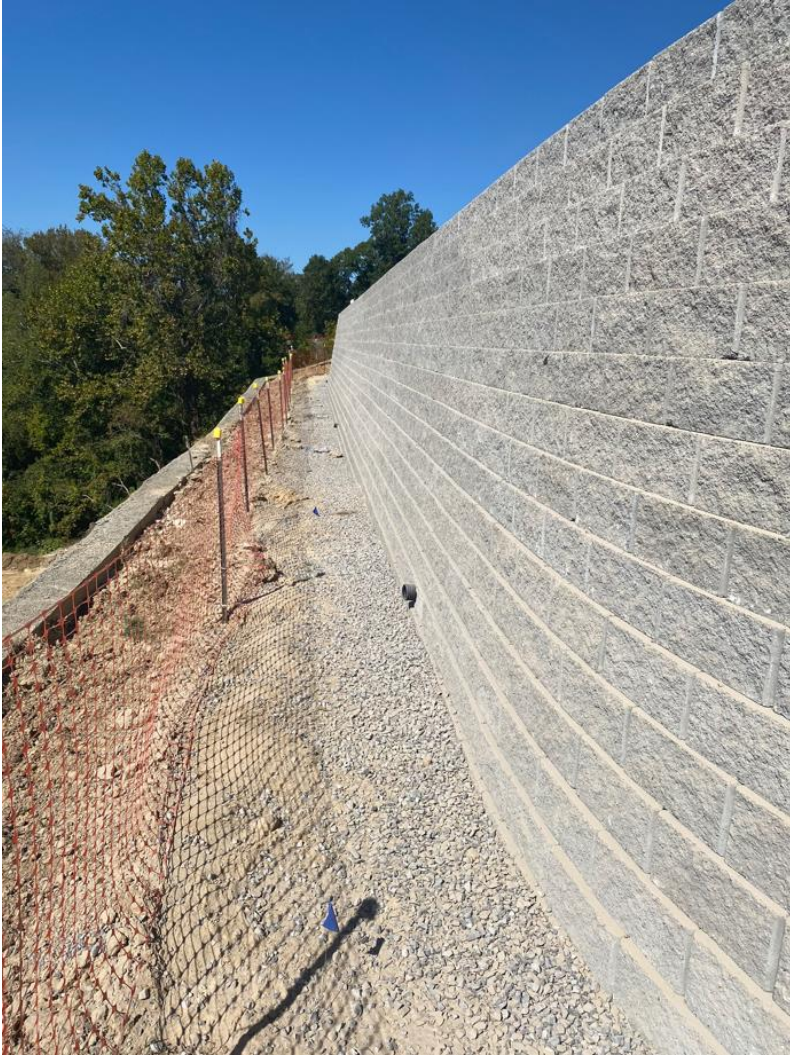
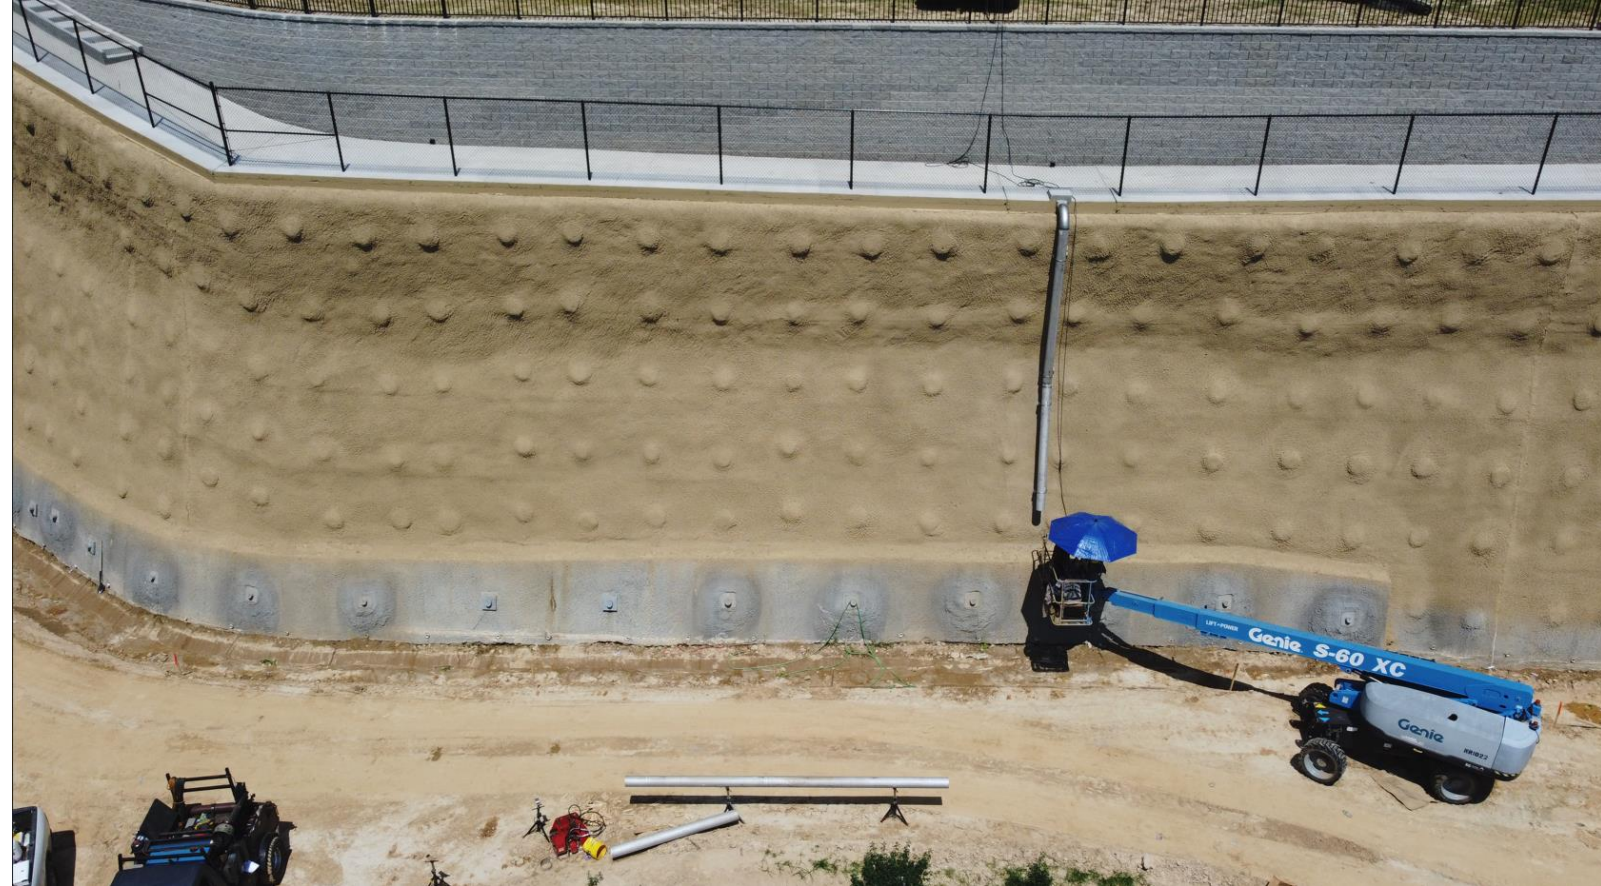
Rebuilt MSE Wall (subcontract) above Soil Nail Wall and Wall Staining

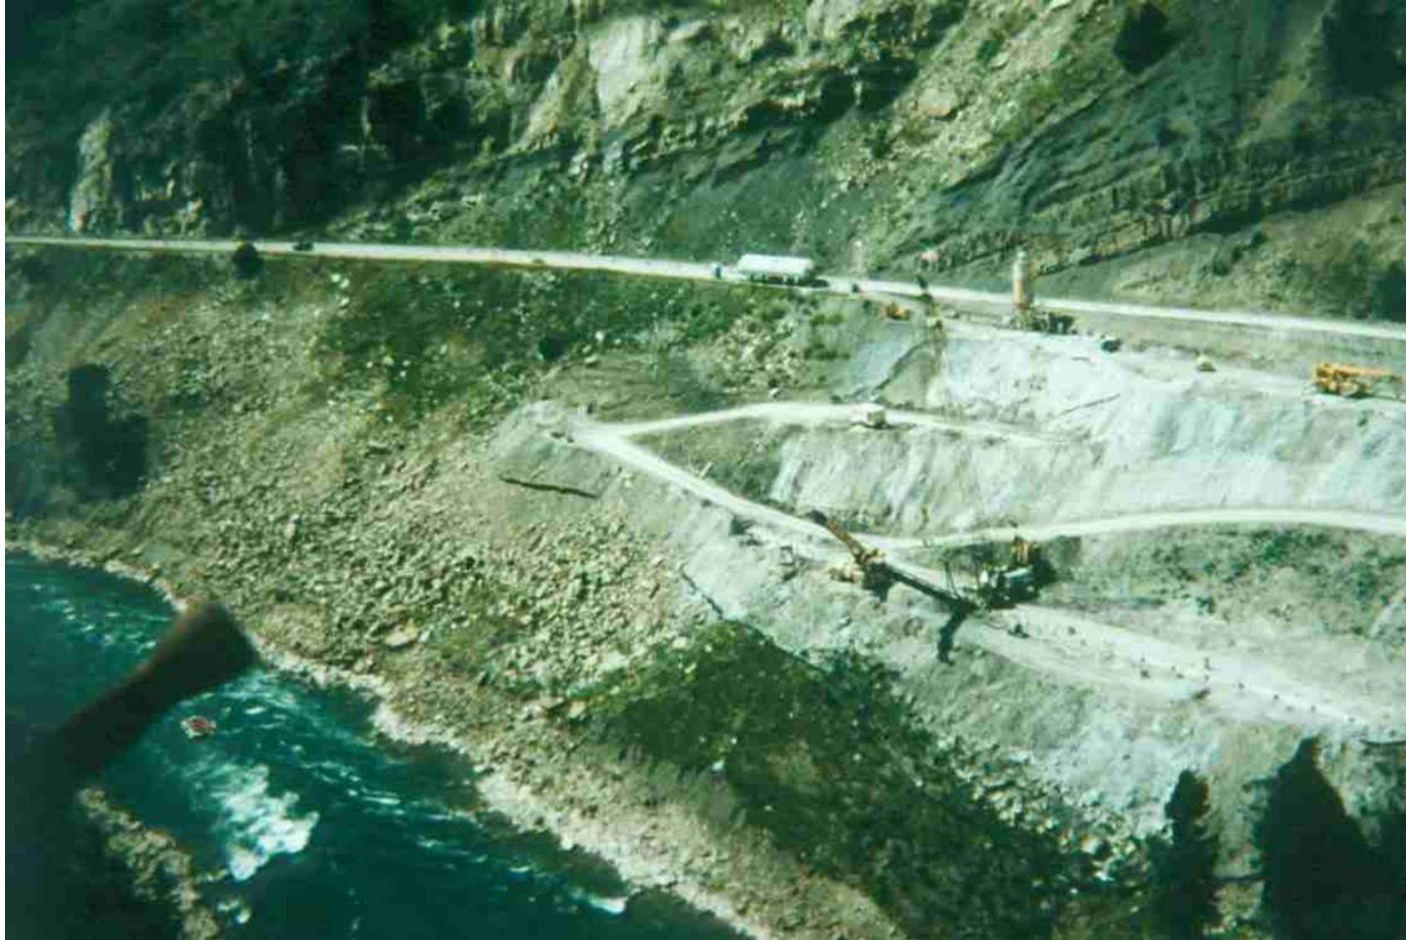
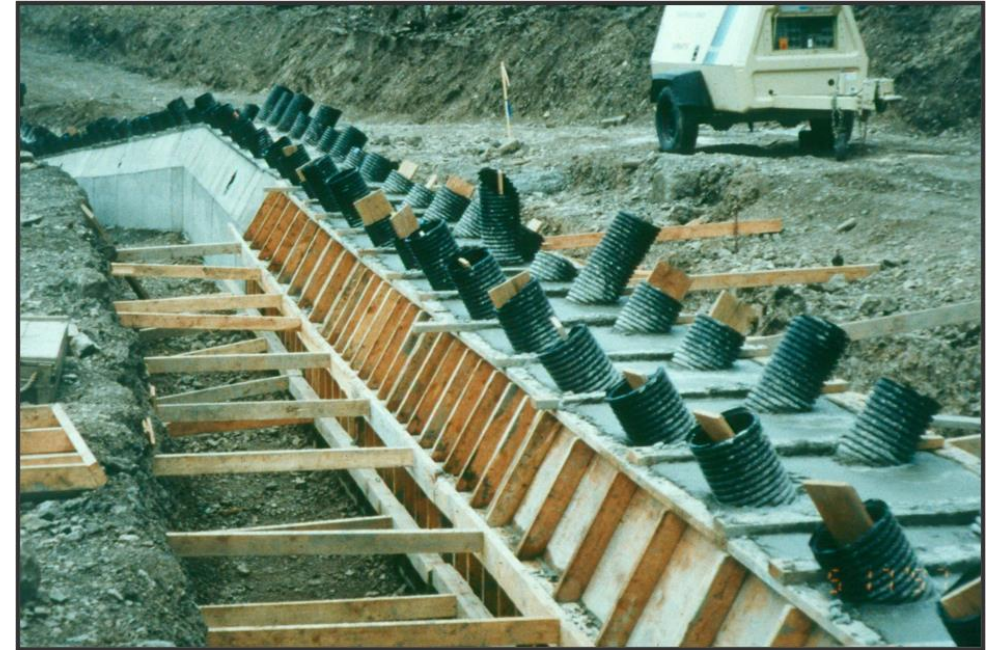
Previous Slide Repairs for WYDOT – Blue Trail Slide

- Upper, intermediate and lower walls constructed
- Micropiles used to construct the “A” portion of the walls
- Strand anchors also used for tieback elements

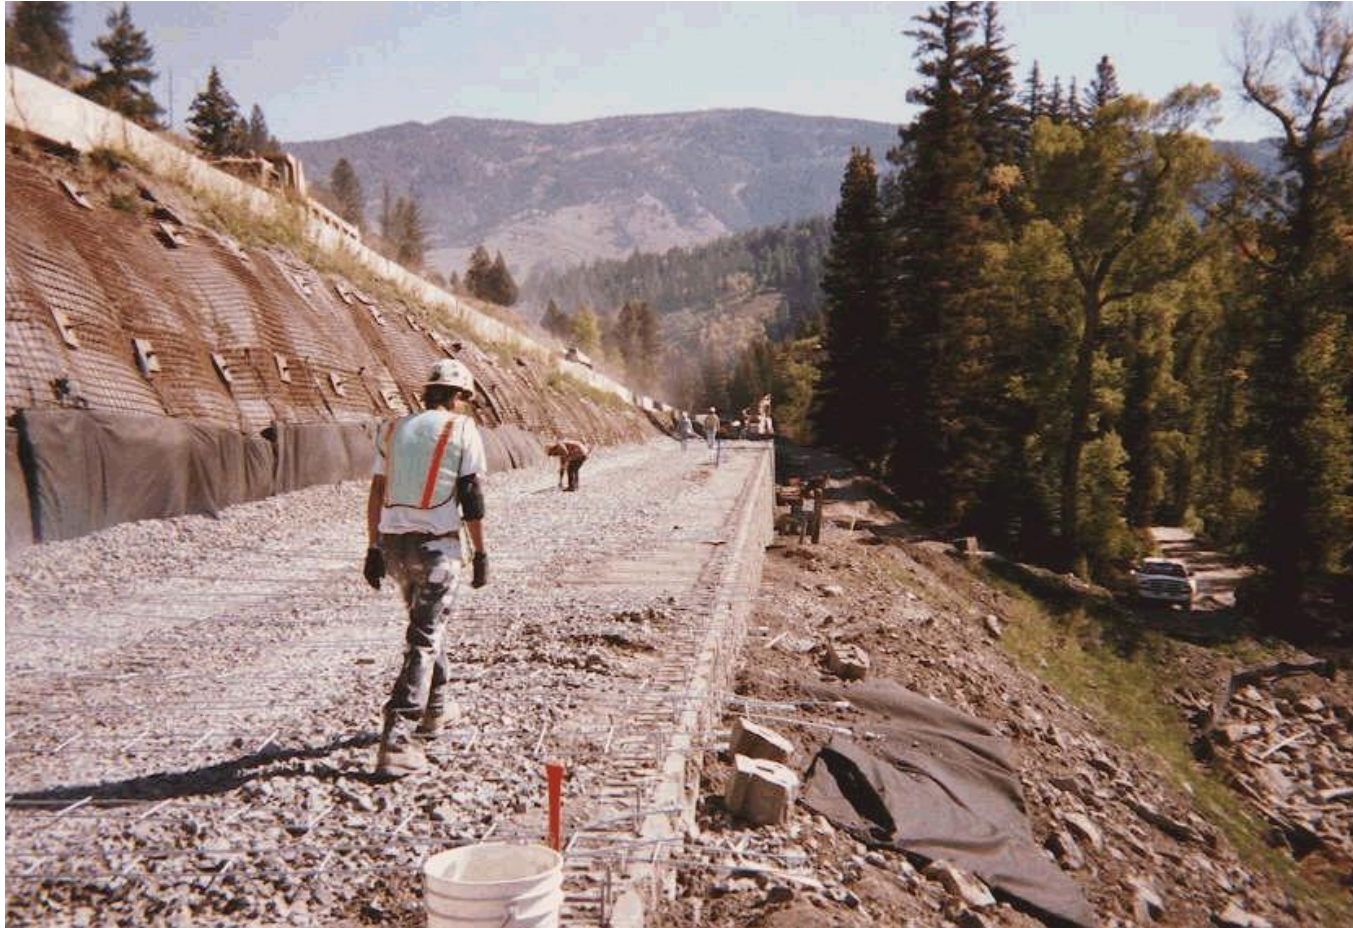
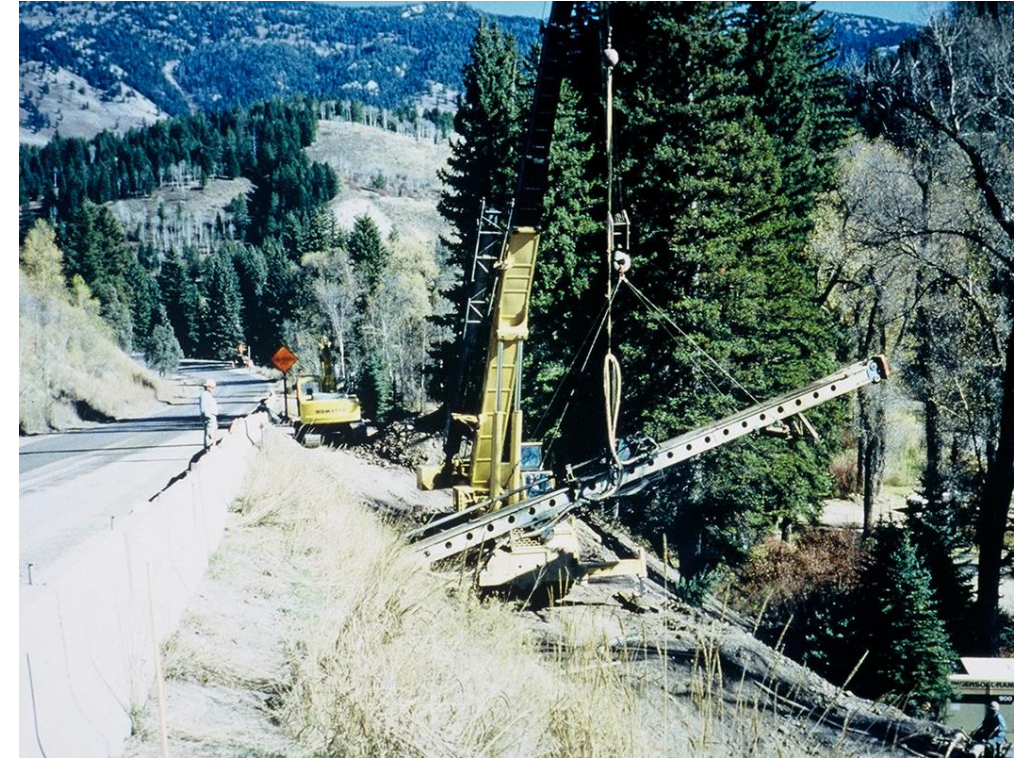
Previous Slide Repairs for WYDOT – Elbow Slide

- Upper and lower soil nail walls
- Shotcrete facing for lower wall
- Temporary steel mesh for upper wall
- Upper wall was relied on through winter
- MSE wall constructed in front of upper soil nail wall the following season
