Ralph B. Peck Lecture

Slope Stabilization using Tall Soil Nail Walls at Natchez National Cemetery and Teton Pass

Case Histories: Two Major Landslides Repaired using Soil Nailing

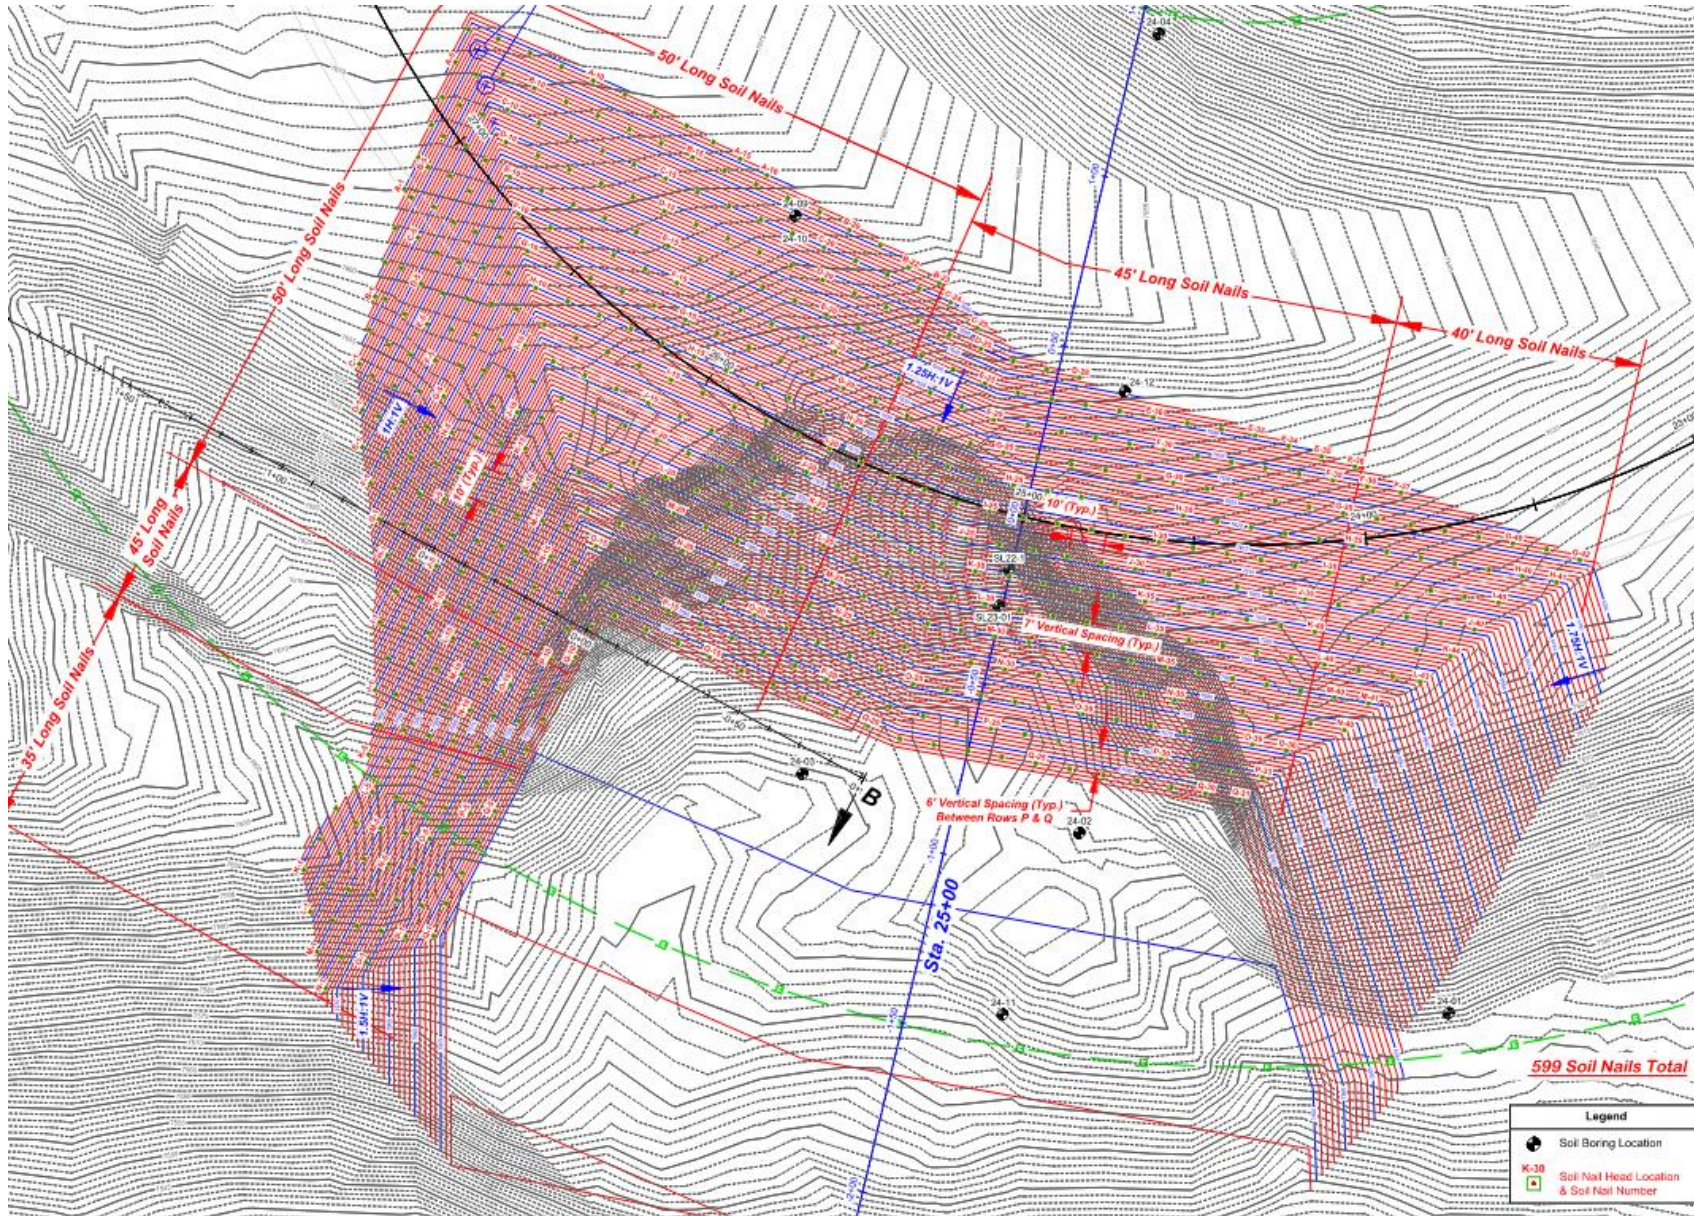
Temporary Shoring Plan

- Temporary shoring solution consists of about 60,000 SF of geotextile and wire mesh facing and 583 (as-built) soil nails, 40-50 ft long.
- L- shaped wall lengths were 410 ft and 115 ft, respectively
- The temporary slope parallel to the road was 1.25(H):1(V) ratio, and 1(H):1(V) ratio perpendicular to the highway

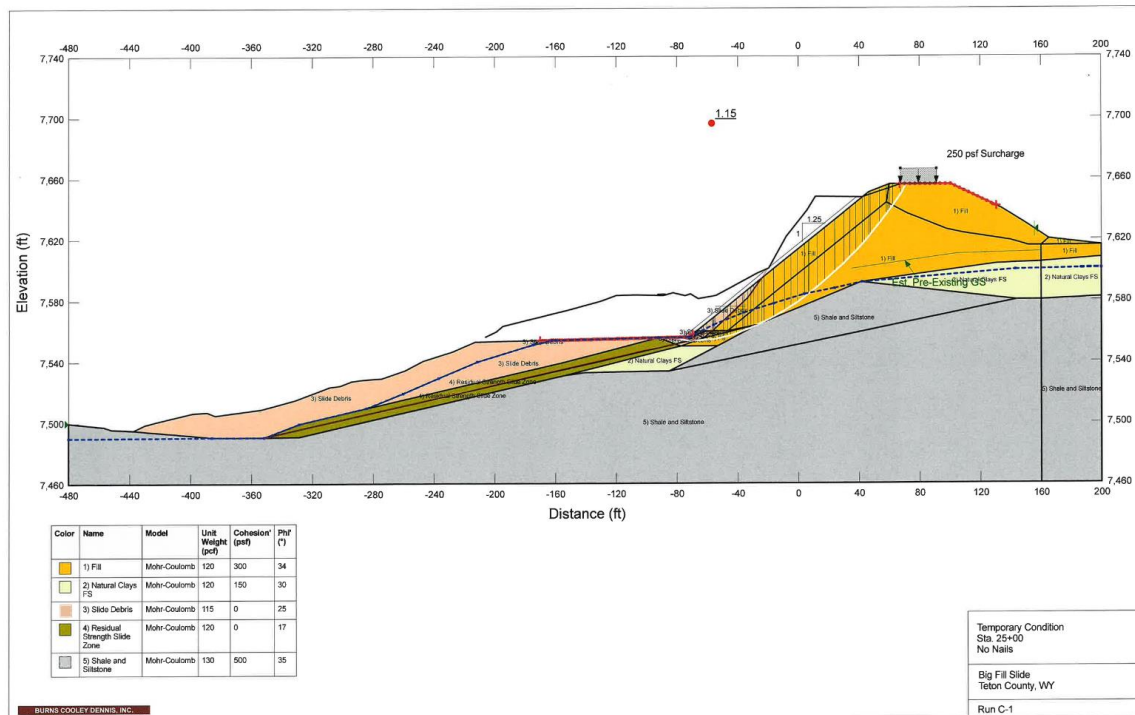
Right Side of Cut: 1.25(H):1.0(V)
Pre-Failure Back Analysis
FS = 1.15 (note: initially lower)

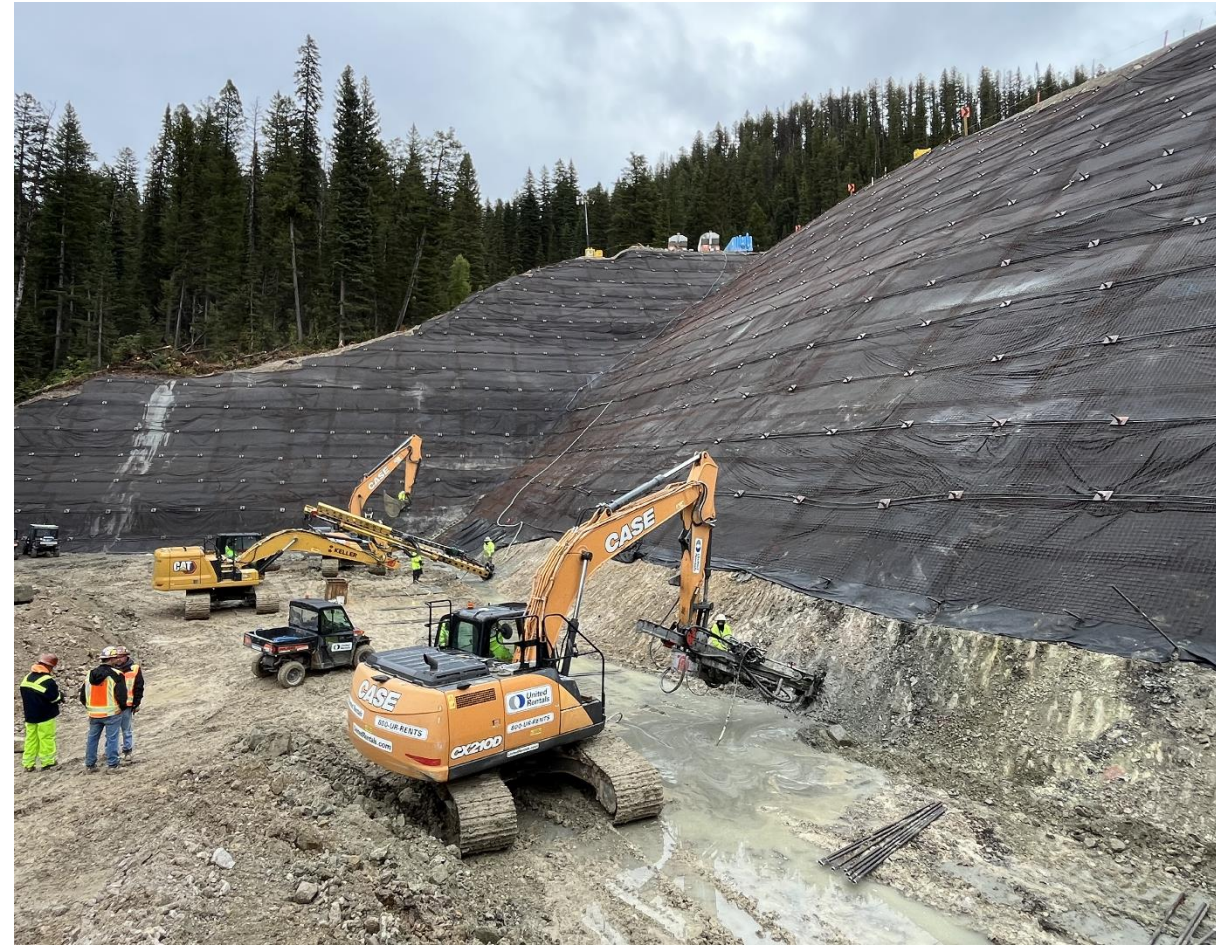
Soil Nail Drilling

- 25 ft and 14 ft masts with top drive drill heads mounted on 20 ton excavators.
- Ishebeck Titan Hollow Bar soil nails 40/20

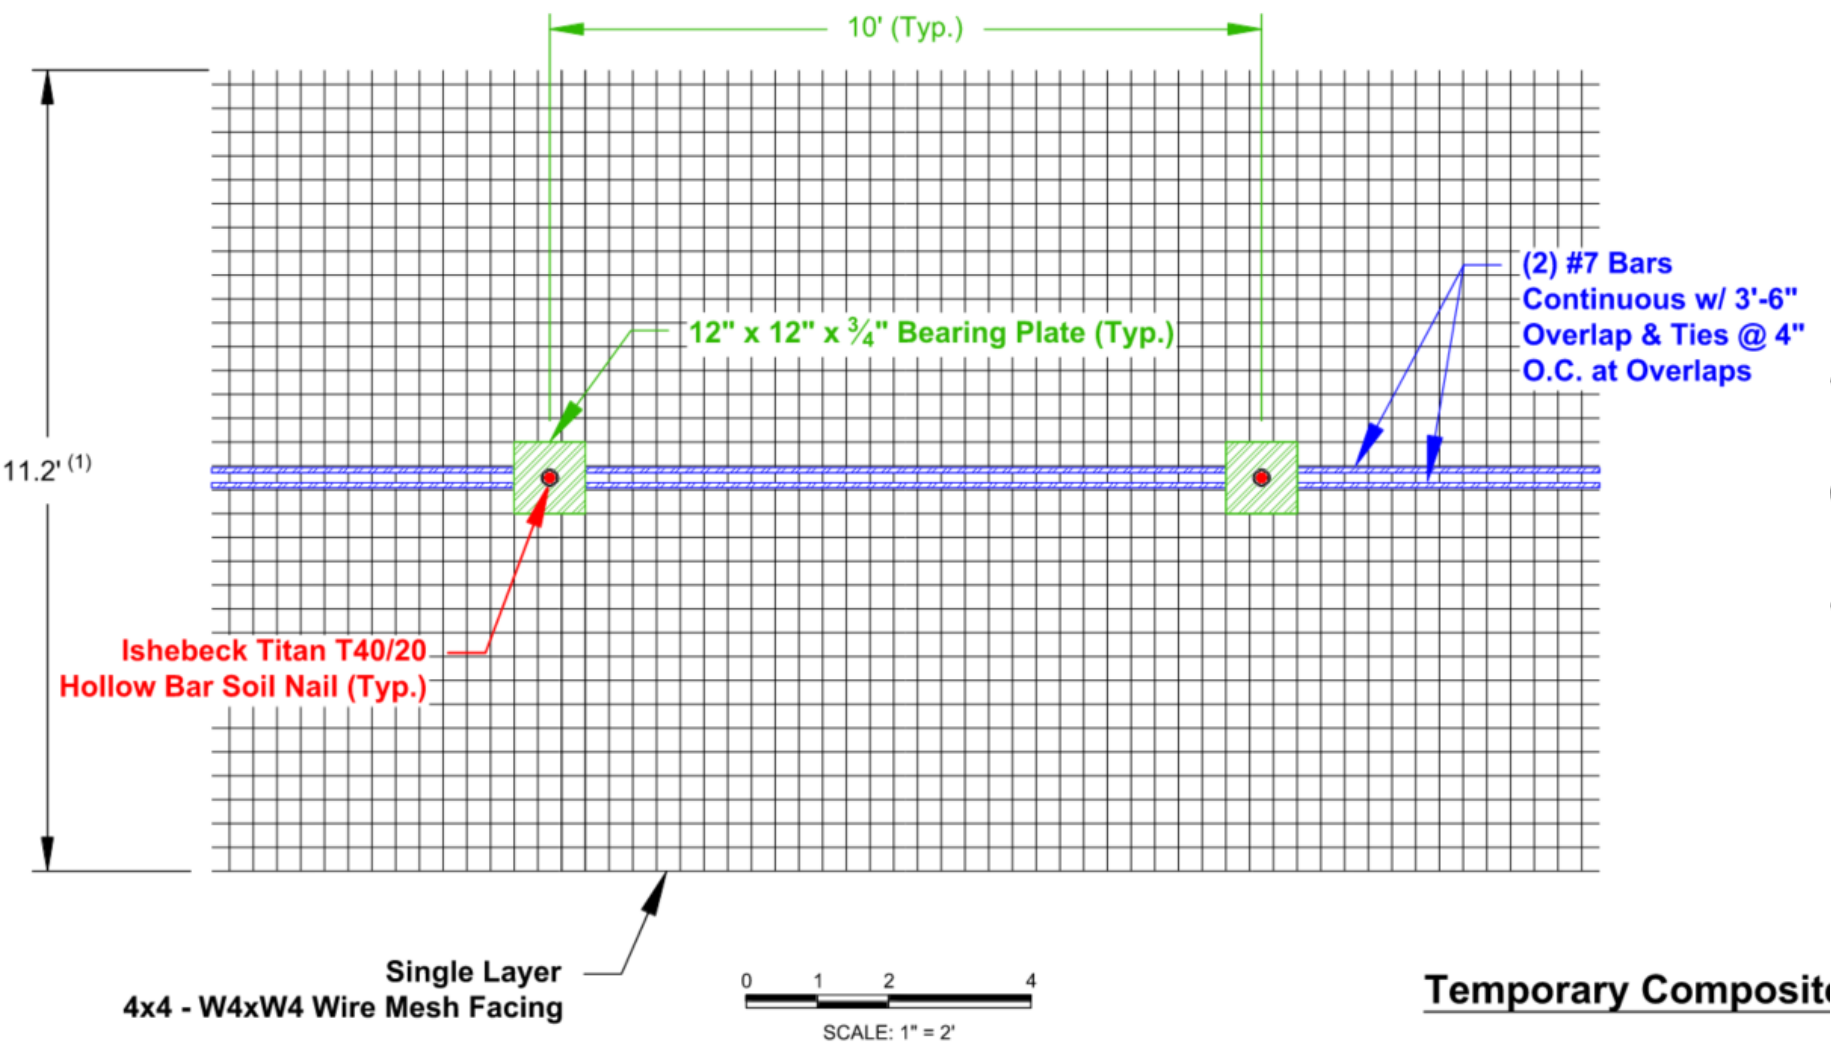
Soil Nail Facing Detail

- High strength wire mesh facing with parallel steel reinforcing bars acting as wales
- Geotextile fabric on the backside against the soil

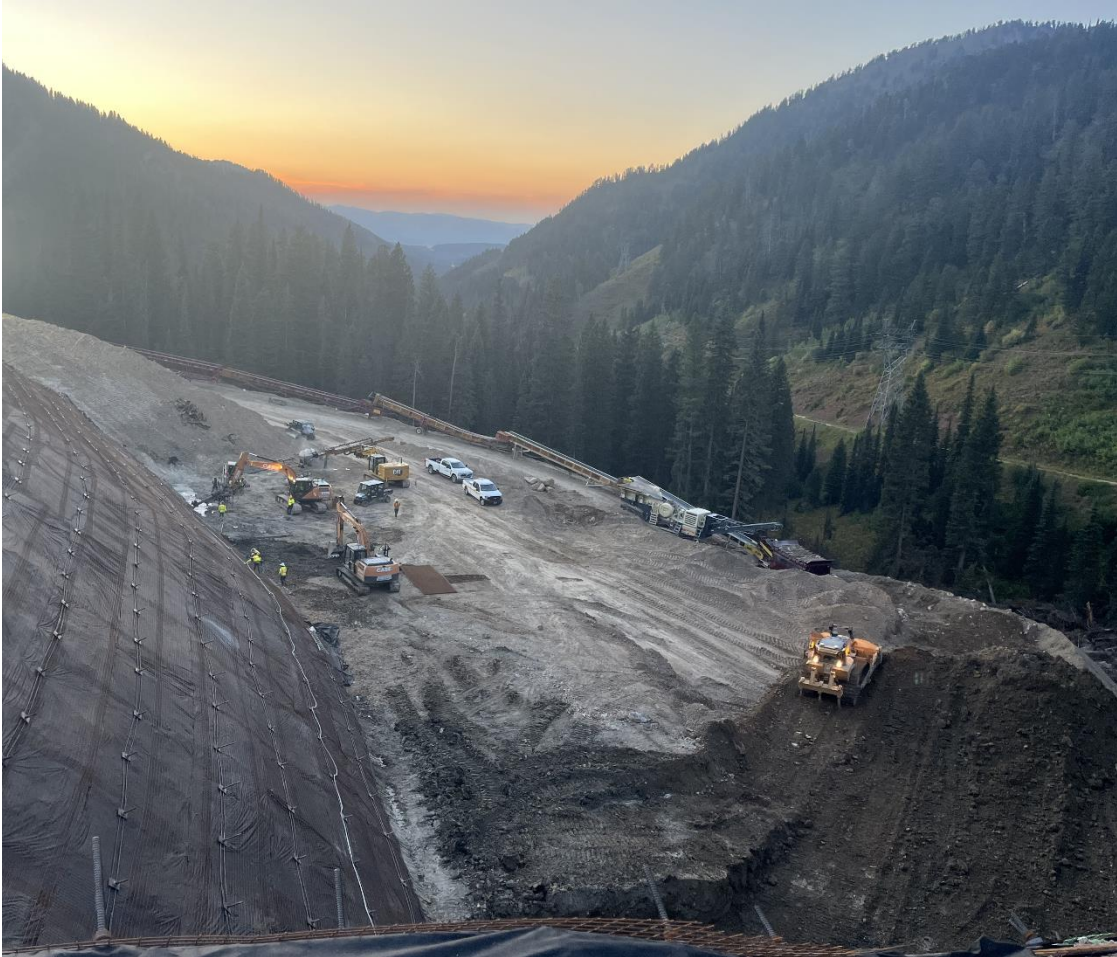
Excavation

- GC Ames Construction had excavation crews working day and night.
- Utilized a conveyor belt, 3 excavators, and 1 dozer to move soil.

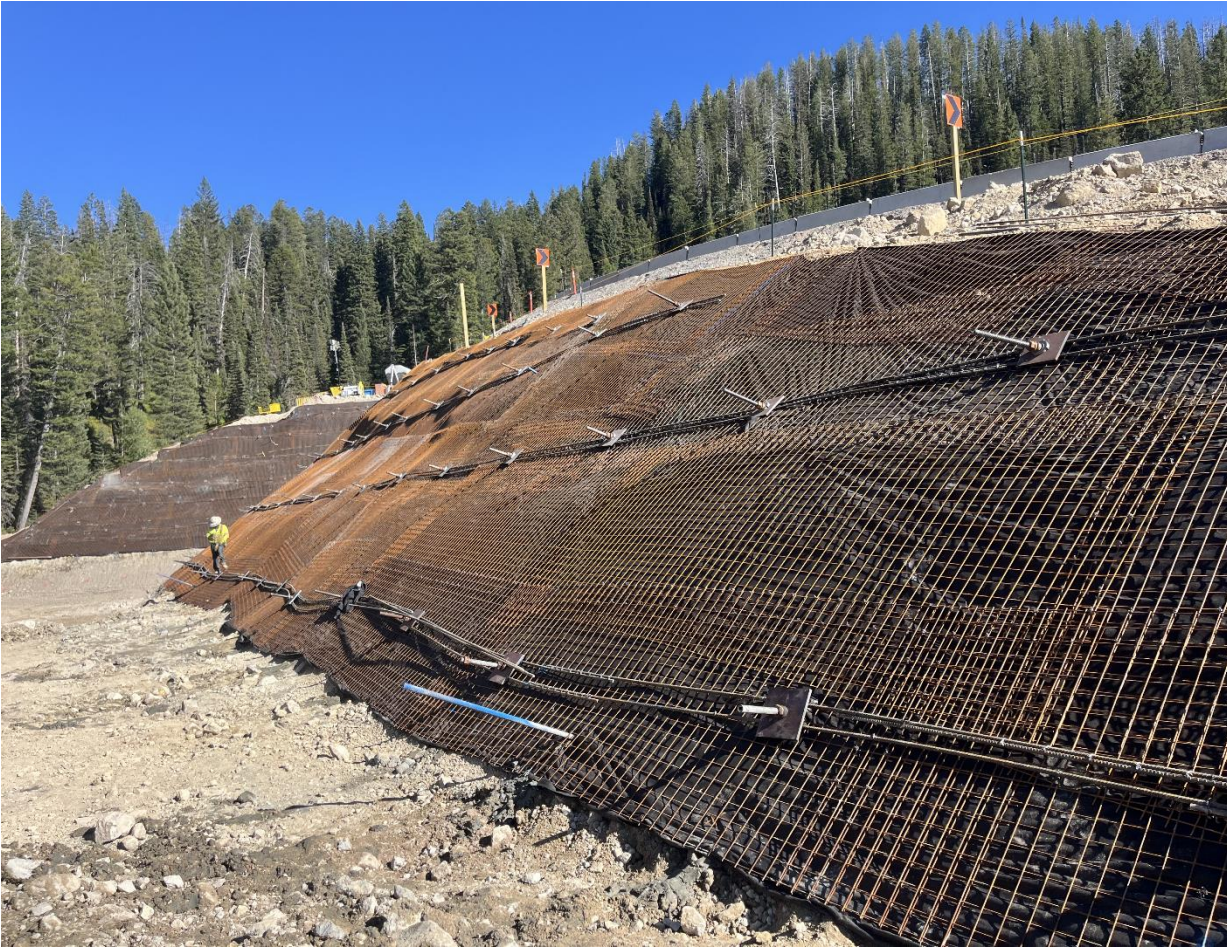
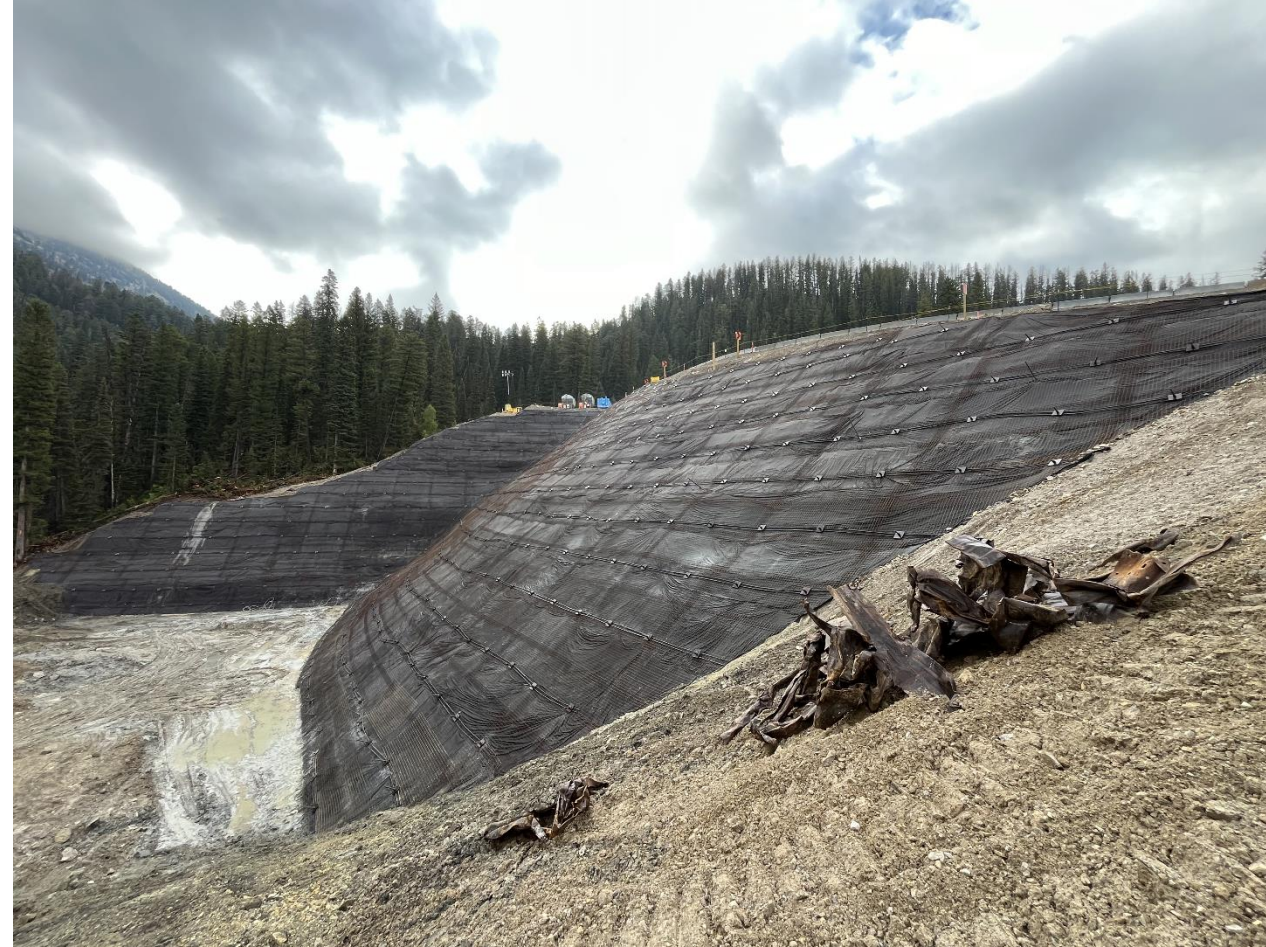
1 Test Nail per Lift

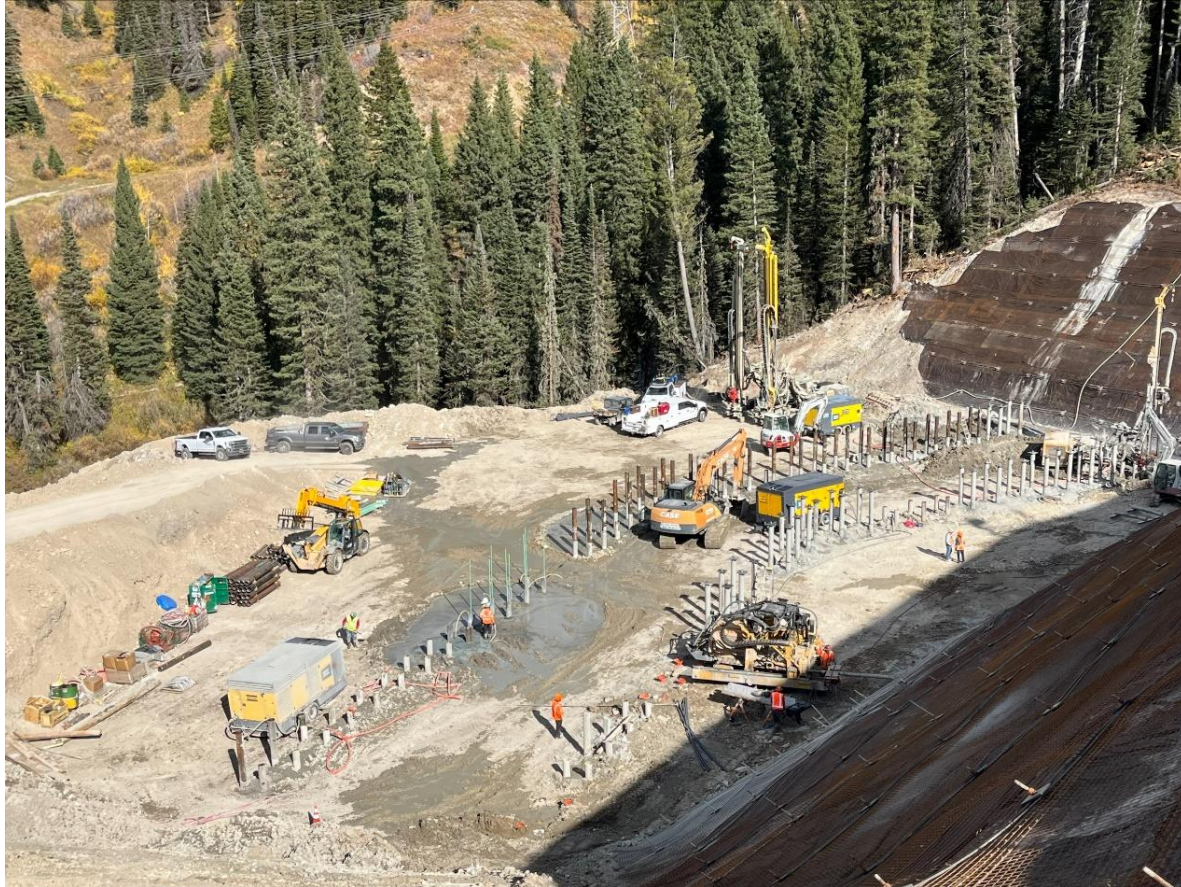
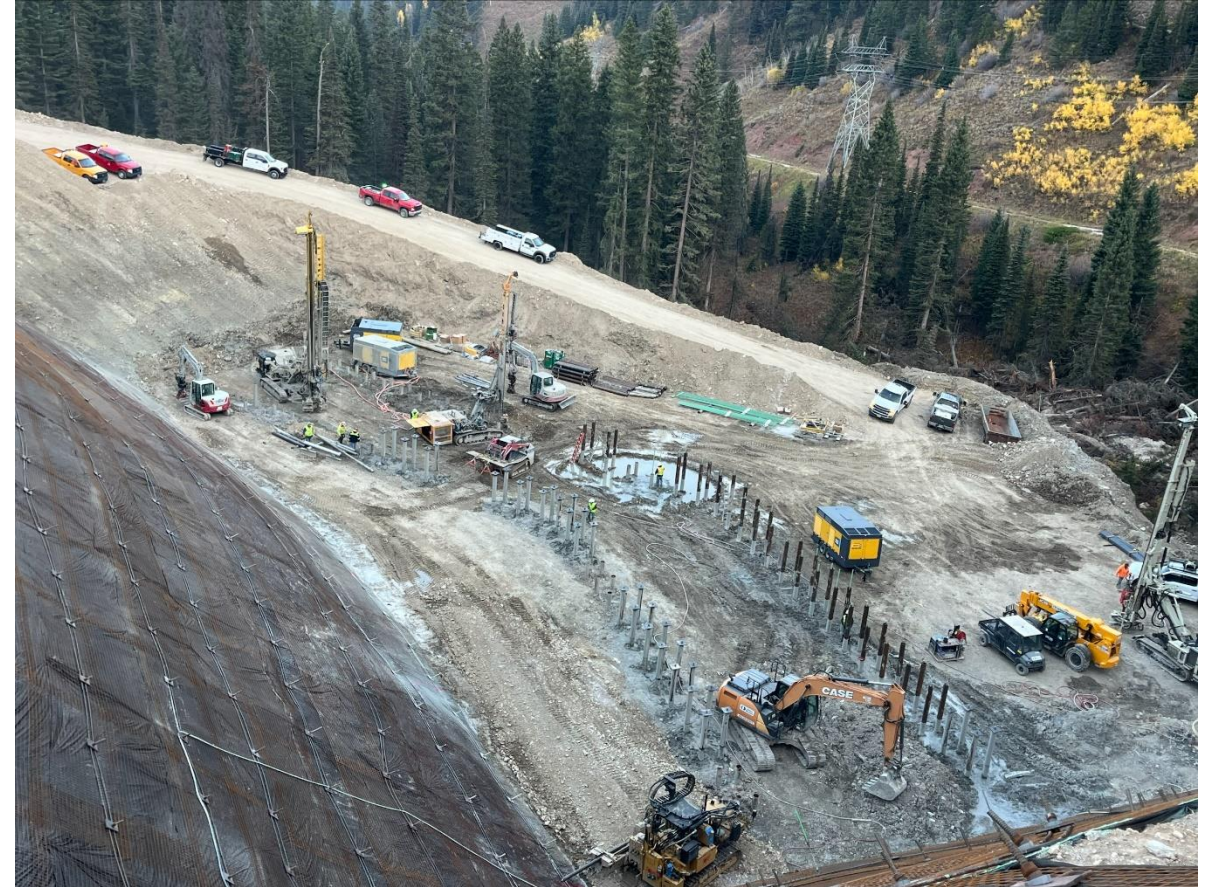
Horizontal Drain Drilling

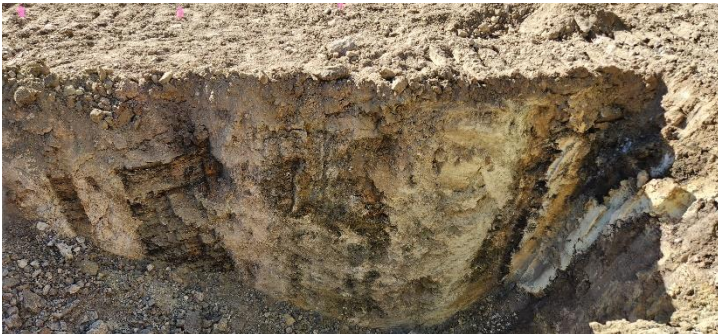
Permanent Slope Stability Micropiles

- Micropiles in each group are connected by a 5ft x 4ft pile cap
- MP Total length: 50 ft minimum
- Steel Pipe (9-5/8in): 35 ft
- 10 ft C-C spacing on pairs
- Rock Socket (8in): 15 ft minimum
- #14 – 75 ksi threadbar in the center
- Test Pits confirmed conditions after soft clay encountered in drilling

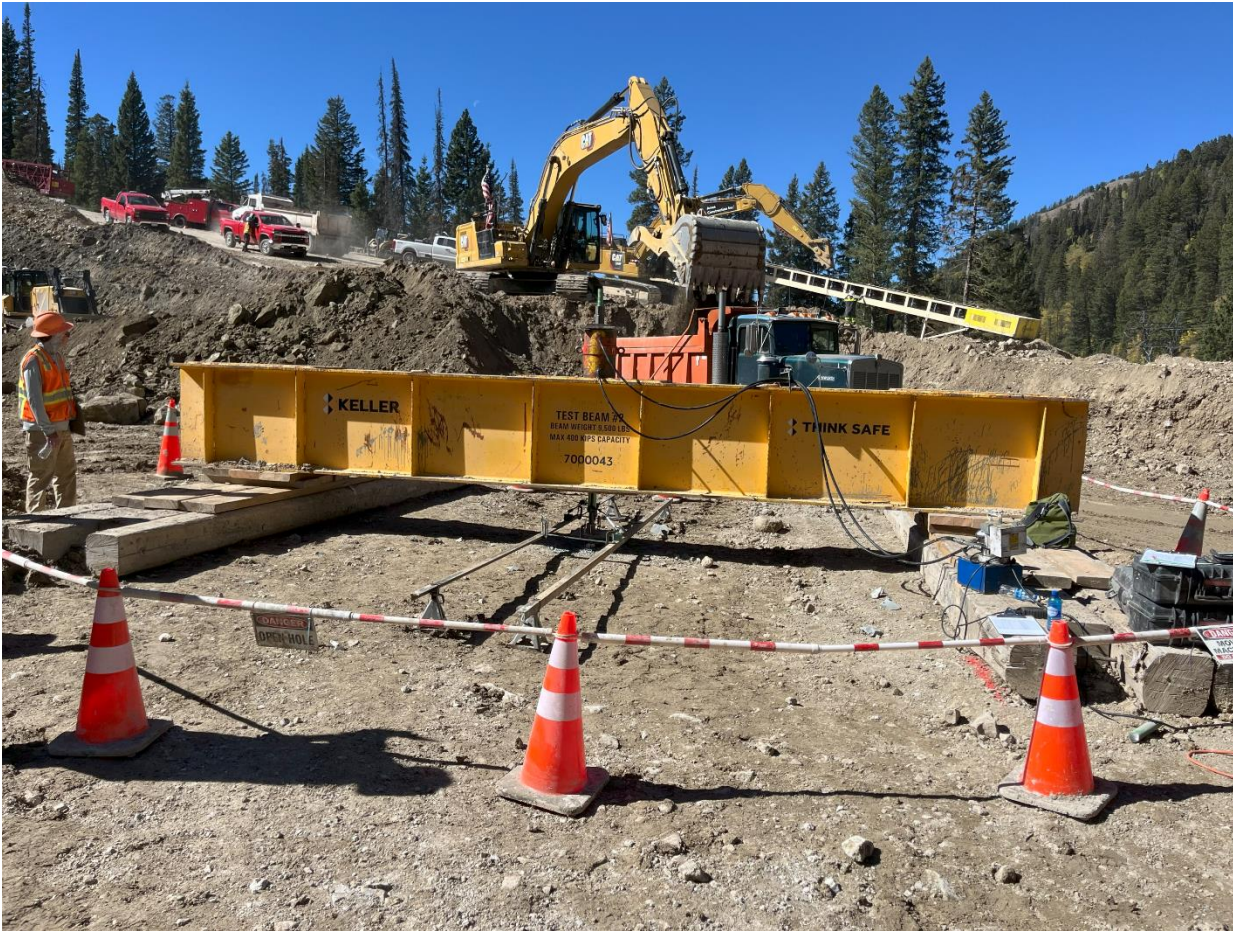
Micropile Testing

- 3 tension tests performed on sacrificial piles constructed using the same means and methods as for the production piles.
- 110 Kip Test Load; 55 Kip Design Load

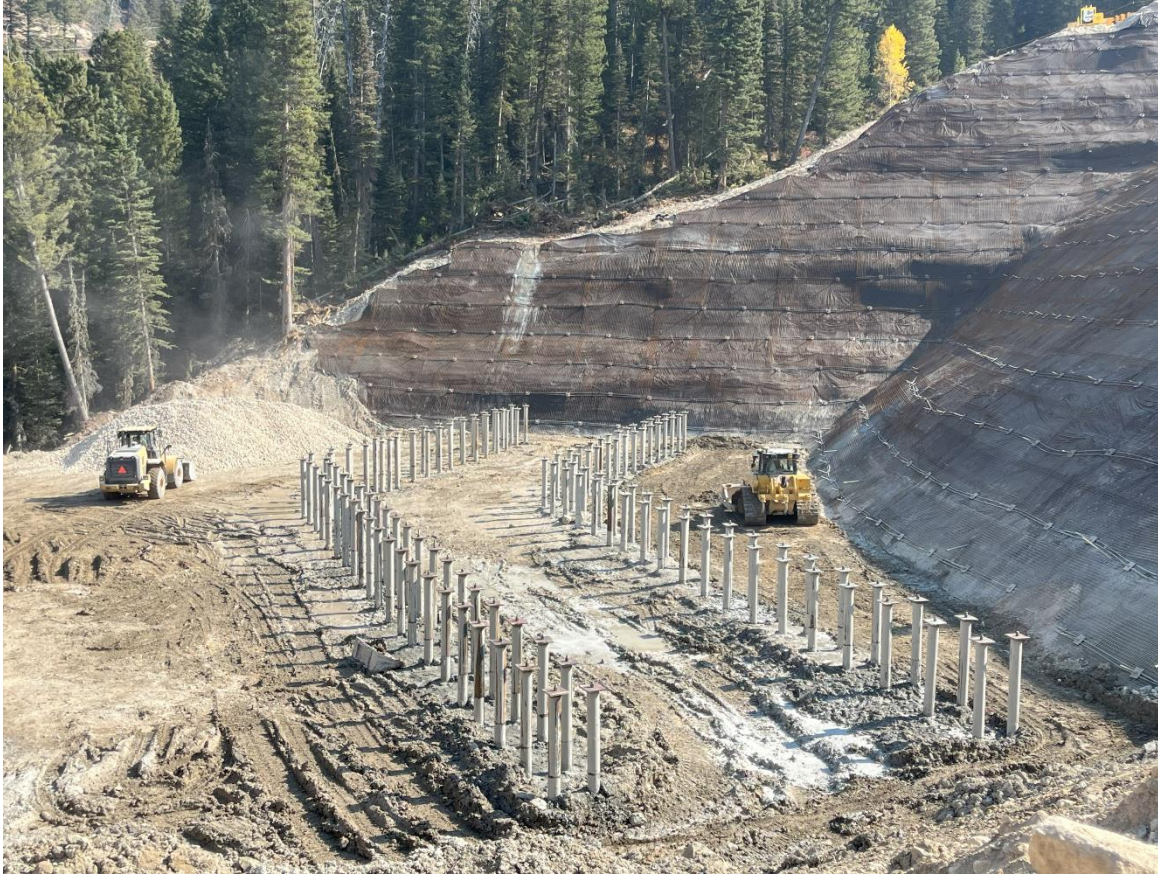
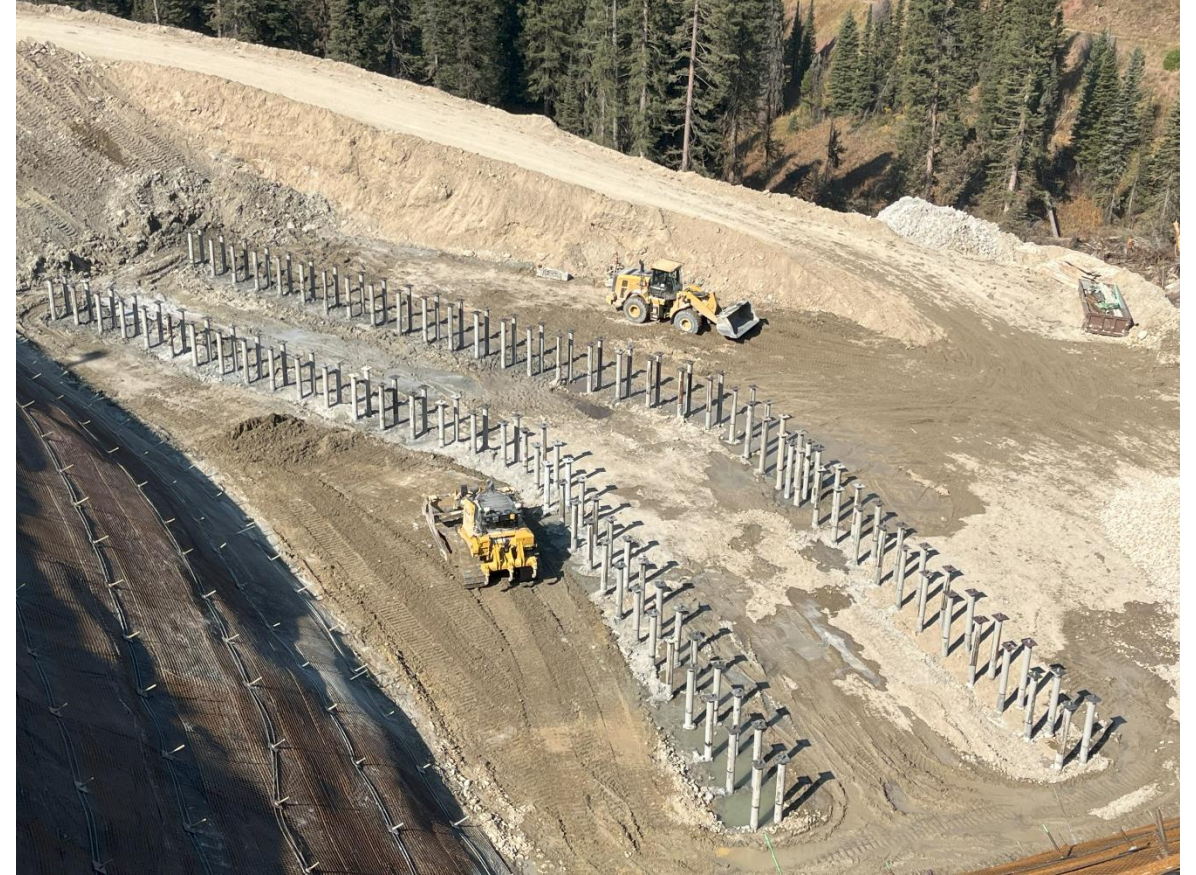
Permanent Slope Stability Micropiles Completed in 3 weeks with 2 crews/2 rigs Working 1 long shift 6 days/week
