# Leveraging Advancing Technologies for Pipe Replacement and Condition Assessment at WaterOne

75<sup>th</sup> Annual Environmental Engineering Conference

Jason Beyer & Peter Gaskamp, PE

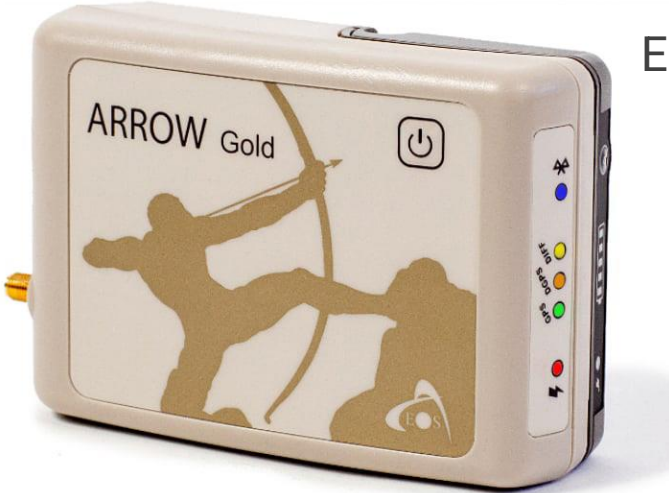
EOS Arrow Gold

- All assets are GPS'd in real time by either our in-house construction crews or inspectors monitoring contracted crews
- All assets then added to GIS in real time by editing staff
  - No longer referring to as-builts or paper forms when posting
- WaterOne VIEW – Internal GIS Mapping

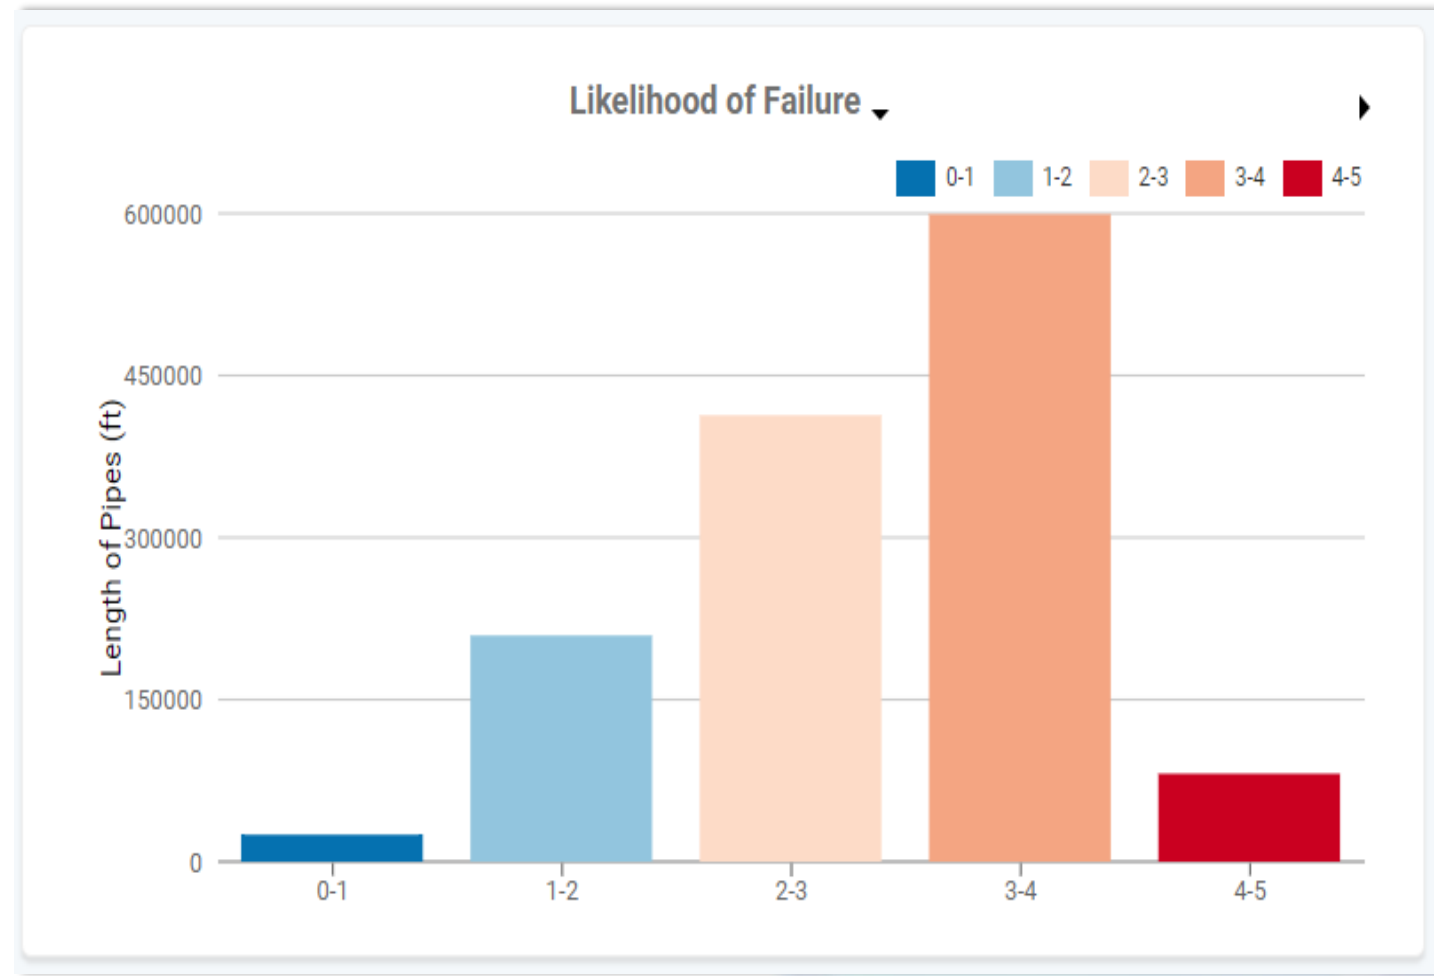
# Validating Results

- Criteria:
  - Correctly predicting at least 70% of the breaks in the top 30% highest risk mains
  - **We each had a week to separately validate results**
- Results: First Model Run
  - Achieved **73%** Accuracy
  - But model was incorrectly associating newly installed water main with old/retired breaks

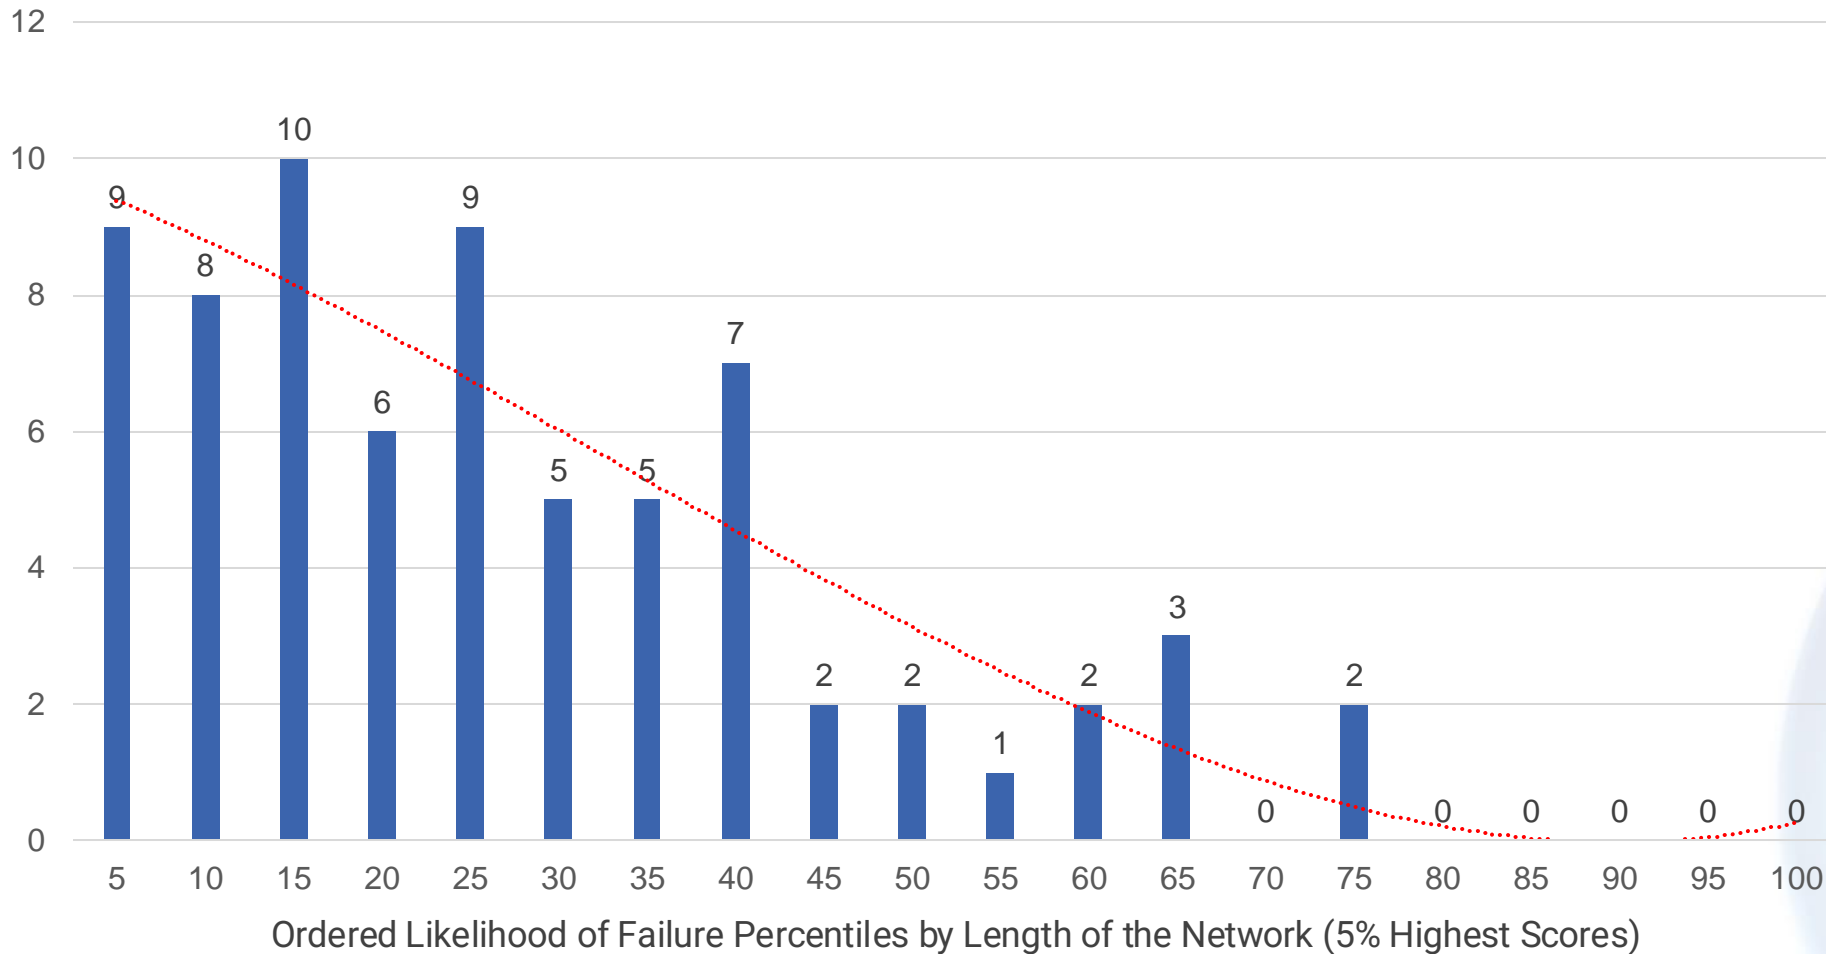
## RECORDED MAINS CAPTURED BY LOF PERCENTILES

- 71 total main breaks used for validation
- Significant skew towards highest risk brackets.
- 27 breaks in top 15% of risk.
- More breaks in top 5% of risk (12%) than the bottom 50% (11%).

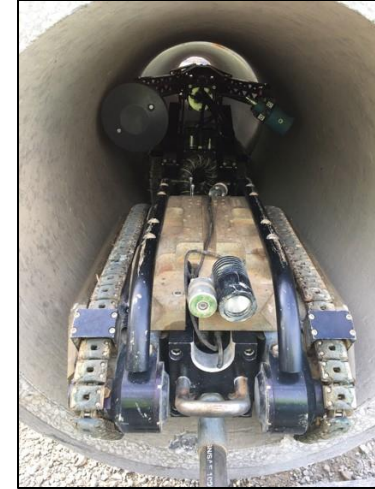
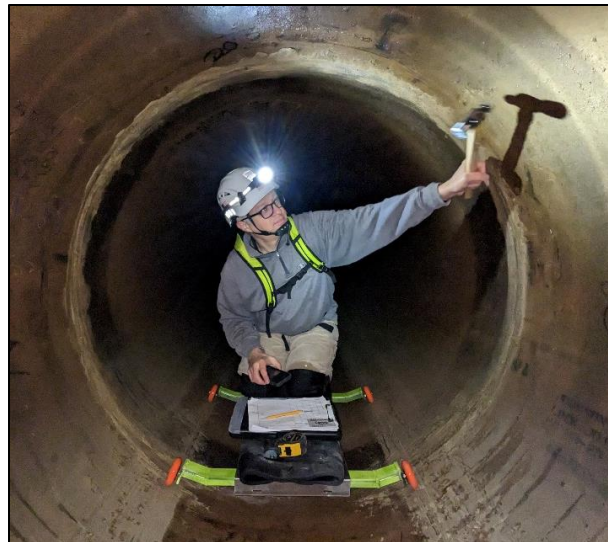
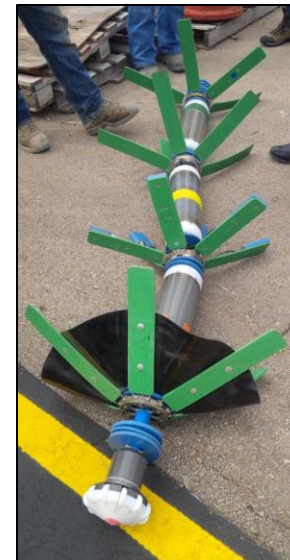
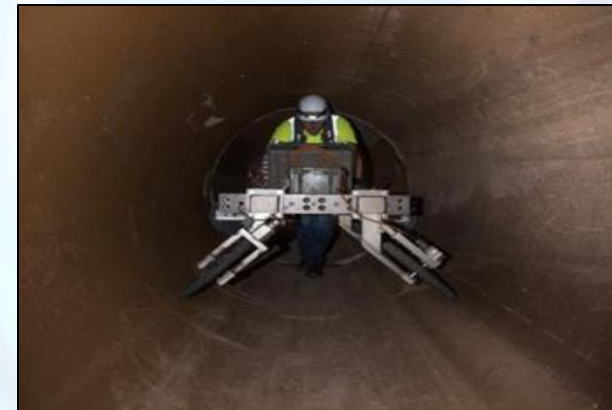
# Overview of Water Pipeline Inspection

- Hire external companies with technology, use own crews for prep work, combined team effort
- Primary high-resolution technologies
  - Electromagnetic (Near Field and Remote Field)
  - Ultrasonic
- Four inspection methods
  - Human entry ( $\geq 36"$ )
  - Robotic
  - Tethered
  - Free-Swimming

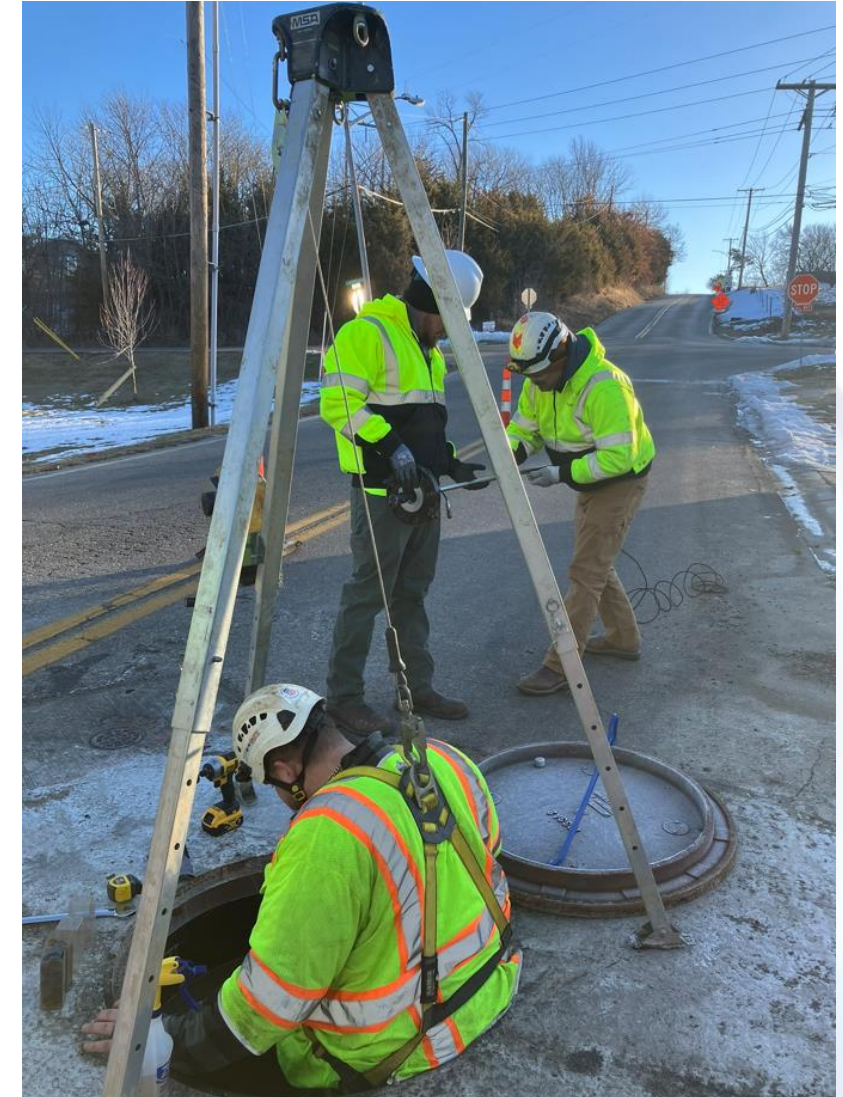
# Woodson Transmission Main

- Reinspected in 2025 with free swimming ultrasonic technology
  - Inform schedule for replacement
  - Quantify rate of corrosion
  - Bonus – comparison of different vendors technology on the same pipeline.
- Draft report due April 2025
- Low investment relative to cost of replacement:
  - Phase II Replacement Cost (just contractor): approx. \$450/LF
  - Phase III Reinspection Cost (just contractor): approx. \$20/LF
