Addressing Slope Failures involving Problematic Soils in Kansas

Amanda Keeney, P.E.
Geotechnical Asset Management Engineer

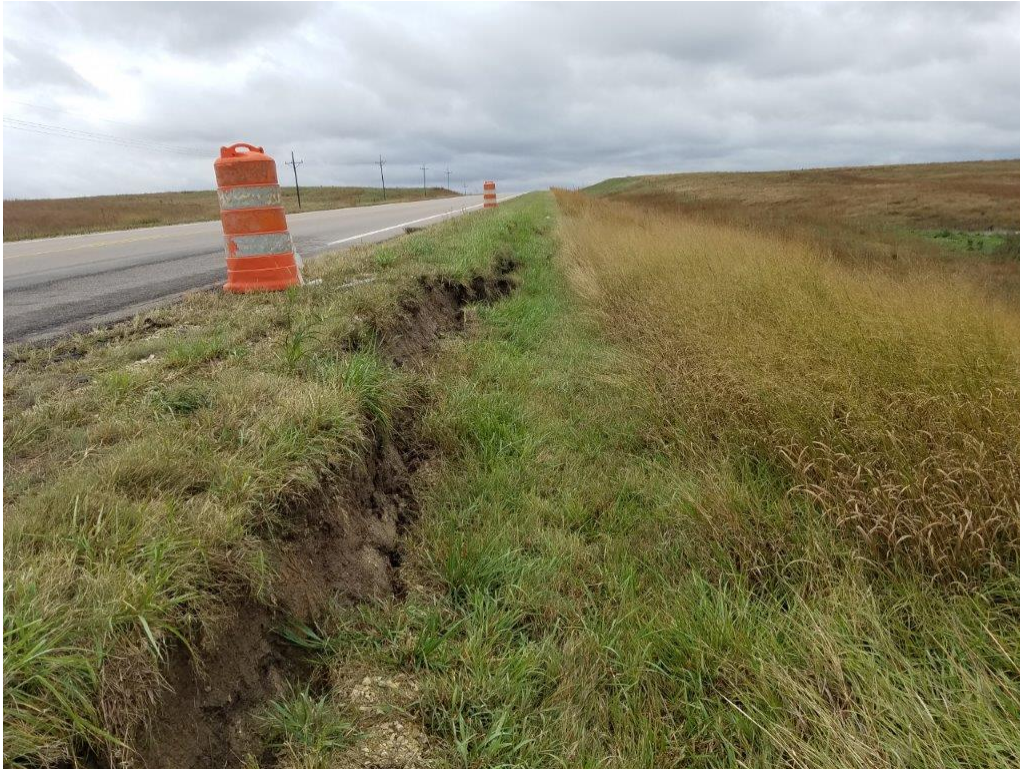
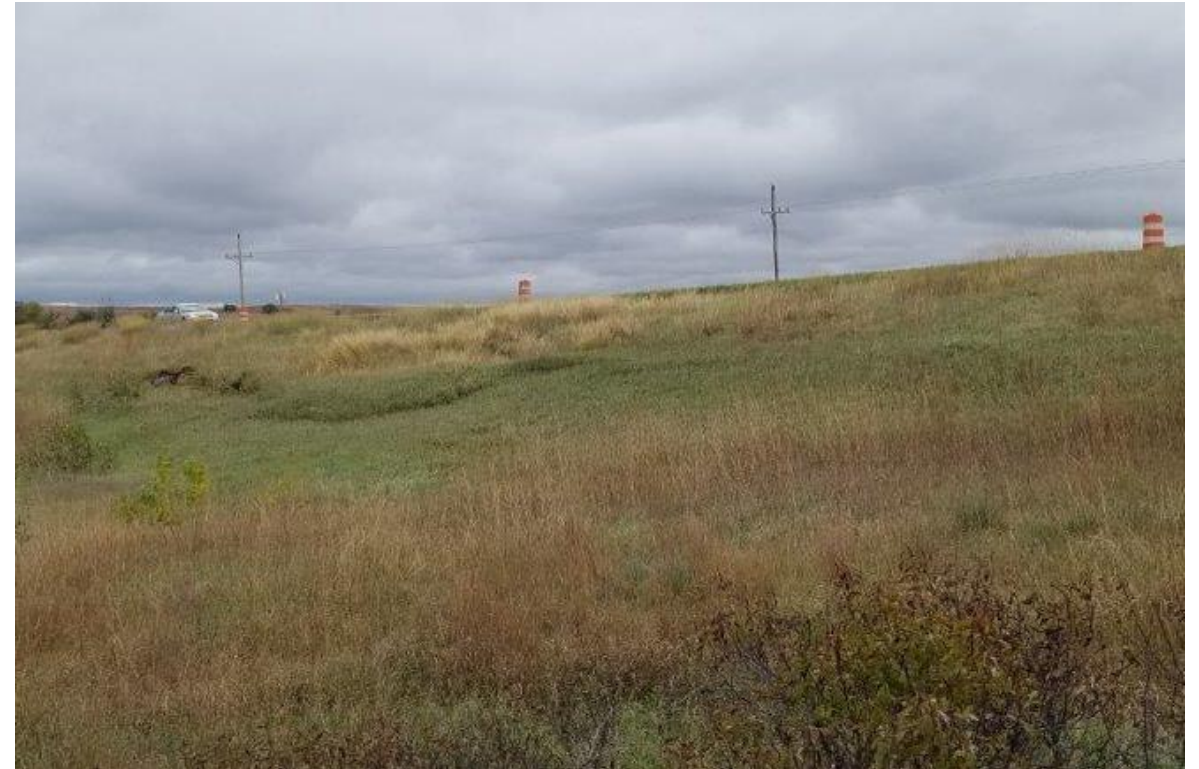
- Investigation Requested: mid Oct. 2018

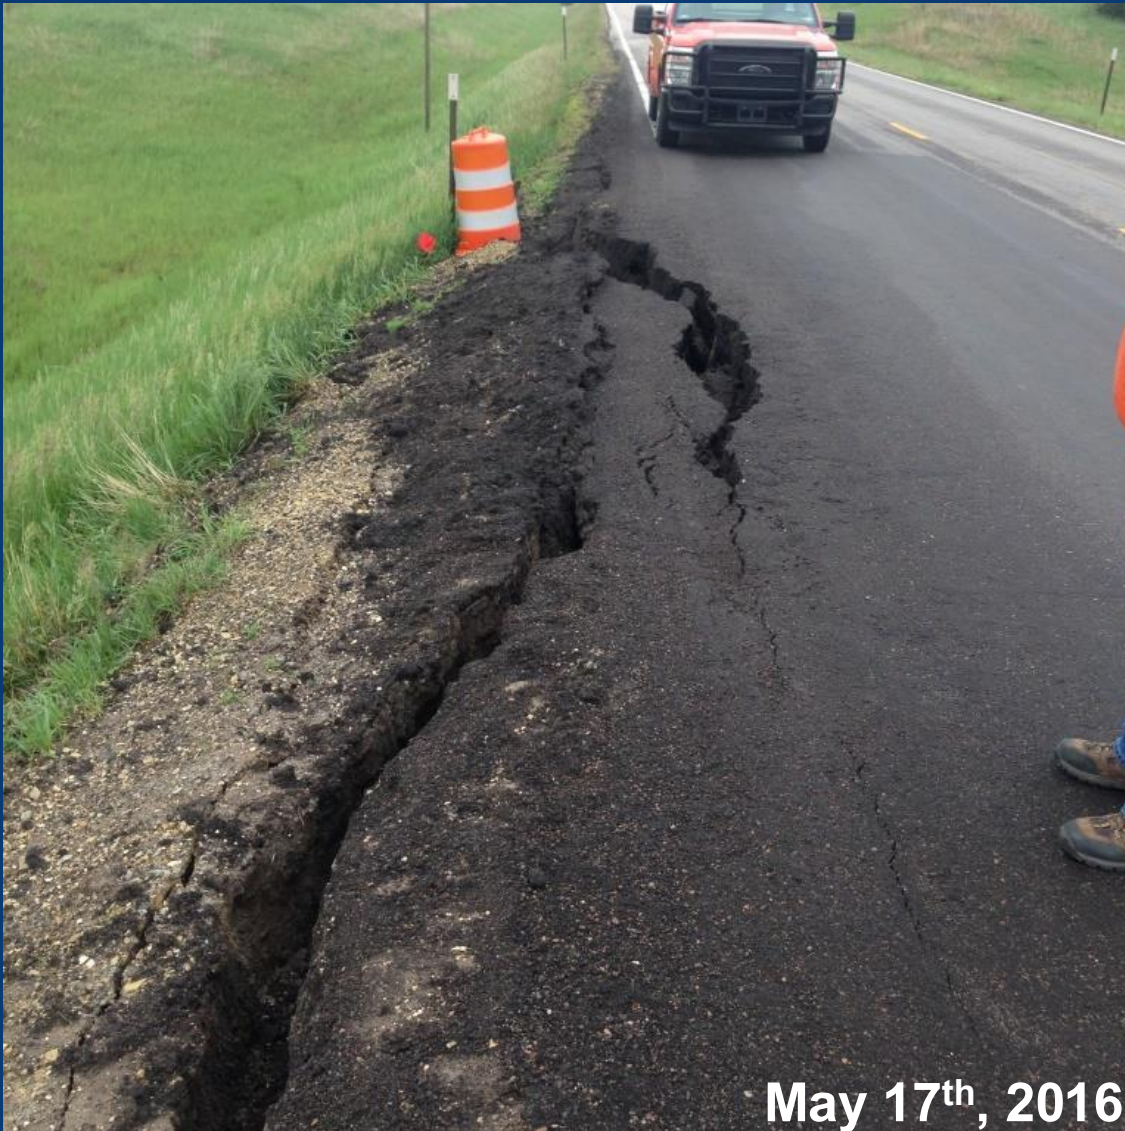
- Time Constraints
 - No lab testing

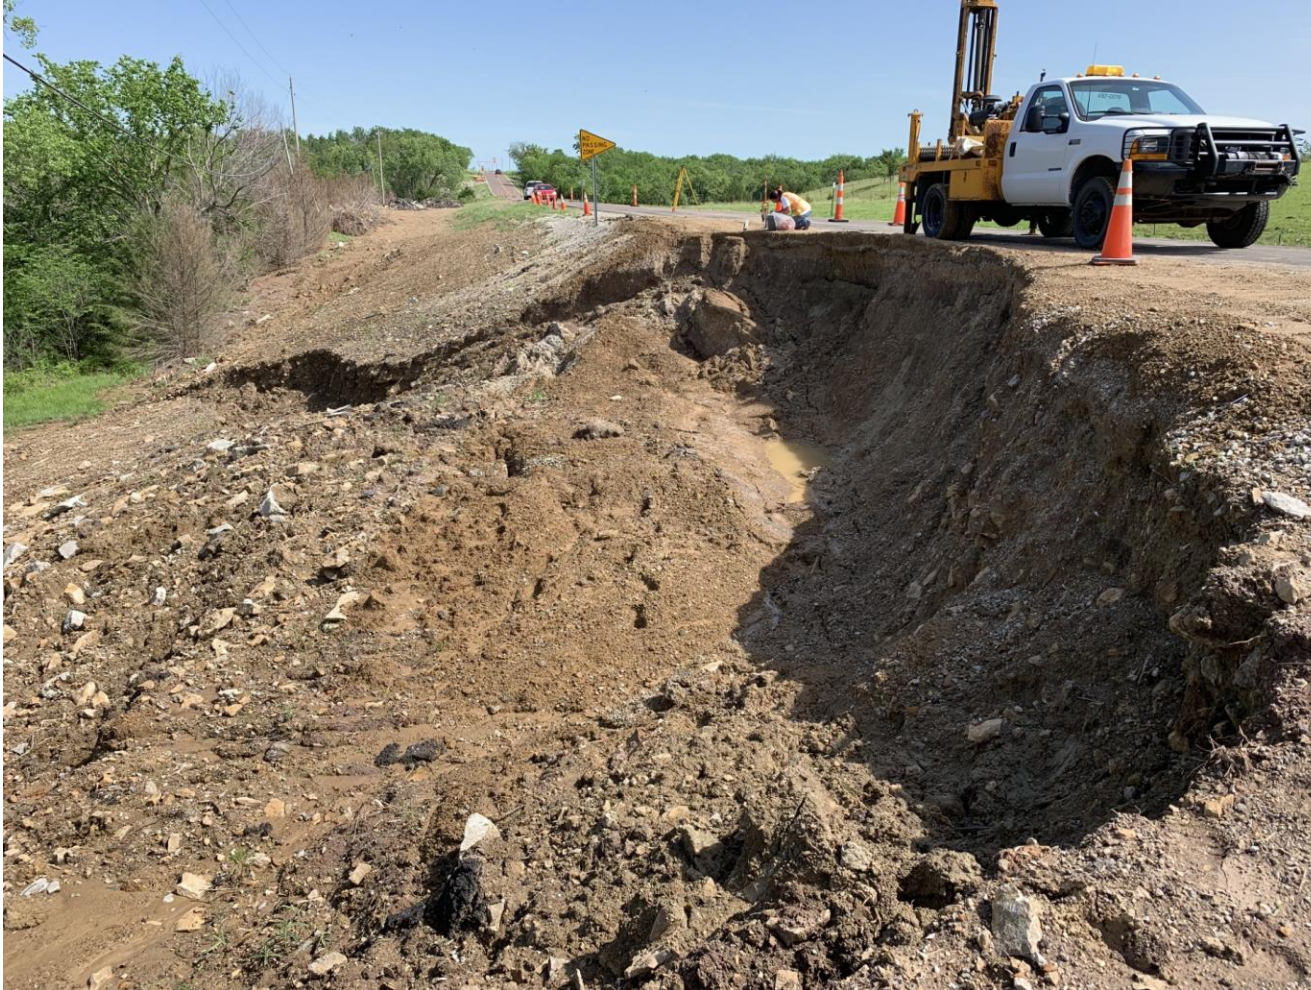
K-105 Failure Background & Soil Properties

Reported Liquid Limits	38 – 55	
Reported Plasticity Indexes	17 – 34	
Reported Effective Friction Angles (ϕ')	17.3	30.9
Reported Effective Cohesion (c') (psf)	700	343

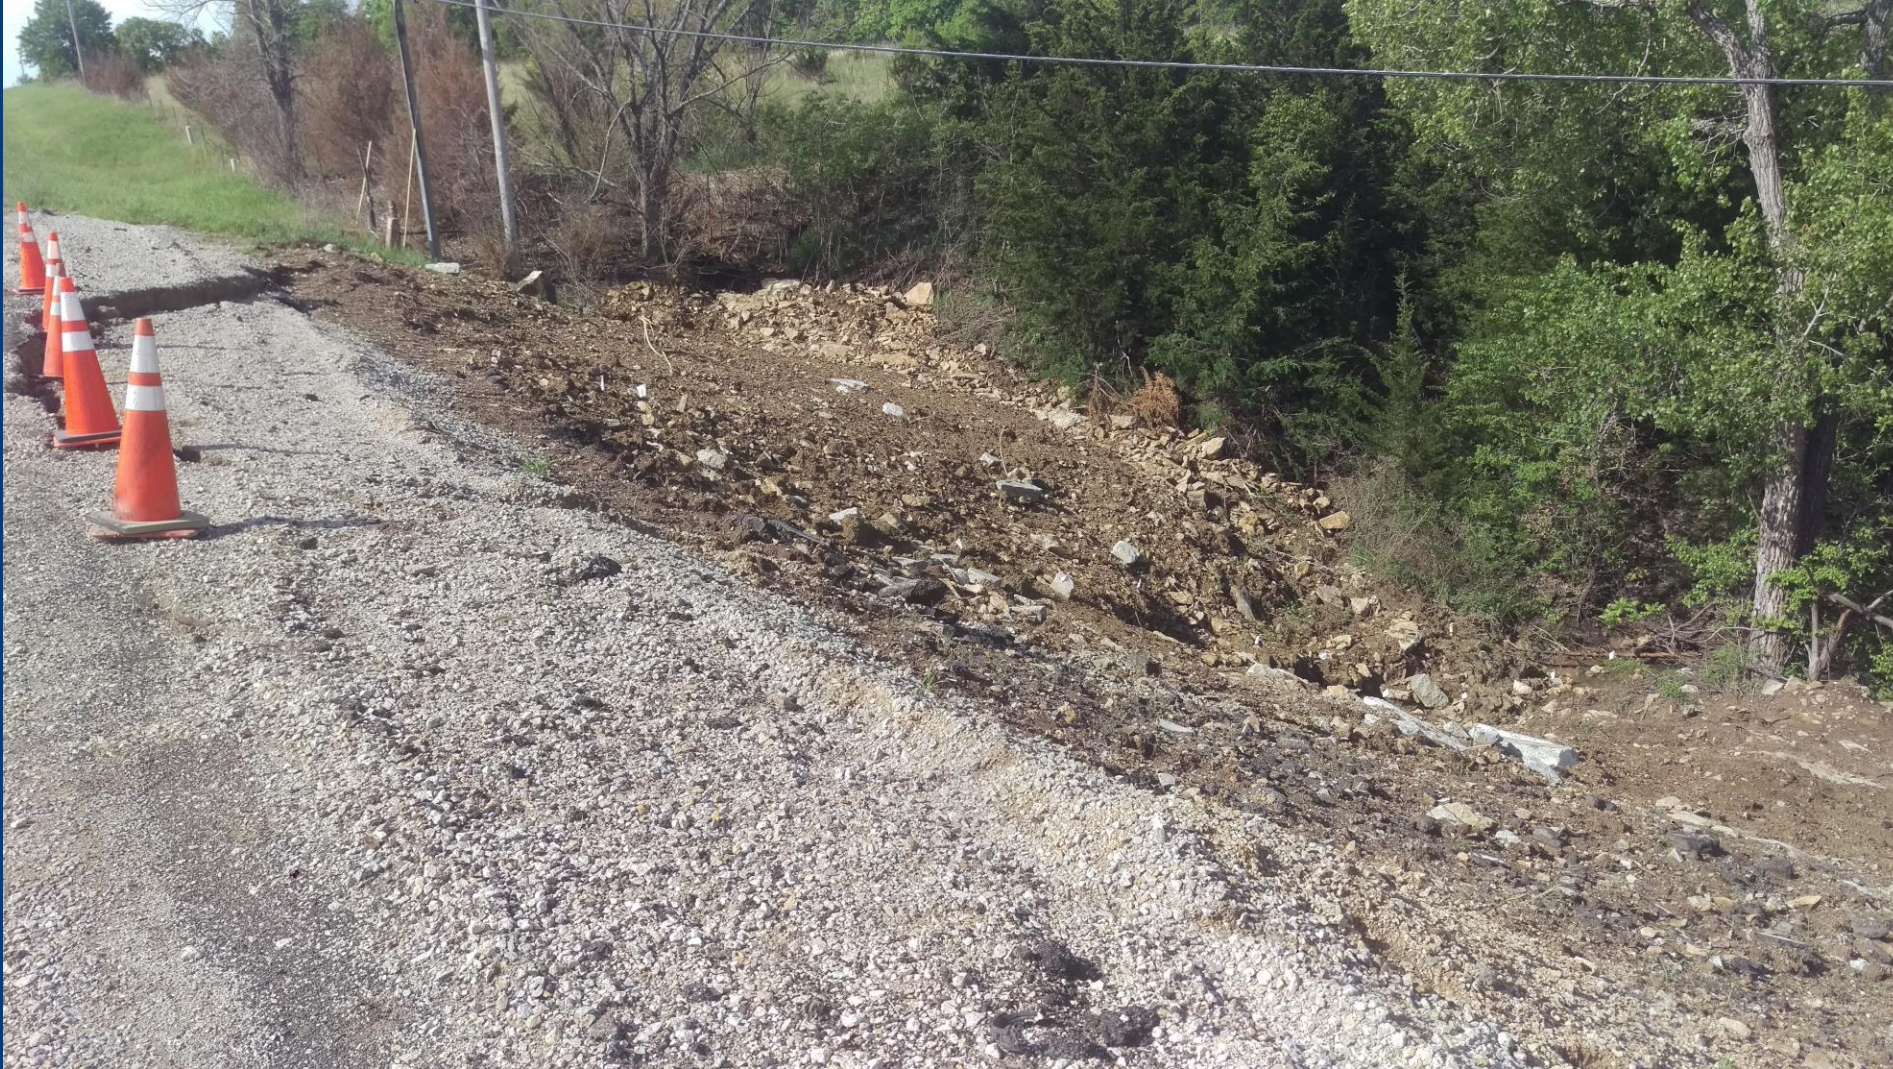
May 10th, 2019

K-105 Slope Failure Background

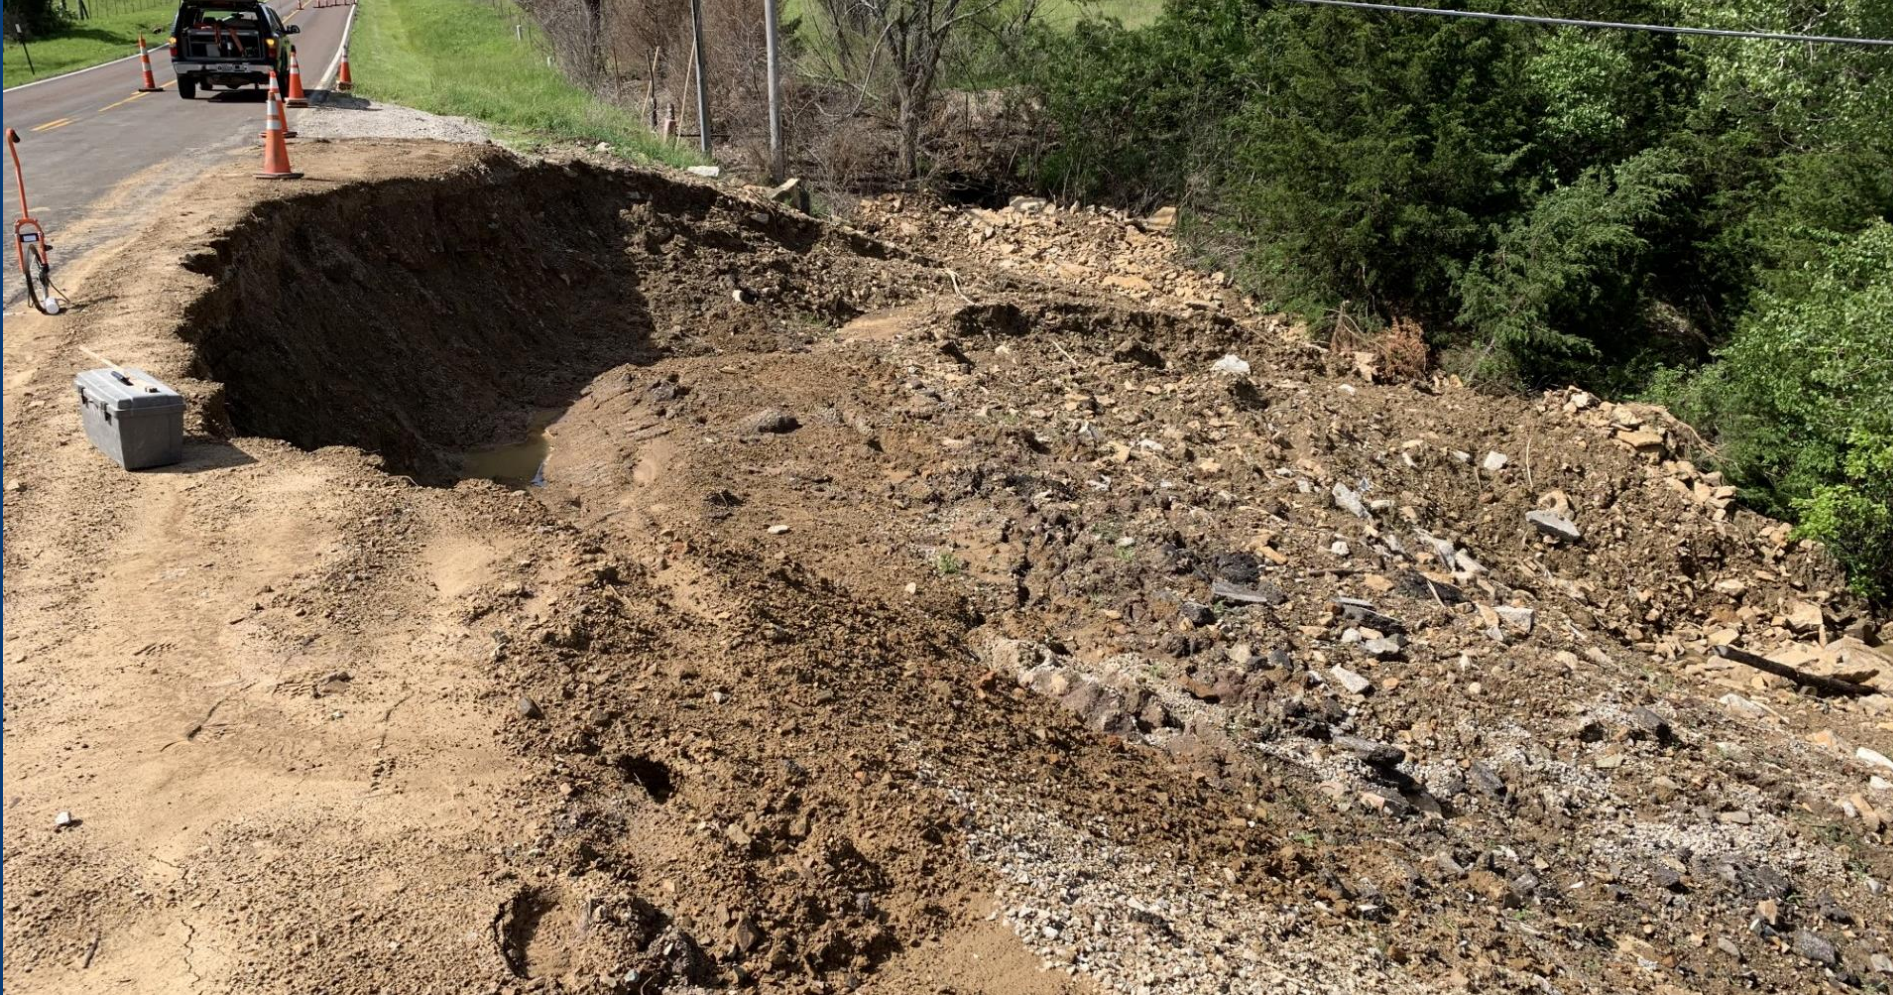
May 22nd, 2019

K-105 Slope Failure Background

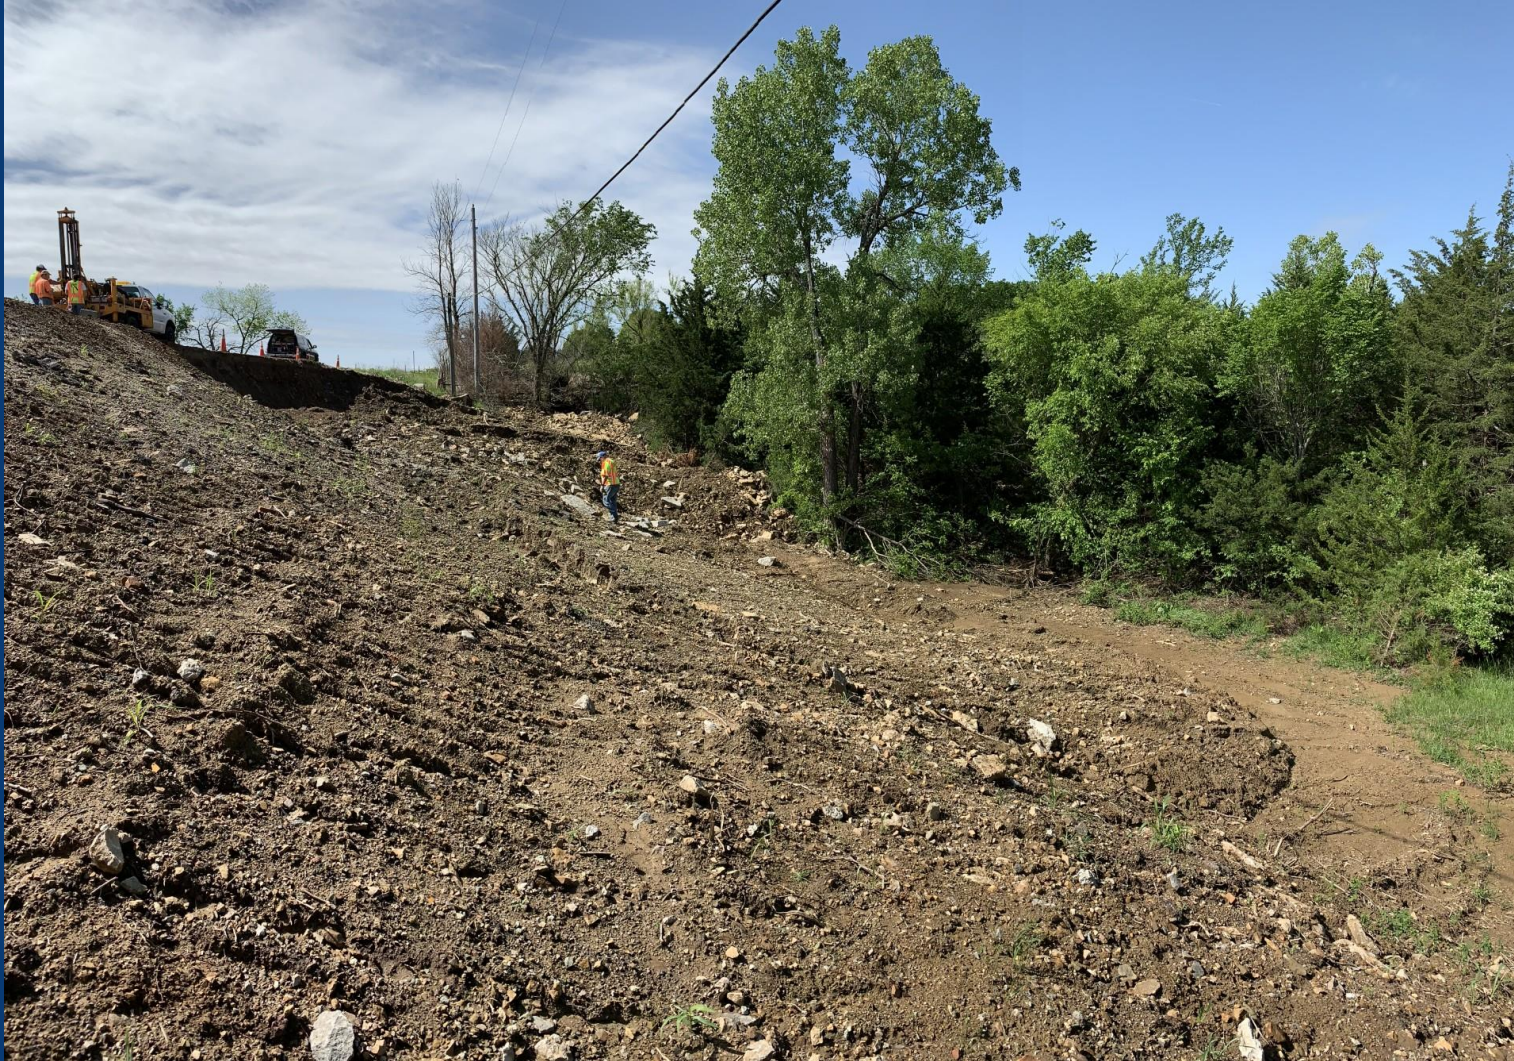
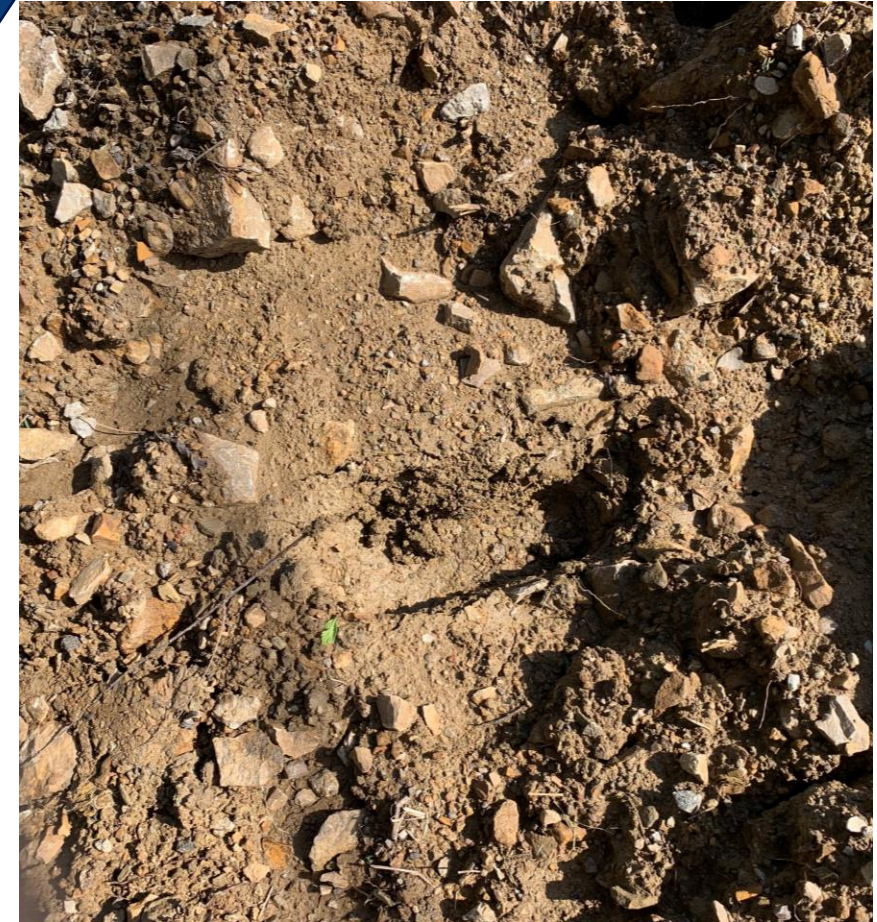
K-105 Slope Failure Background

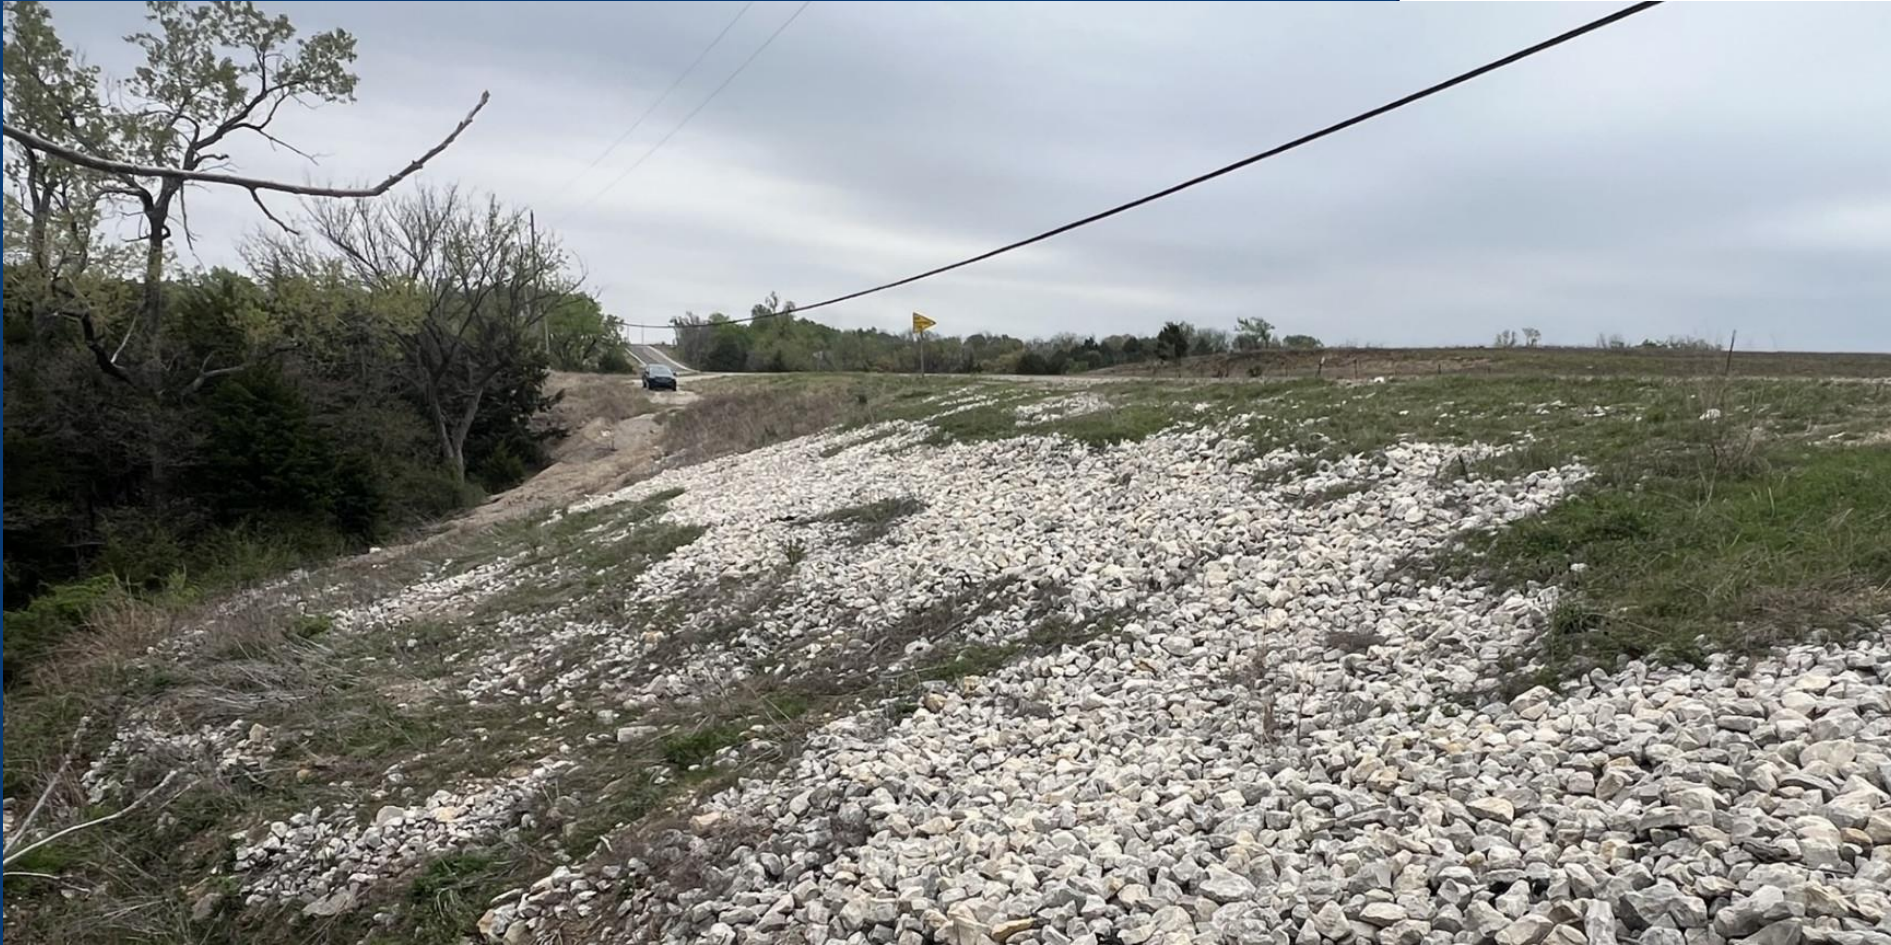
April 2025

K-105 Slope Failure Ongoing Performance

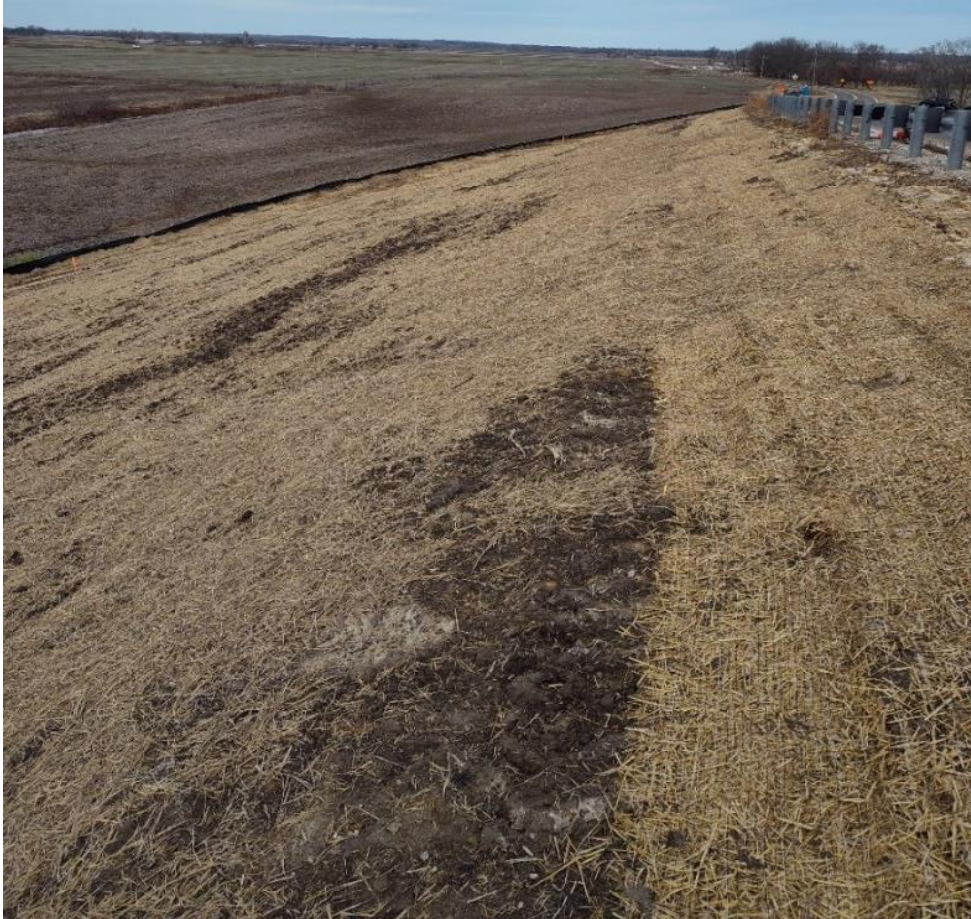
- **Importance of Follow-up visits**
- Identifying and Addressing Slope Failures before they impact the roadway
- Safely accessing sites to conduct investigations and repairs

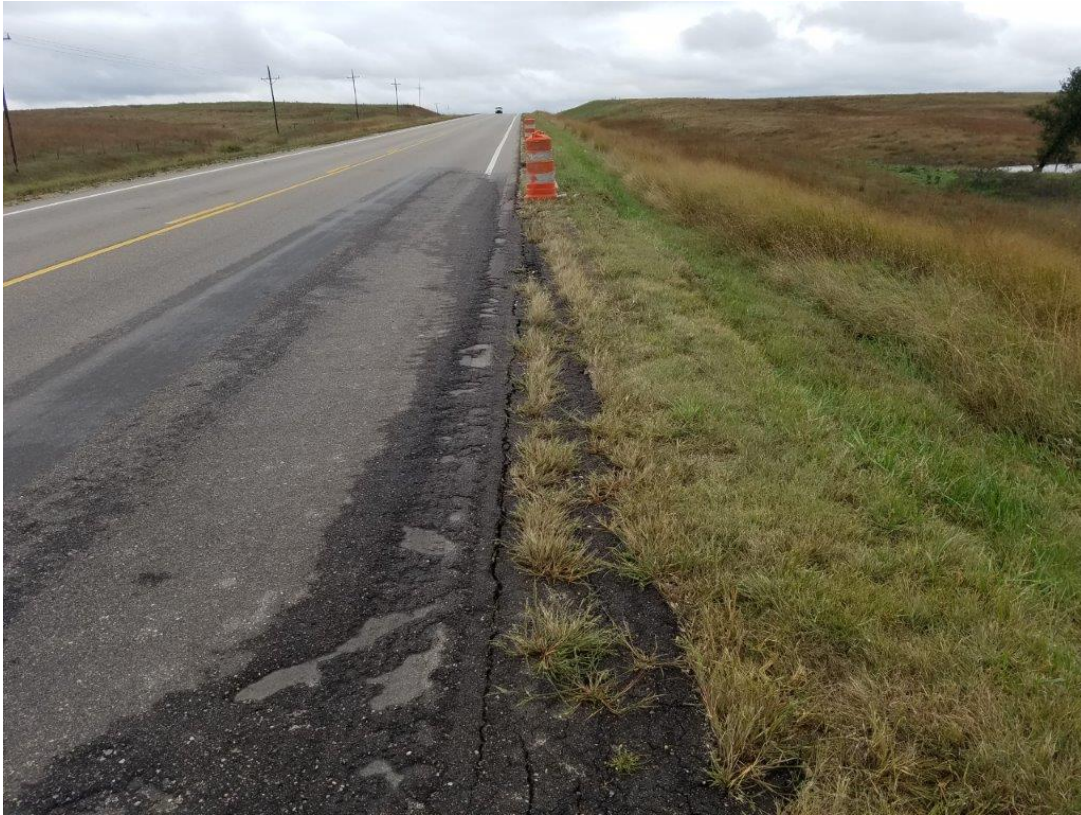
- Importance of Follow-up visits
- **Identifying and Addressing Slope Failures before they impact the roadway**
- Safely accessing sites to conduct investigations and repairs

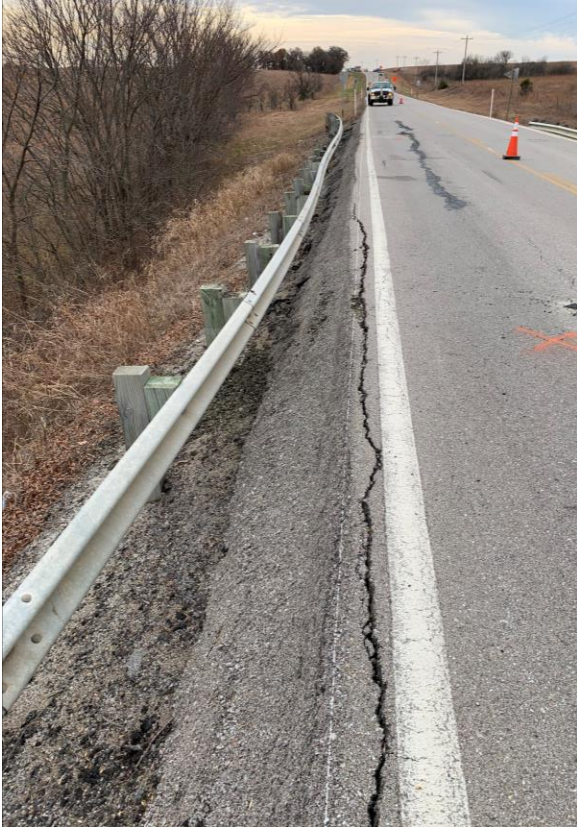
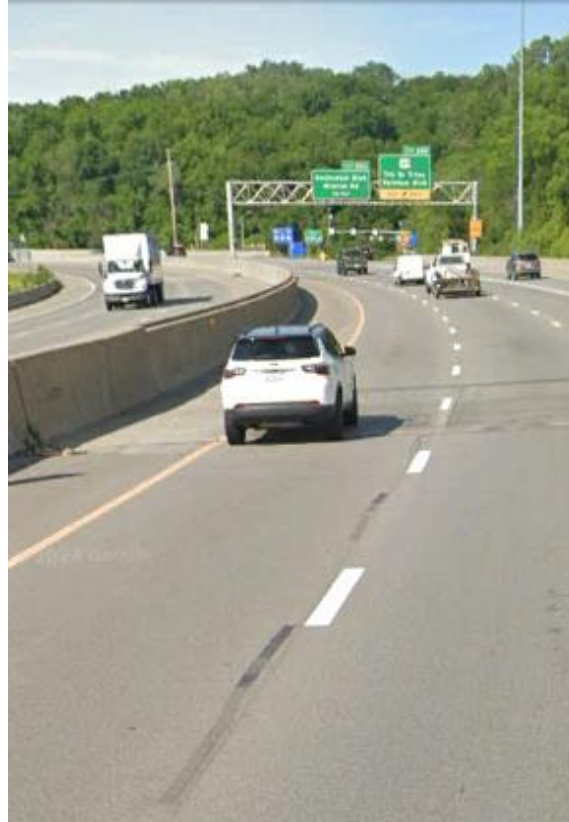
- Importance of Follow-up visits
- Identifying and Addressing Slope Failures before they impact the roadway
- **Safely accessing sites to conduct investigations and repairs**
